U.S. Department
of Agriculture

Forest Service

October 2006

Low-Water Crossings: Geomorphic, Biological, and Engineering Design Considerations

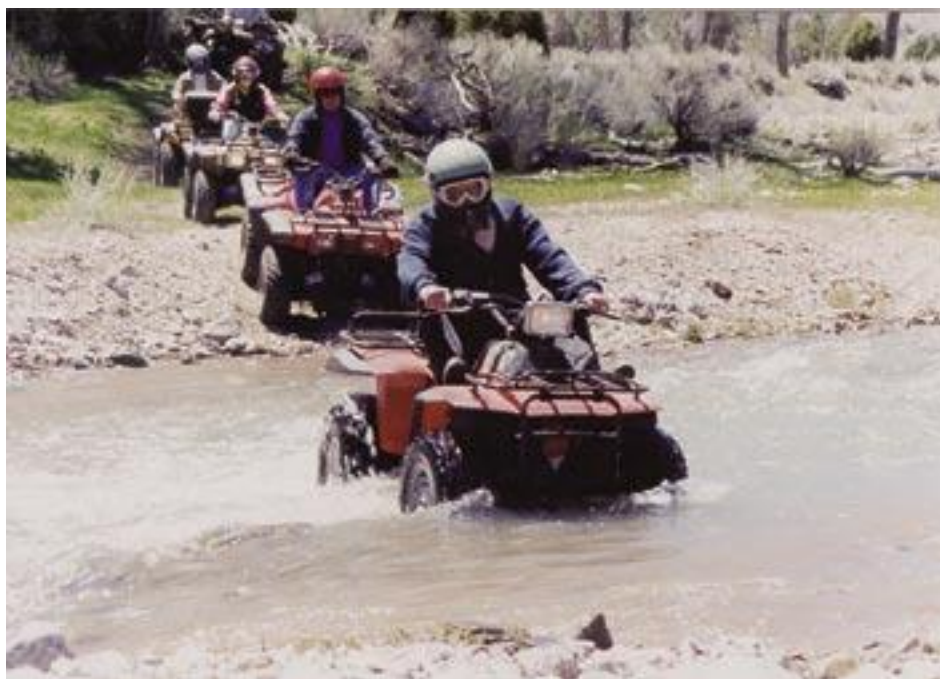
Unimproved fords are simply natural crossings. Figure 1.2 shows an example of an unimproved ford.

Figure 1.2—Unimproved ford on the Fishlake National Forest, Utah.

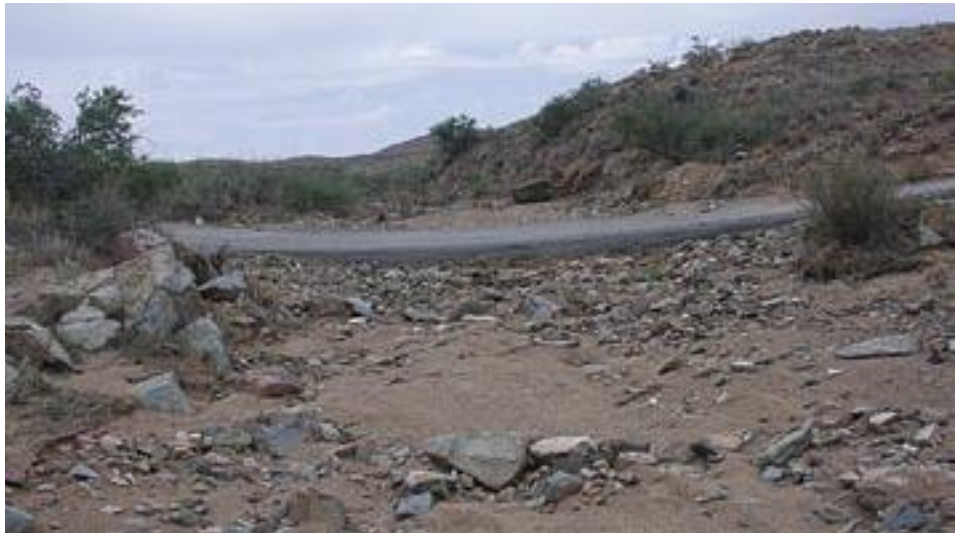
Improved fords have a stable driving surface of rock, concrete, asphalt, concrete blocks, concrete planks, **gabions**, **geocells**, or a combination of materials (fig. 1.3). Sometimes a small channel or slot is included at the structure's low point to pass very low flows and aquatic animals. The downstream roadway edge may be stabilized and defined with logs, riprap, gabions, or **Jersey barriers**.

Figure 1.3—Improved ford on an ephemeral tributary of the Agua Fria River, Arizona.

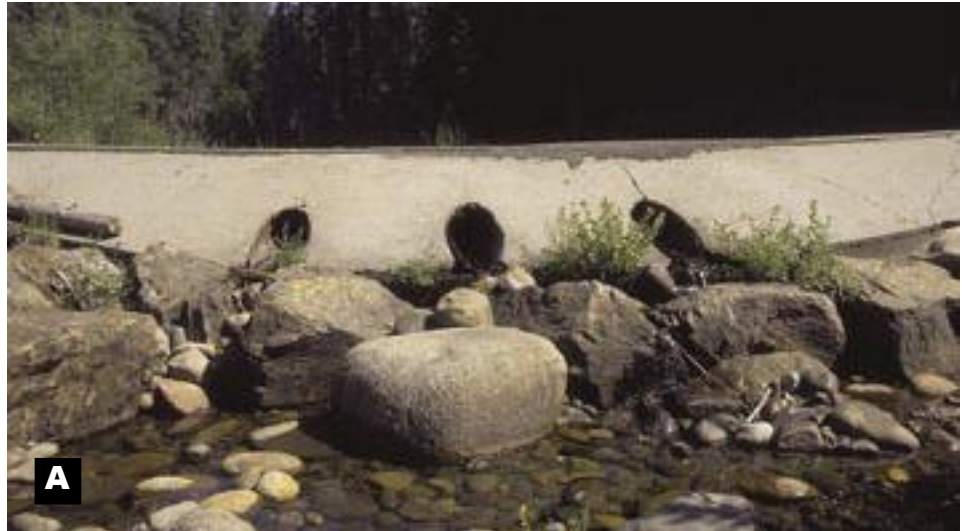
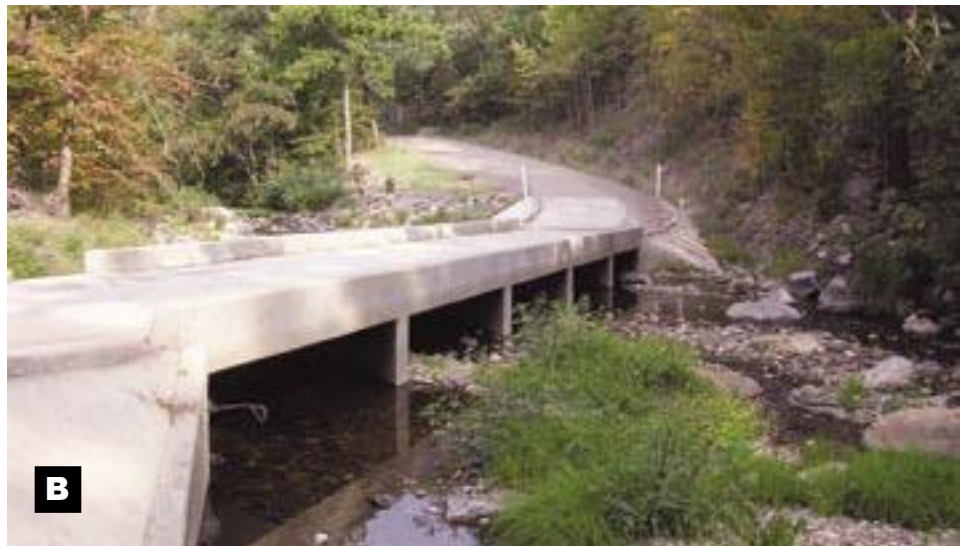
Figure 1.6 illustrates the difference between high- and low-VAR fords. The California example (fig. 1.6A) is an old structure that mostly blocks the bankfull cross section area. The Arkansas vented ford (fig. 1.6B) was constructed in 2004 with the express goal of allowing fish and sediment passage.

Figure 1.6—(A) Low-VAR ford on the Eldorado National Forest, Northern Sierra Nevada, California. (B) High-VAR ford on the Ouachita National Forest, Arkansas. Note that this site is on a curve and needs safety warning signs.

A common type of high-VAR ford is a series of box culverts that approaches or matches stream width and bankfull depth (figs. 1.6B and 1.7). These structures typically look like bridges and, where the bottoms are embedded, can be mistaken for bridges. High-VAR fords may not significantly obstruct flow until the water surface rises to the top of the structure.

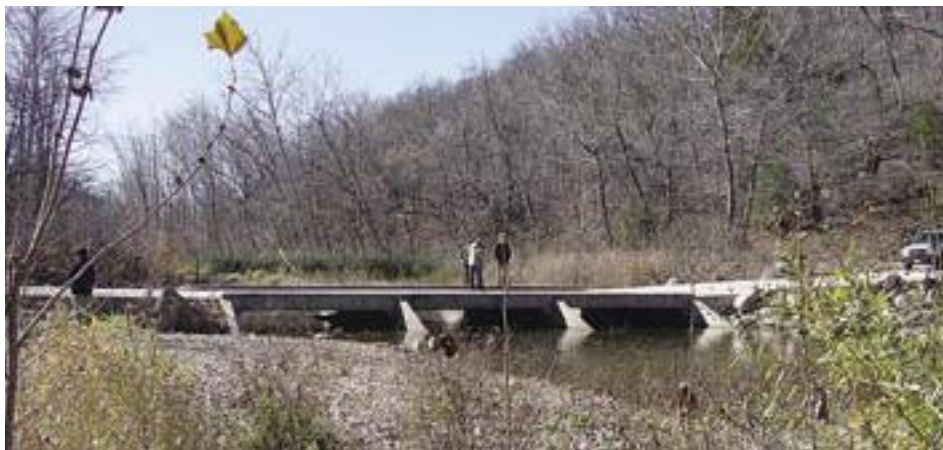
Figure 1.7—High-VAR ford composed of three box culverts, Mark Twain National Forest, Missouri.

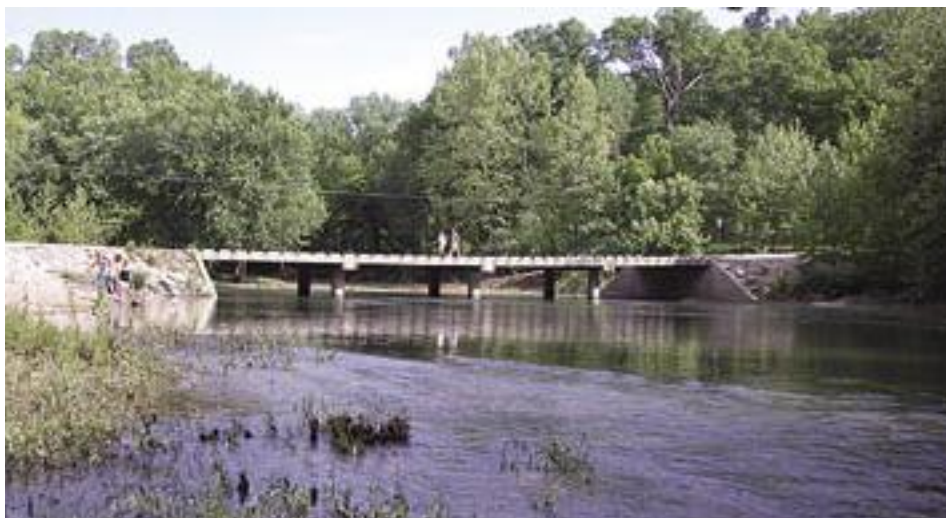
In this publication, we define *low-water bridges* as open-bottom structures with elevated decks and a total span of at least 20 feet (fig. 1.8). They may be designed with one or several piers. Low-water bridges generally have greater capacity and are able to pass higher flows underneath the driving surface than most vented and unvented fords. As with fords, however, low-water bridges are designed and installed with the expectation they will be under water at higher flows. *Forest Service Manual* (FSM) 7720 (Transportation System Development) requires all structures receive specific hydrologic, hydraulic, structural, and foundation design in accordance with the American Association of State Highway Transportation Officials (**AASHTO**) *Standard Specifications for Highway Bridges*. A qualified engineer must design the low-water bridge and review the completed structure.

Figure 1.8—Low-water bridge at Boiling Springs, Big Piney River, Missouri.

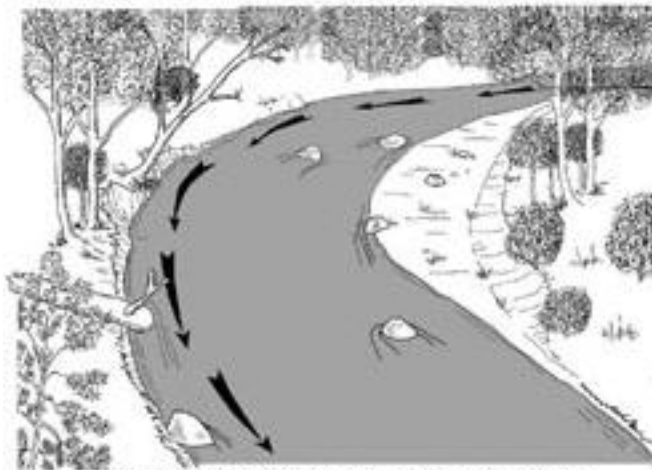
ACTIVE BANK SCOUR WITH VERTICAL CUT BANKS, SLUMP BLOCKS, AND FALLING VEGETATION

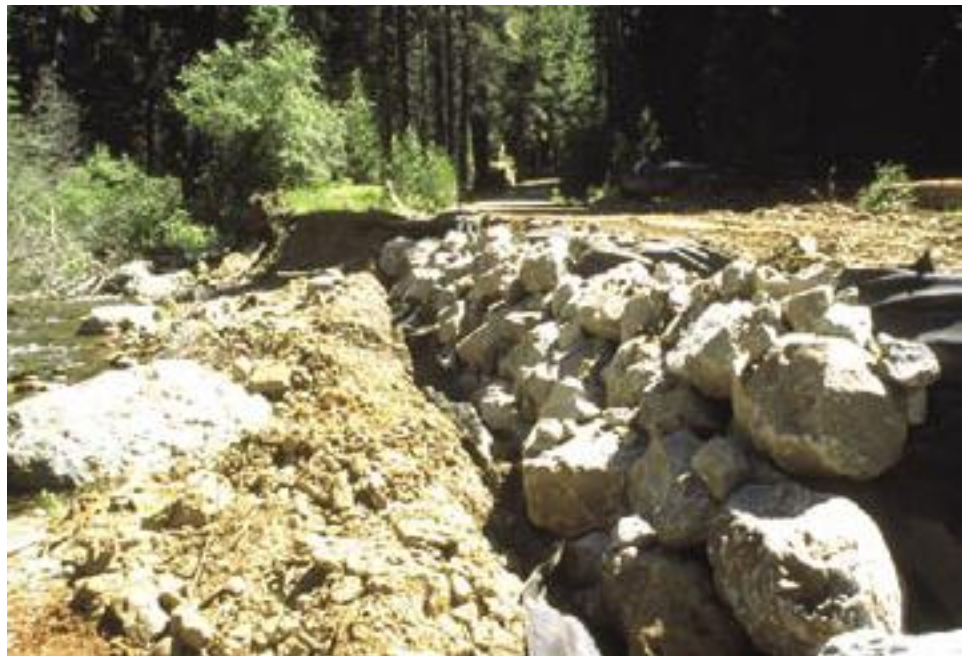
Figure 4.14—Poplar Creek riprap streambank stabilization structure under construction, Plumas National Forest, 1998. The geotextile prevents erosion of fine soil through the voids in the riprap.

simultaneously prevents soil particle movement and retains fine soil in place. In critical applications, a multiple layer of filter material may be desirable. Filter aggregate is commonly either coarse sand or graded gravel placed in a 6-inch minimum thickness layer. Geotextiles, most often used today in filter applications under riprap, are usually a needle-punch nonwoven fabric weighing at least 6 ounces per square yard. Alternatively, it is possible to use a woven geotextile where the opening percentage and size are designed to the specific gradation of the soil it is protecting. Geotextiles also help protect fine soils against erosion where there are voids in the large rock riprap (fig. 4.14).

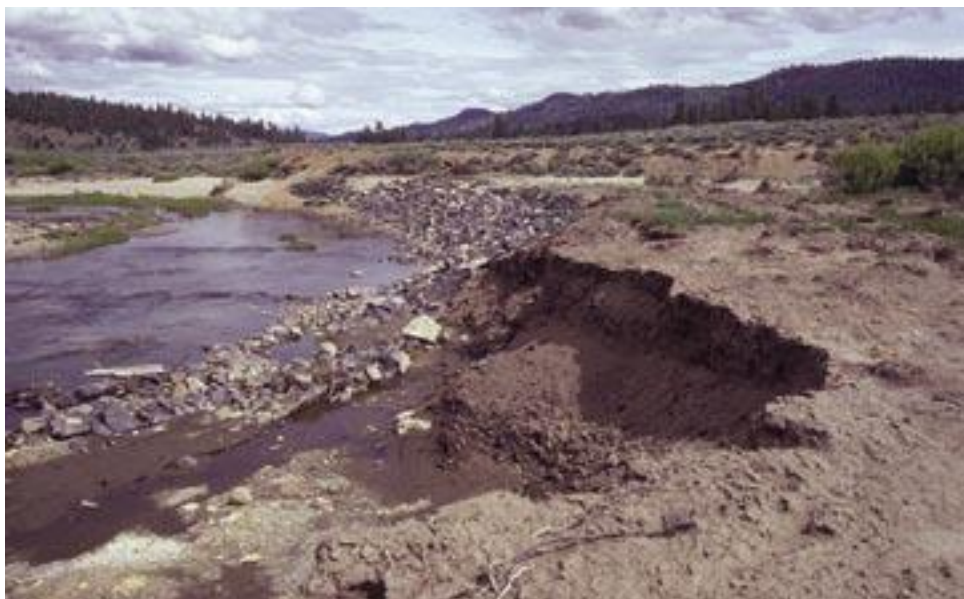
Figure 4.16—Looking downstream at a failed riprap installation on Red Clover Creek, Plumas National Forest.

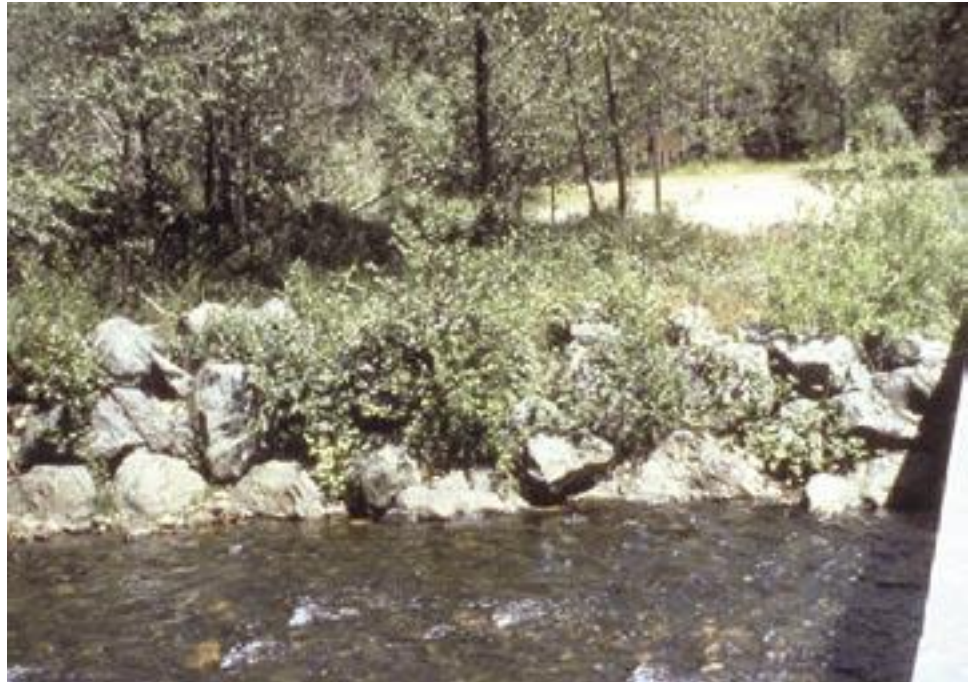
Figure 4.17—Large riprap with vegetation used for streambank stabilization, French Creek Crossing, Plumas National Forest.

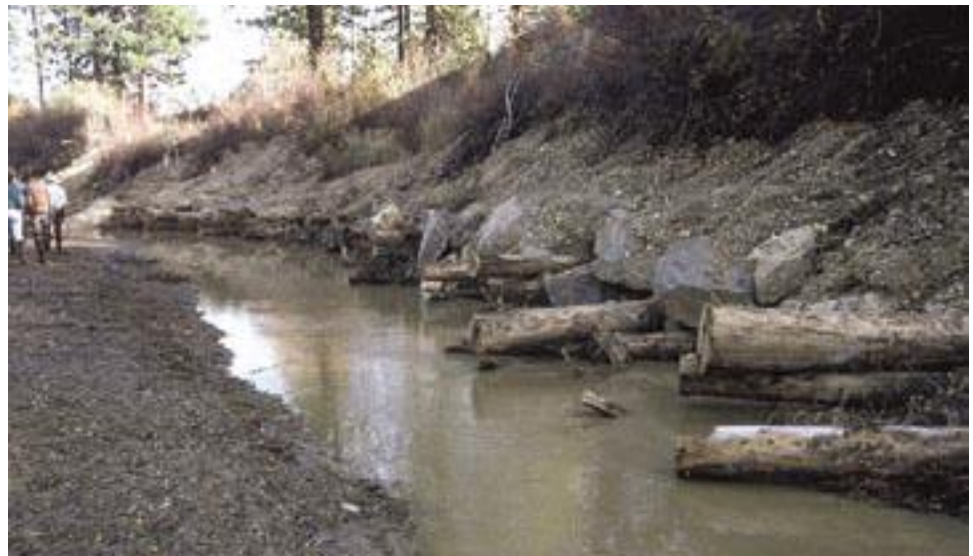
Figure 4.18—Rootwads and boulders used to stabilize a high streambank, Wolf Creek restoration project, Greenville, California, 1990.

Vegetation is the most desirable method of streambank protection (as well as some channel protection where vegetation can grow) because of low cost, aesthetics, and compatibility with the natural environment. Vegetation alone, however, is typically suitable only for streambank protection with velocities in the range 1 to 5 feet per second. It is not adequate for protecting turbulent flow areas, areas of fast or impinging flows, midchannel piers, or areas generally underwater. Vegetative stabilization performance can be significantly improved by using it in conjunction with rootwads and boulders (figs. 4.18 and 4.19), biotechnical treatments, and reinforcing mats.

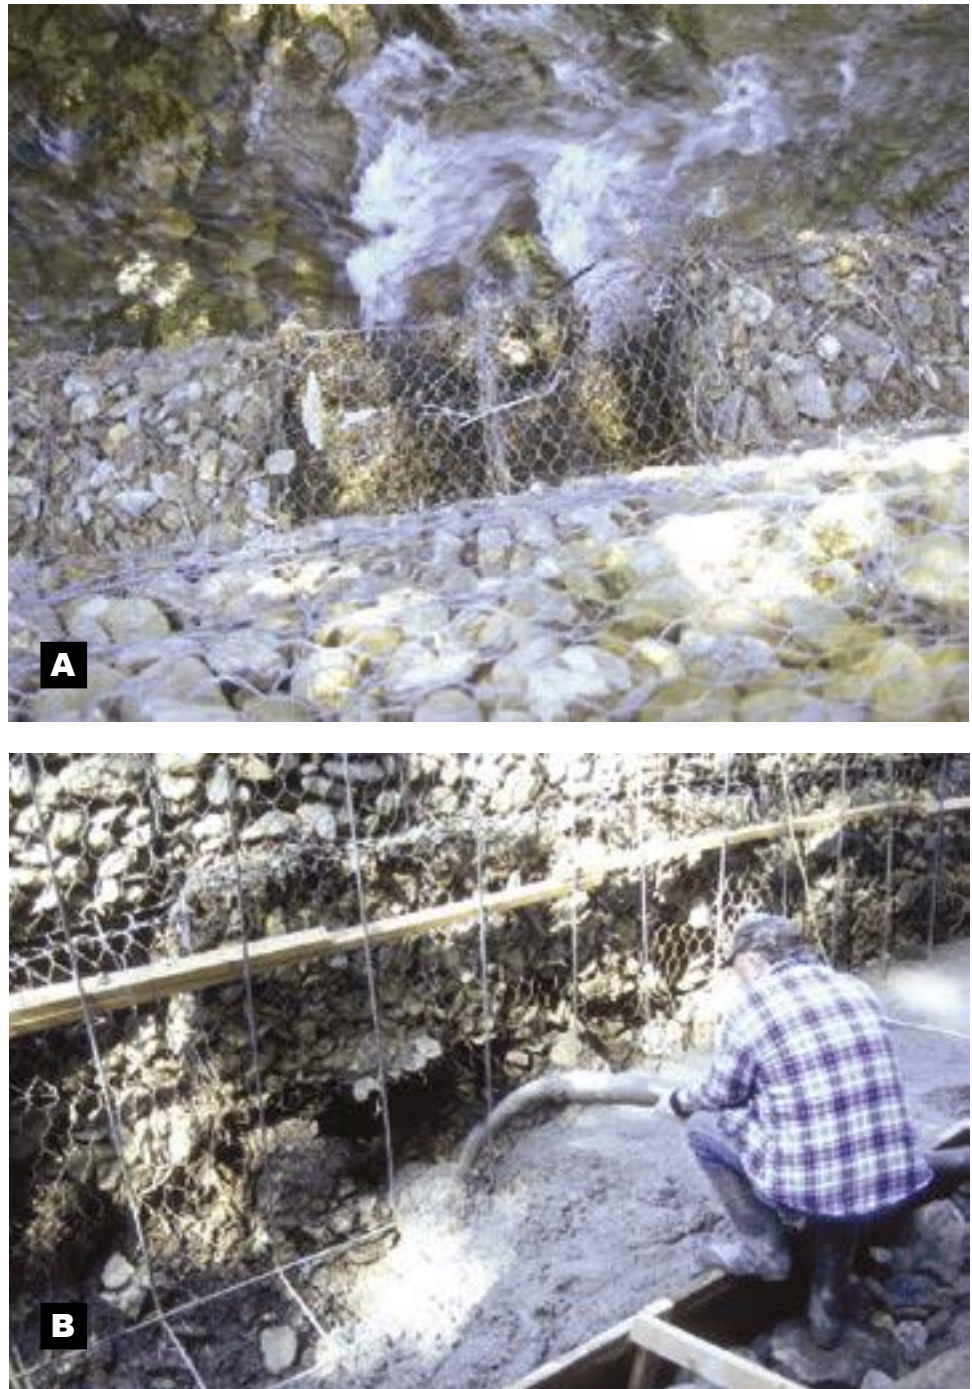
Figure 4.20—Gabion-basket failure and maintenance. a) Looking down at gabion baskets constructed to stabilize streambanks on Soda Creek, Plumas National Forest. Wire has rusted, allowing rock to wash away. b) To repair the stabilization structure, a concrete wall was poured in front of the damaged gabions.

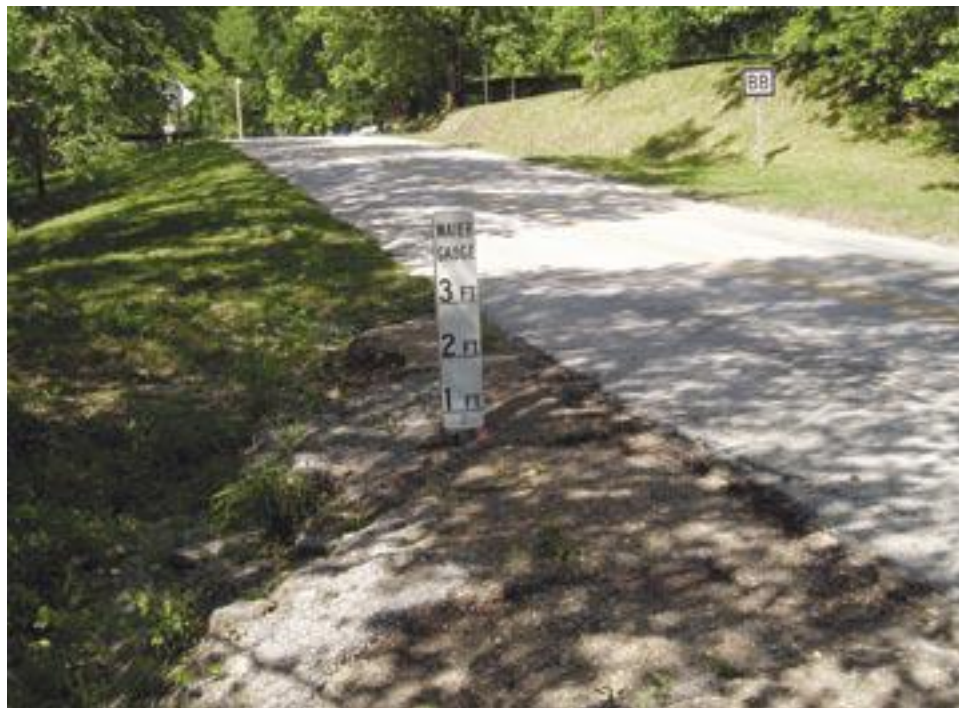
Figure 4.22—Typical depth marker, Missouri county road.

Where practical, use depth markers to indicate the depth of flow over the structure (fig 4.22). Depth markers may be impractical or require periodic maintenance in channels carrying a lot of debris. Alternatively, a system of colored posts could be used where flow level green suggests safe passage, flow level yellow suggests marginally safe conditions, and flow level in the red zone indicates an unsafe condition.

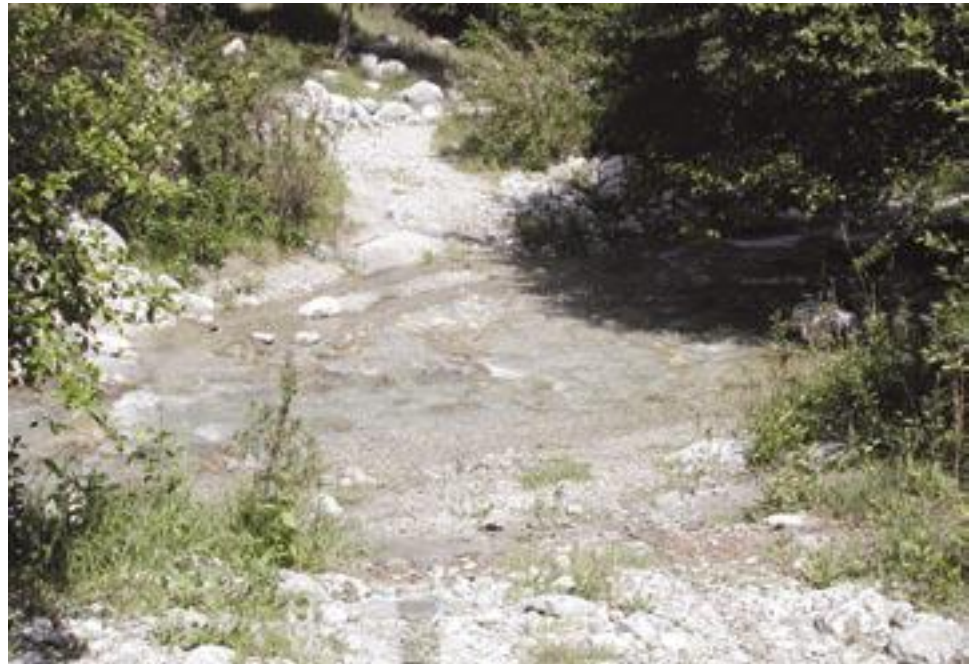
Figure 5.1—Unimproved rock ford on the East Fork San Gabriel River, Angeles National Forest, California.

Unimproved at-grade fords are crossings where vehicles simply drive across the channel without the benefits of hardening or grading. The ideal site for an unimproved ford is one with rocky, hard substrate (fig. 5.1) or bedrock. Even where the channel bottom is hard, the streambanks can be soft and erodible. In such cases, traffic generally causes the stream to widen as the banks break down and wash away. This problem can be fixed by “improving” the ford—removing soft soils and replacing them with select coarse rock.

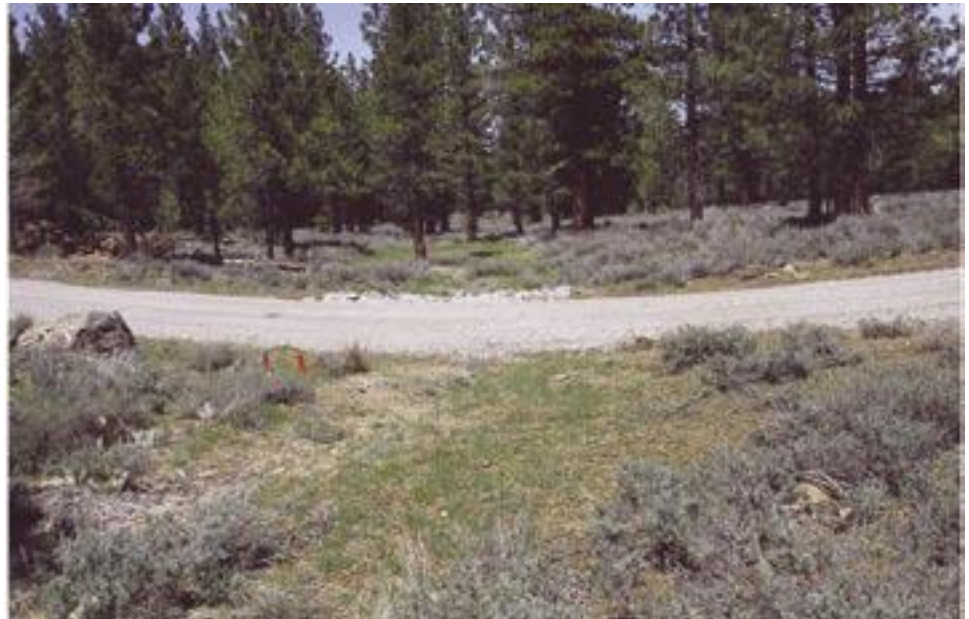
Improved rock fords are usually constructed by overexcavating the roadway area 6 to 8 inches deep and backfilling the excavation with well-graded coarse rock back to the natural stream channel level. Coarse rock size should be selected to resist movement at maximum flow velocities, and mixed with finer material for trafficability. Often two separate layers of rock are needed to satisfy both concerns. The downstream outlet area of the ford may be stabilized with moderately large riprap. A naturally coarse rocky stream channel bottom or a smooth bedrock area is ideal and requires no overexcavation.

Figure 5.2—At-grade improved rock ford, Plumas National Forest.

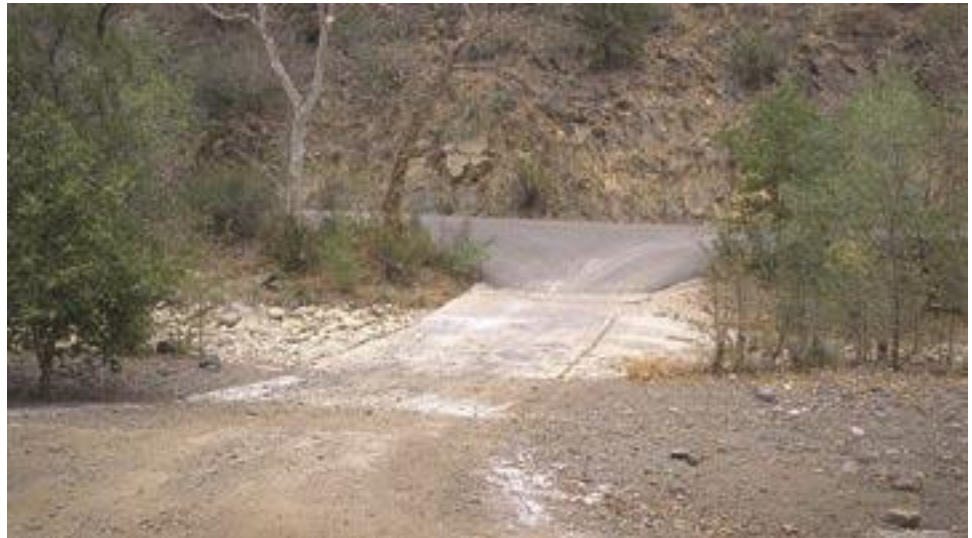
Figure 5.3—Old concrete slab ford with grout apron, Ashdale Administrative Site, Tonto National Forest. (case study 8)

Concrete slabs can withstand a large amount of debris or sediment overtopping the structure without damage (fig. 5.3). They are relatively common on flashy desert streams, even streams large enough to provide at least intermittent fish habitat. Except when backwatered, they commonly create fish passage problems because of the increased flow velocity and shallow flow across the smooth concrete slab (case study 8). Roughening the slab with embedded boulders or a rough concrete finish may help promote passage, but will not solve the problem completely. Elevated slabs or flat slabs in a steep channel with a water drop along the downstream edge require more downstream scour protection and often create a jump barrier (fig. 5.4).

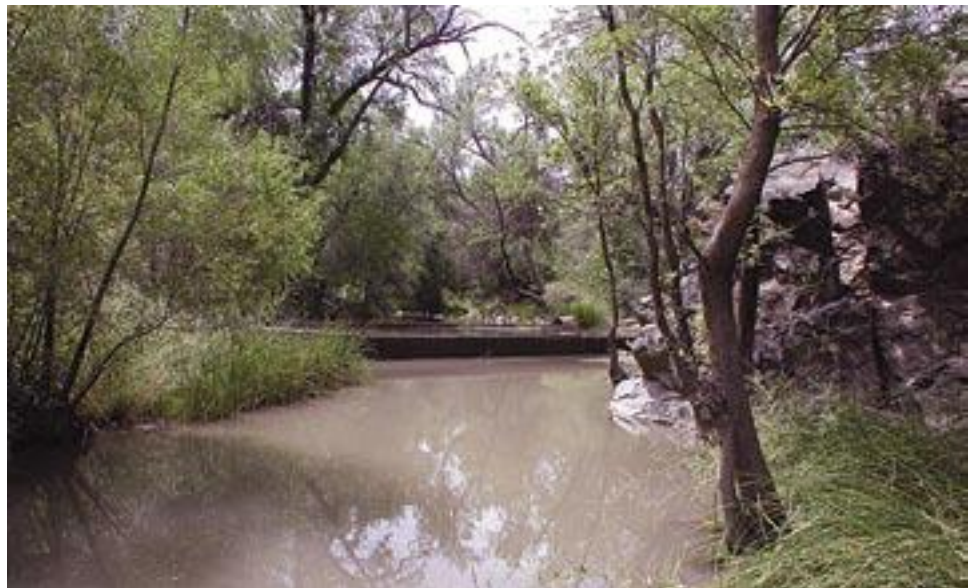
Figure 5.4—Concrete slab creates fish barrier at low flow, Seven Springs, Tonto National Forest.

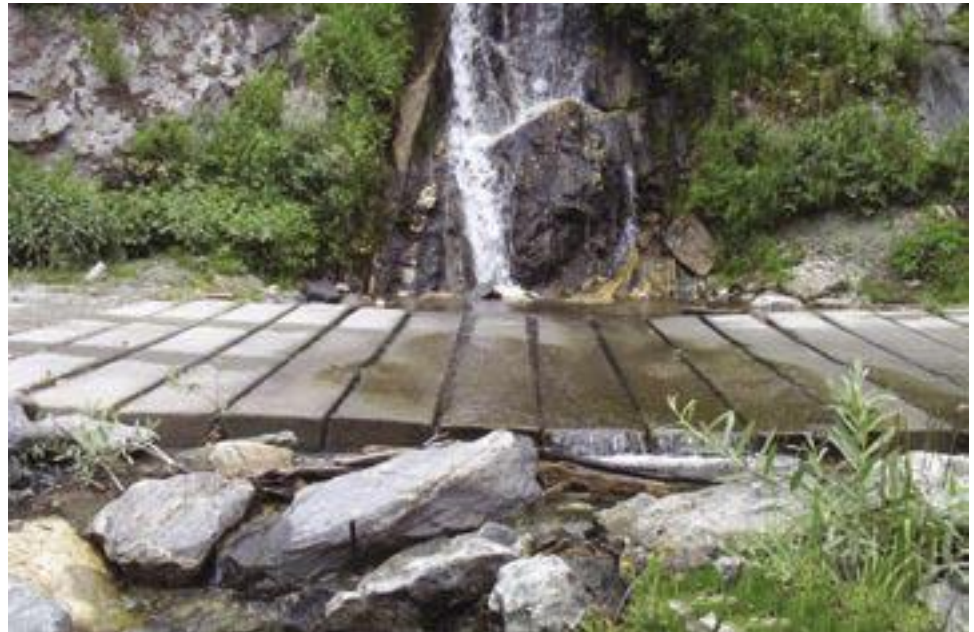
Figure 5.5—Concrete plank ford at edge of the North Fork Clearwater River, Clearwater National Forest, Idaho.

Precast concrete planks also are used in at-grade fords to provide a concrete-hardened driving surface. The structure typically consists of individual 12-inch by 12-inch by 16- to 20-foot long, steel reinforced, precast concrete “planks” or logs, bolted together with iron flanges to hold their spacing (McNemar 1983). The planks are placed upon a prepared, graded rocky surface. The outlet may be armored with riprap to protect against the increased flow velocities across the planks and through the small channels between the planks (case study 5). The structure acts like a vented ford (with small vents) at low flow, with a dry driving surface and with flow going between the planks (fig. 5.4).

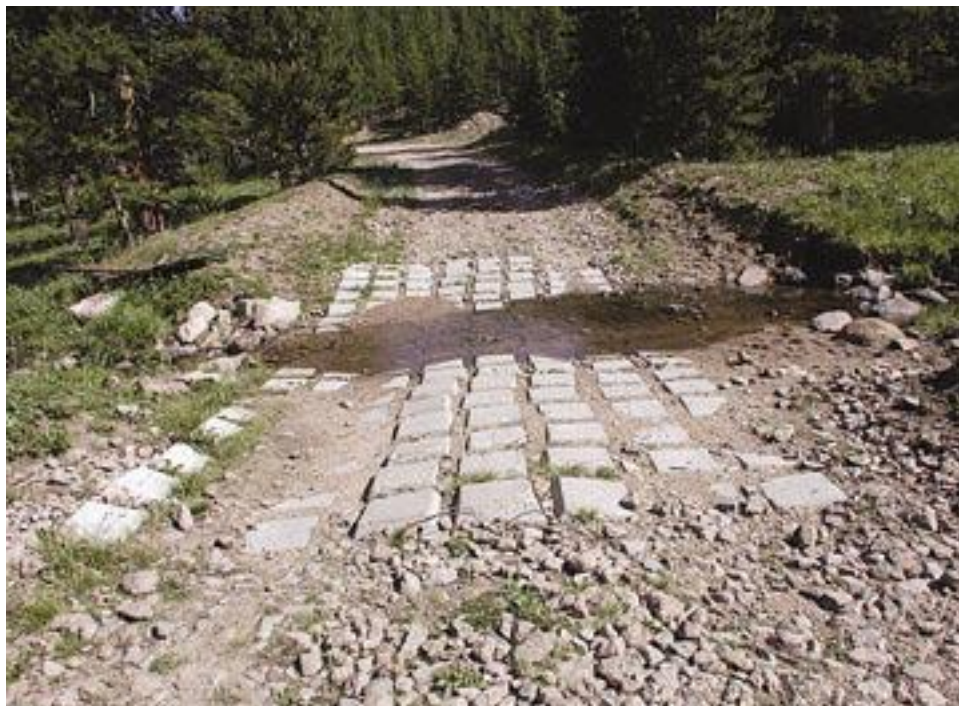
Figure 5.6—Cable concrete block ford, Bighorn National Forest, Wyoming. Note that mat should extend higher to protect the crossing adequately.

protection, such as riprap, may be needed along the downstream edge of the structure. The mats can be anchored in place simply with rebar and cable clamps, or with soil or rock anchors in a dynamic environment.

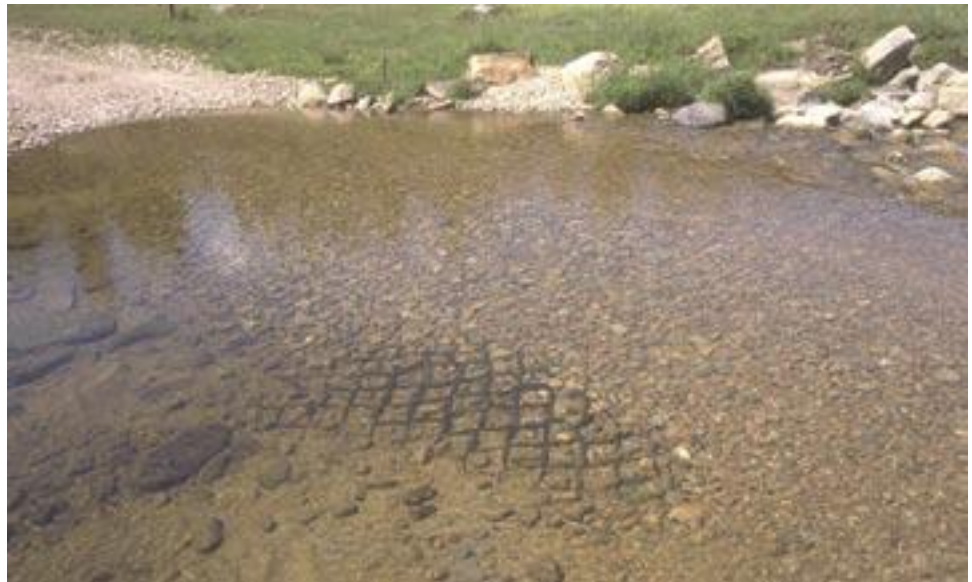
The site should be dewatered to facilitate construction and minimize site sediment production. Then, the roadbed is excavated to the depth of the geocells plus cover, and prepared by removing boulders, filling voids with gravel, leveling, and compacting the base of the crossing (fig. 5.7). The first step in installing the mat is to place the geotextile layer on the base. Second, the geocells are expanded in place across the area on top of the geotextile, and staked down. Third, the geocells are backfilled with 1½- to 4-inch-minus gravel or smaller crushed rock by dumping the material directly into the expanded cells. Finally, the geocells are covered with a 4- to 6-inch-thick layer of a relatively coarse aggregate (a thicker layer of aggregate can be used if more structural support is needed). Ideally, all materials should be well-graded, angular, and relatively free of fines to minimize sediment in the creek. The top of the cells, plus some cover rock, should be at the level of the natural stream channel bottom (case study 7).

Figure 5.7—Geoweb installation on the South Fork Tongue River, Bighorn National Forest, Wyoming. Note exposure of geoweb due to traffic and water flow.

The collapsed geocell sheets come in bundles approximately 11 feet long and 5 inches thick. Although the geocells are easy and quick to expand and fill, after their bedding is prepared, they can be easily overstretched if their dimensions are not carefully checked (overstretched cells lose some of their capacity). Once the geocells are properly cut to size, expanded, and laid out, they can be staked in place with 3-foot-long rebar and bent into a hook-shaped stake. If work is done in the stream current (note: this is not recommended), only short sections of geocell should be filled at a time. If the relatively fine cover material is washed off during a flood or by traffic, it will need periodic replacement. This low-water crossing is best suited for light traffic such as local administrative traffic or access into campgrounds. Tire action and fast water flow can remove the gravel cover and expose the geoweb (figs. 5.7 and 5.8).

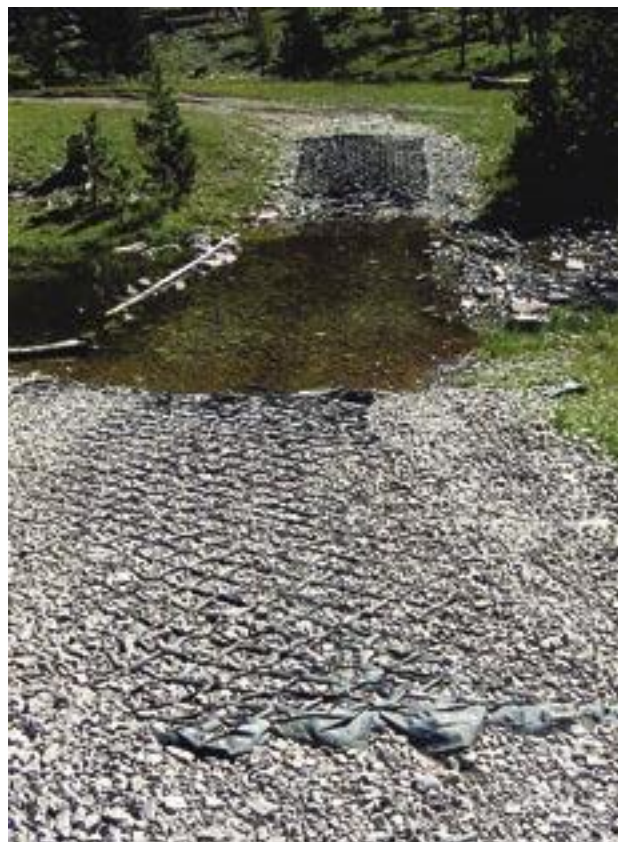
Figure 5.8—Geoweb exposed by tire action on road approaches, Ashley National Forest, Utah.

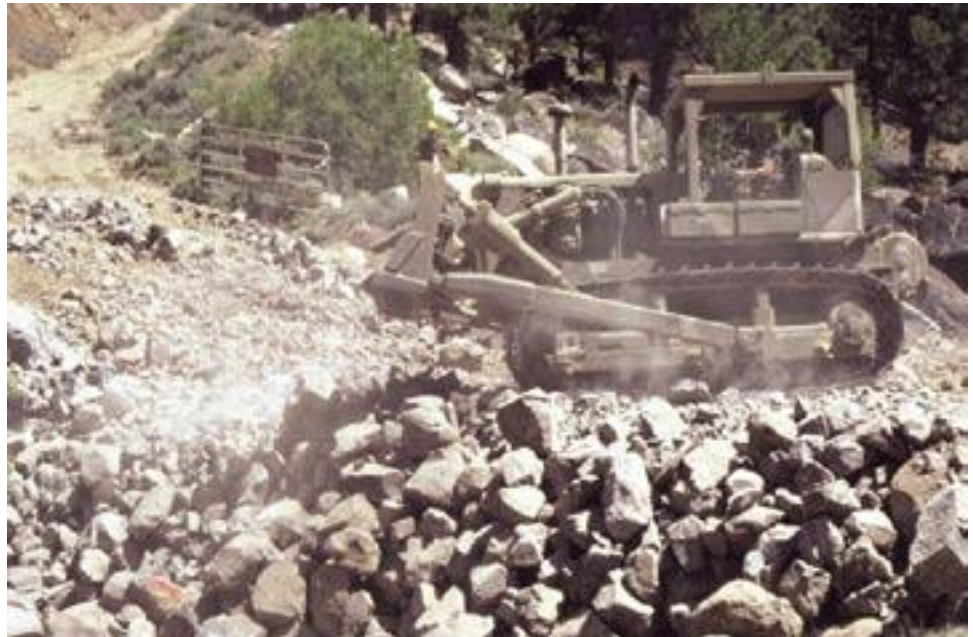
Porous, large rockfill fords are raised rockfills built to be overtopped by high flows or debris flows (fig. 5.9; see also fig A111). They are used in steep topography and in deep, incised channels where a crossing requires a high fill for good road alignment. Initially, they are porous so some water passes through the fill, but with time, they usually “silt in,” becoming impermeable and allowing flows to go over the top of the structure. They are, therefore, best suited for headwater areas where streamflows are relatively low, but carry considerable debris.

Figure 5.9—Dooley rockfill ford under construction, Plumas National Forest, California.

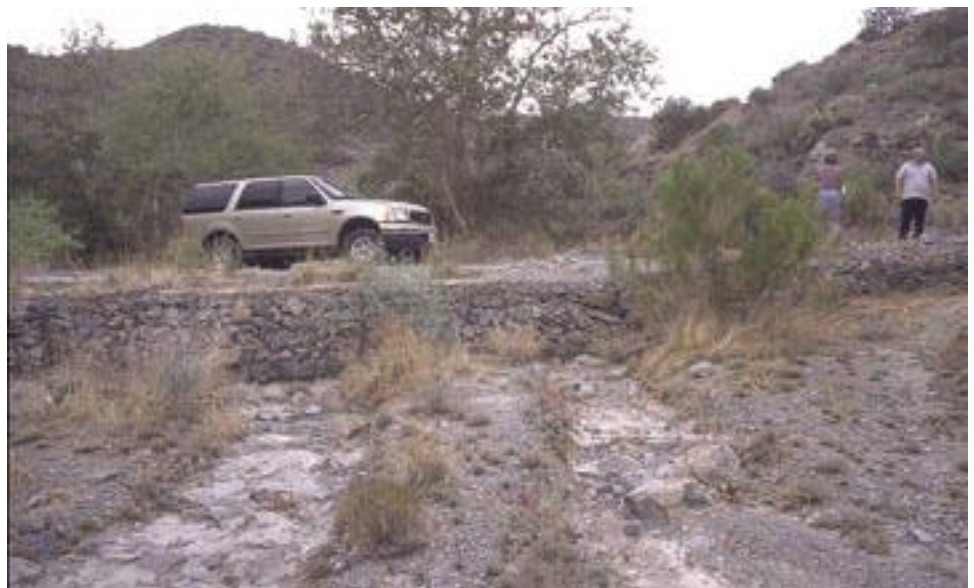
Gabions, jersey barriers (sometimes called “K” rail), other concrete walls, or even logs have been used in relatively low-gradient channels (up to 10-percent slopes) to hold the road prism in place (case study 4) (Leydecker, 1973). To ensure the gabions or jersey barriers do not move, it is common to partially bury them forming a sill on the road’s downstream edge. Frequently, the actual roadway platform is then made of local rocky channel material, placed with a 3- to 5-percent outslope across the road and the sill. The barriers should be placed to form a gentle U-shaped weir across the channel (the U faces downstream) to concentrate flow midchannel. The structure usually creates a low waterfall below the crossing, so the structure may be a barrier to fish and other aquatic species. Therefore, this type of structure should not be used in channels where AOP is needed (fig. 5.11).

Figure 5.11—Gabion ford, Tonto National Forest, Arizona.

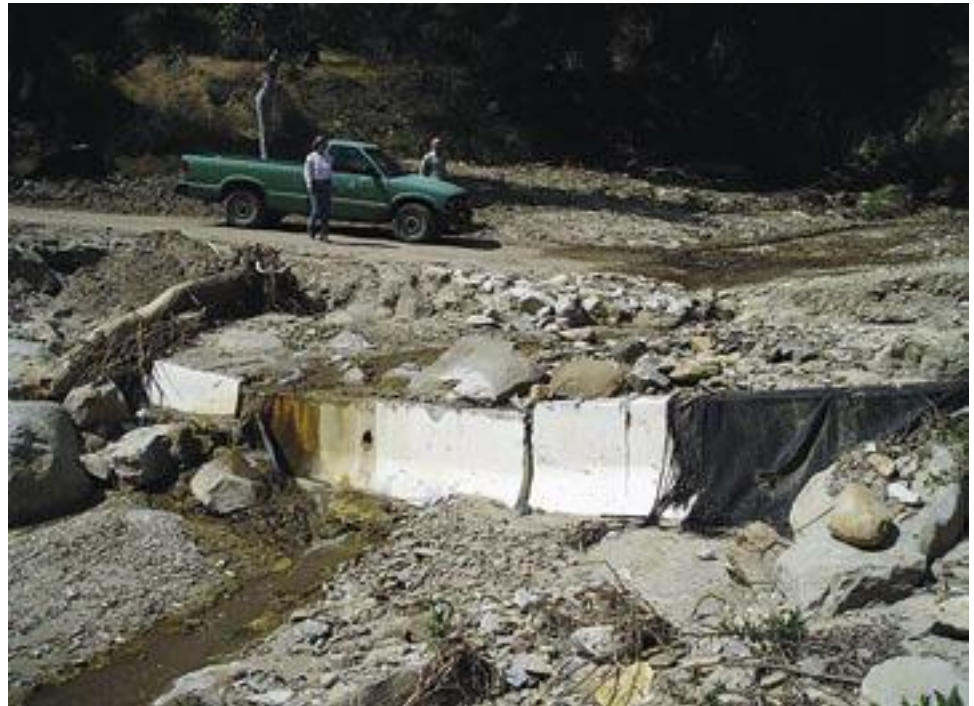
Figure 5.12—Jersey barriers used for a temporary ford after the Ojai wildfire in 2004, Los Padres National Forest, California.

If Jersey barriers are set too high, the crossing may be too flat and sediment may deposit on the road during high flows. The waterfall over the downstream edge of the ford will also promote toe scour, and the barriers may be pushed over by the lateral pressure of the road fill (fig. 5.12). Ideally, Jersey barriers should be set into the stream channel at roughly half their height to prevent them from overturning or sliding downstream. Actual grade and height of the sill will depend on the channel gradient and other conditions.

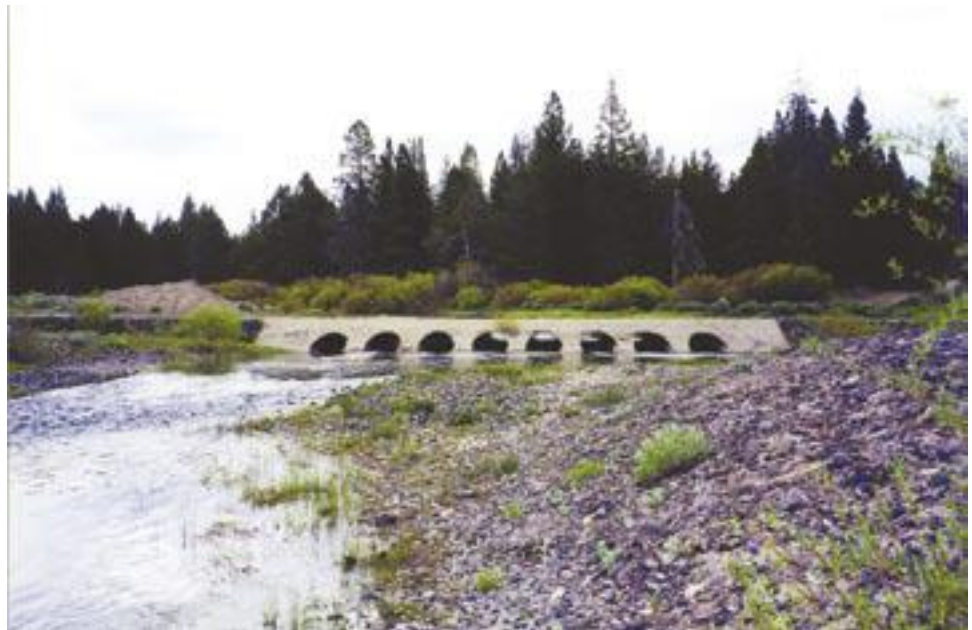
Figure 5.13a—Murdock vented ford, Plumas National Forest, California looking upstream (note excavated sediment upstream of ford).

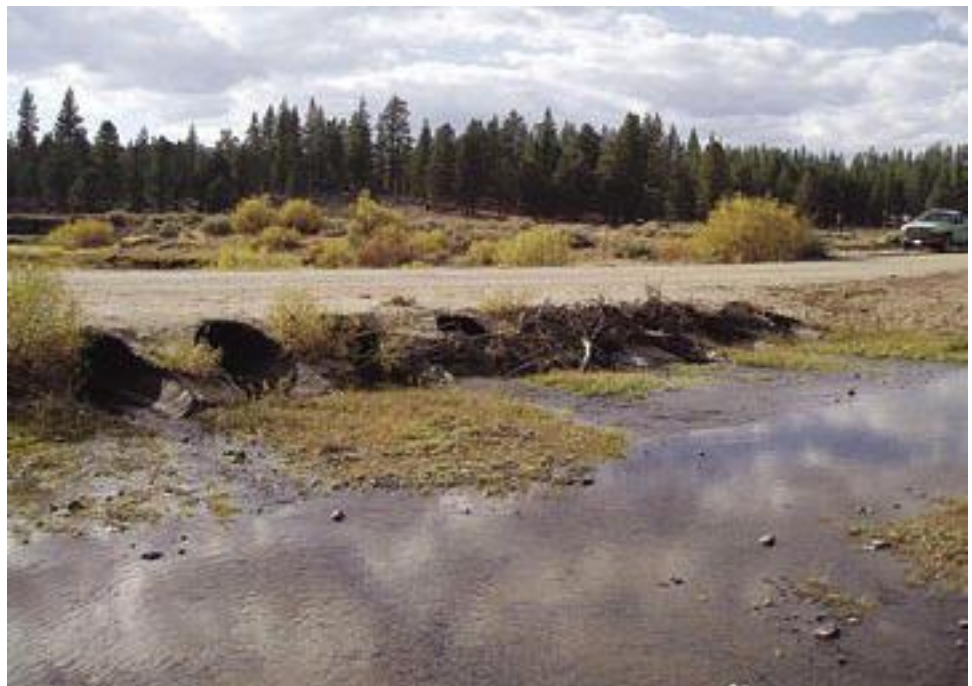
Figure 5.13b—Murdock ford, looking downstream at inlets partially plugged with woody debris after a high flow.

The major disadvantage of this structure is that it typically has a low VAR and acts as a dam across the channel at high flows (case study 11). The damming effect causes upstream backwater and aggradation (fig. 5.13a) and sometimes downstream degradation and scour. Both processes contribute to channel instability and high maintenance costs. Pipes in these structures often plug with debris and usually require, at the least, cleaning in the inlet area after a major storm event (fig. 5.13b). In addition, these structures often prevent fish passage where culvert outlet velocities are high, where flow depth is very shallow in the pipes, or where there is a drop at the culvert outlet. Low water velocities and backwater through the culvert can allow for some fish passage.

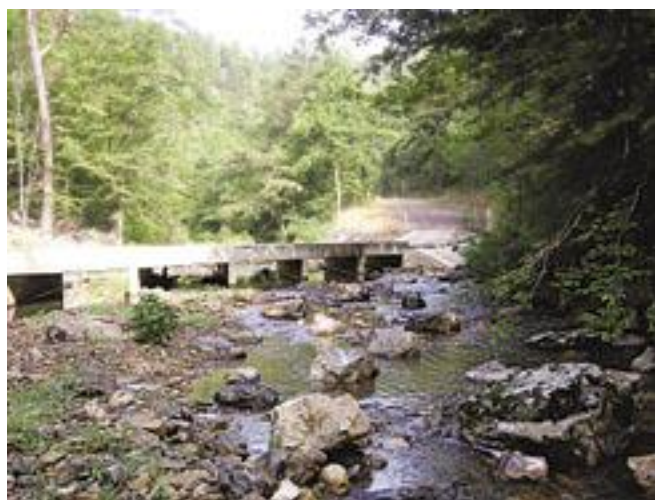
Vented fords are often constructed with raised platforms and box culverts to pass low to moderate flows (fig. 5.14). Vehicles are kept out of the water at all times except during high flows. Although these structures are similar to vented fords with culvert pipes, they commonly have a larger waterway open area across the channel, or a high VAR. They also tend to be shorter in the along-stream direction than crossings with pipes. They readily pass small debris through the structure but can still plug with large woody debris in a major storm event. The box structures are typically structural concrete and may have either a solid bottom or vertical walls set upon spread footings, with a natural channel bottom. The roadway surface may be solid reinforced concrete, or it may consist of metal grating, such as cattleguard material, which can be removed to clean debris from the structure. Typically, these structures are relatively expensive, but they can perform very well, minimize traffic delays, and maximize channel function and aquatic organism passage (case studies 13, 14, 15, 16, 18, and 19).

Figure 5.14—Long Creek embedded concrete box high-VAR ford constructed in 2005, Ouachita National Forest, Arkansas.

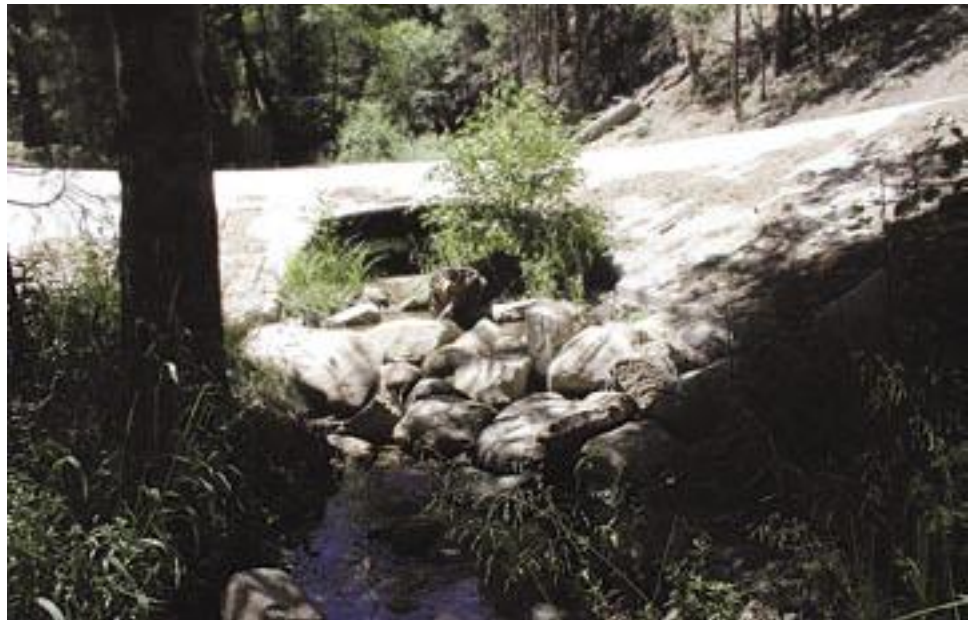
This vented ford is desirable because it offers some of the economic advantages of culverts with the broad-span advantages of a bridge. The structure usually has a high VAR and can or should span the entire drainage, preferably to the bankfull width. Ideally, the structure is a bottomless arch with spread footings parallel to the stream channel, minimizing disturbance to the middle of the stream channel and preserving the natural substrate. This structure is ideal for “stream simulation,” where the natural channel width and bottom material are preserved (fig. 5.15).

Figure 5.15—Metal bottomless arch high-VAR ford, San Bernardino National Forest, California.

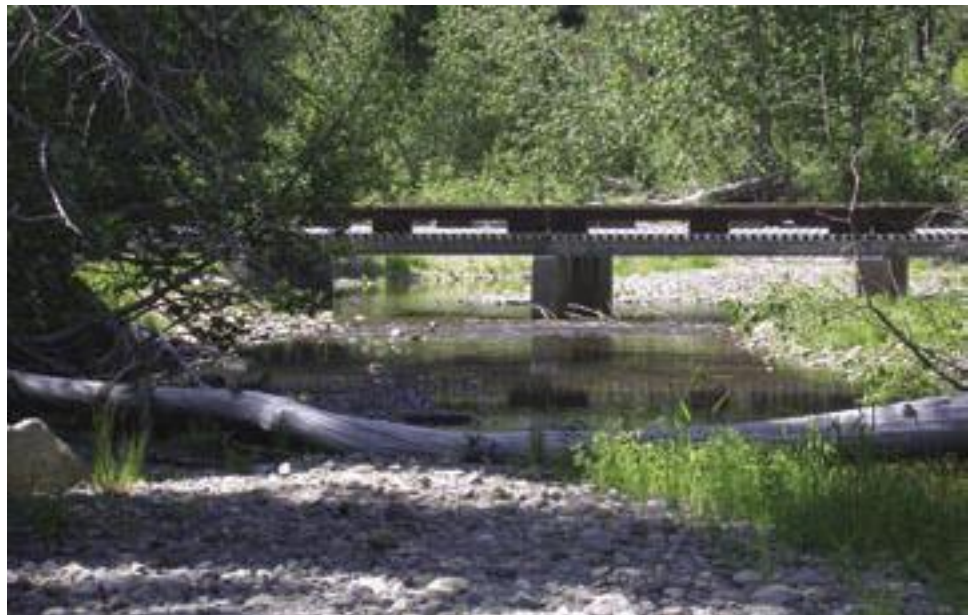
In this publication, we define low-water bridges as structures supported by piers or spread footings with a natural stream channel bottom. They can look quite similar to embedded box-culvert fords, but are commonly longer and have no floor. Low-water bridges have a raised superstructure over a natural stream channel bottom, a total span of more than 20 feet, and are designed to sustain overtopping (Brink 1974 and 2000). Generally, they have the highest VAR of any of the low-water crossing structures. To function as “low-water” bridges, the structures need to be above bankfull elevation to pass flow most of the time, yet be low enough to be overtopped by larger floods (Webb 1994) (fig. 5.16).

Figure 5.16—Capps low-water bridge, Eldorado National Forest, California.
