U.S. Department
of Agriculture

Forest Service

October 2006

Low-Water Crossings: Geomorphic, Biological, and Engineering Design Considerations

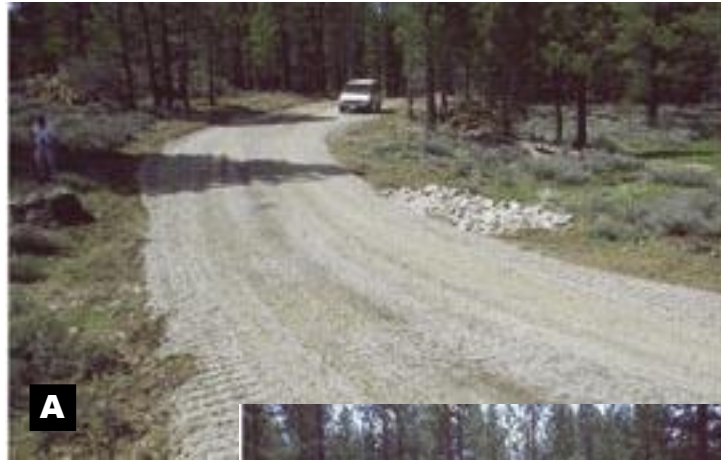
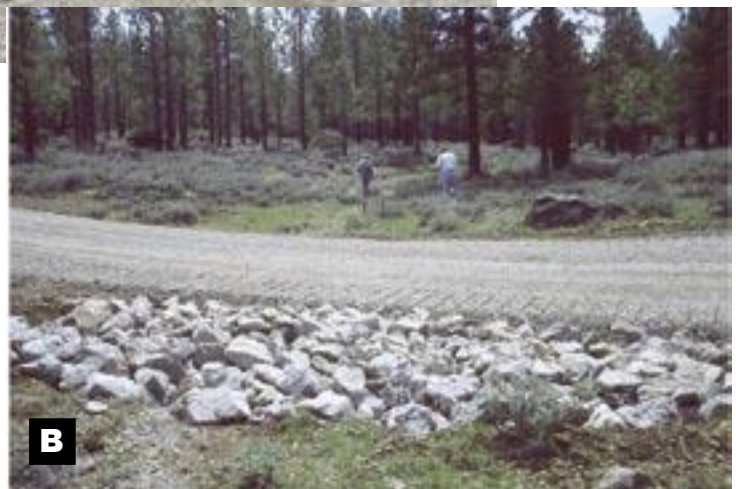
Figures A1a and A1b. Red Clover rocked dip. Figure A1a. Flow is from left to right across the dip. Figure A1b. View is upstream.

This ford was constructed in 2001 as a simple rock-armored ford across an unnamed ephemeral draw on a road constructed to access a timber sale. The ford is a simple, elongated rolling dip with a riprap-reinforced subgrade with aggregate surfacing and a riprap-armored outlet (figures A1a and A1b). The road is 12 feet wide and the armored portion of the ford is 30 feet long. The entire roadway surface through the dip is approximately 120 feet long. The structure is relatively new so it has only been through two mild winters. This design is the “standard” simple, rock ford.

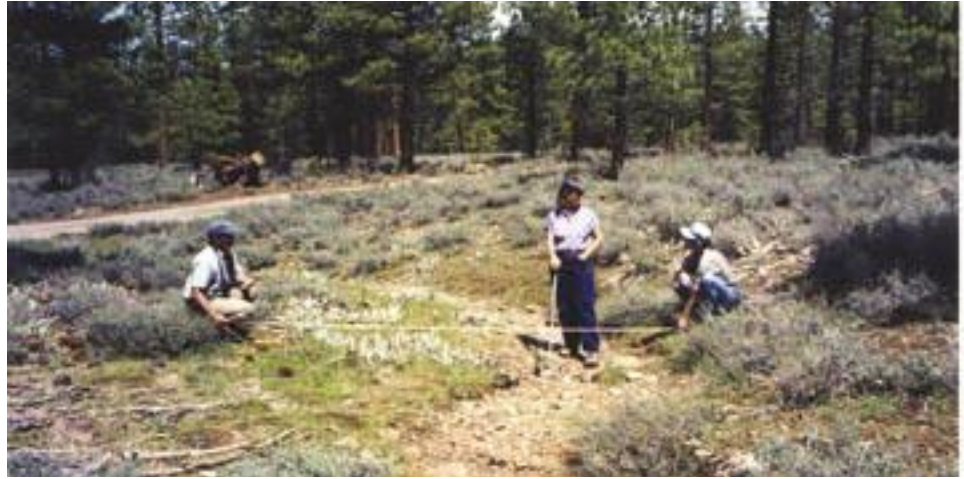
Figure A2. Measuring bankfull channel dimensions on the ephemeral channel upstream of dip.

Channel Description: The channel is only slightly entrenched with banks that are relatively flat and stable except for local scour at some bends (figure A2). Bank vegetation is coniferous trees, shrubs, and grasses. The channel varies from 4 to 10 feet wide near the site and channel slope is about 3 percent. The substrate is a poorly graded mixture of clayey sands, some gravels, and occasional volcanic rocks.

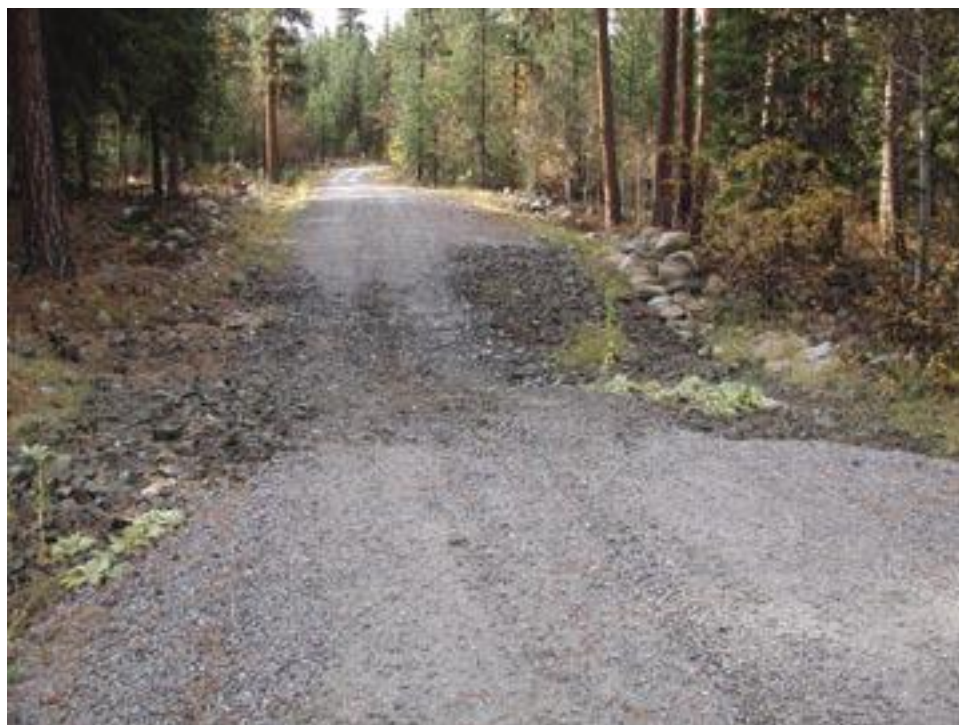
Figure A4. Hardened rock ford on East Chewuch Road.

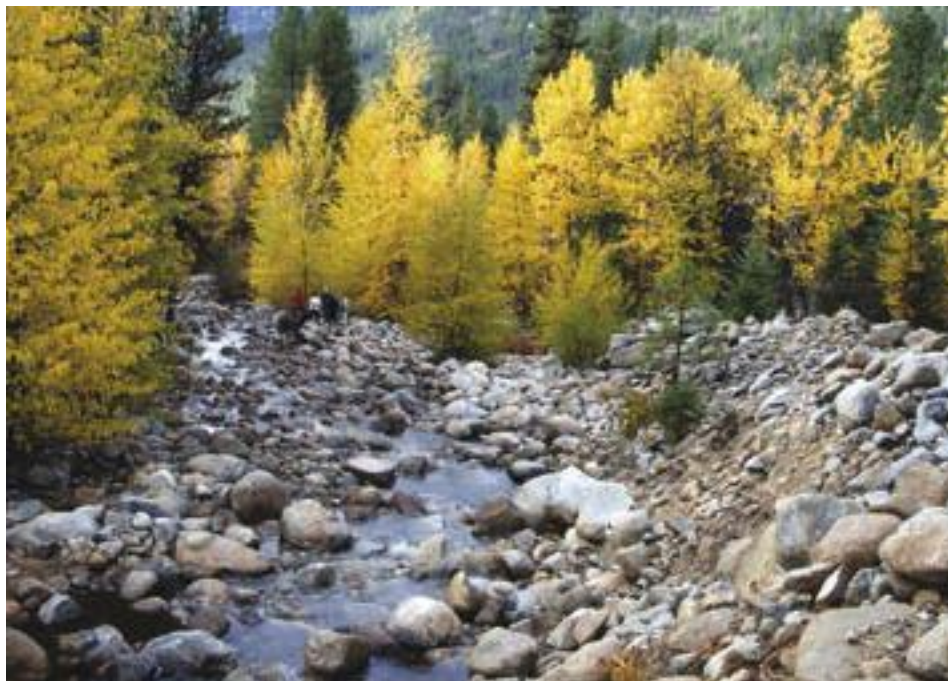
Figure A5—Twenty-mile creek was channelized near the top of the alluvial fan. Note levee at right of photo.

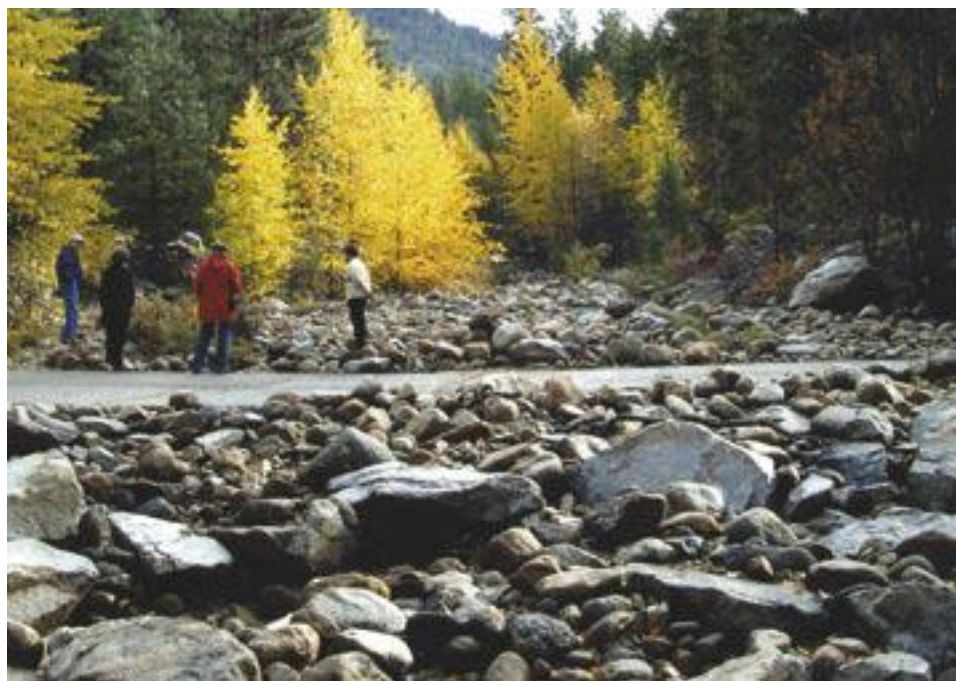
Figure A6—Vented ford plugged with boulders.

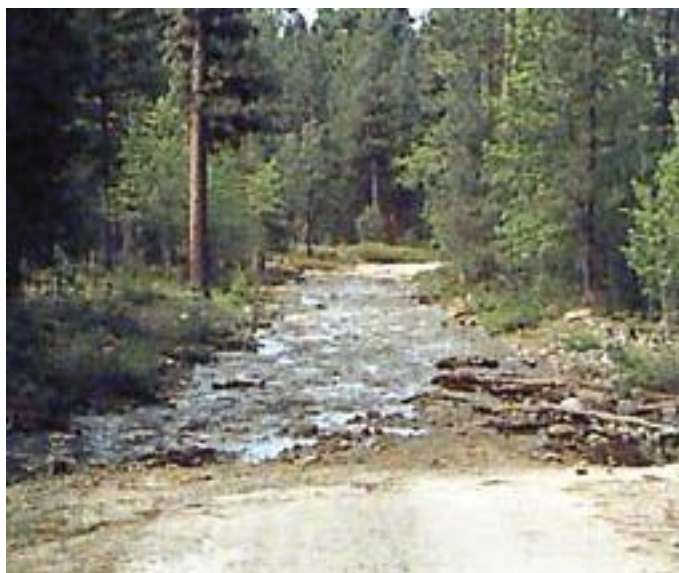
Figure A7—Plugged culvert causes water diversion down road before construction of rock fords.

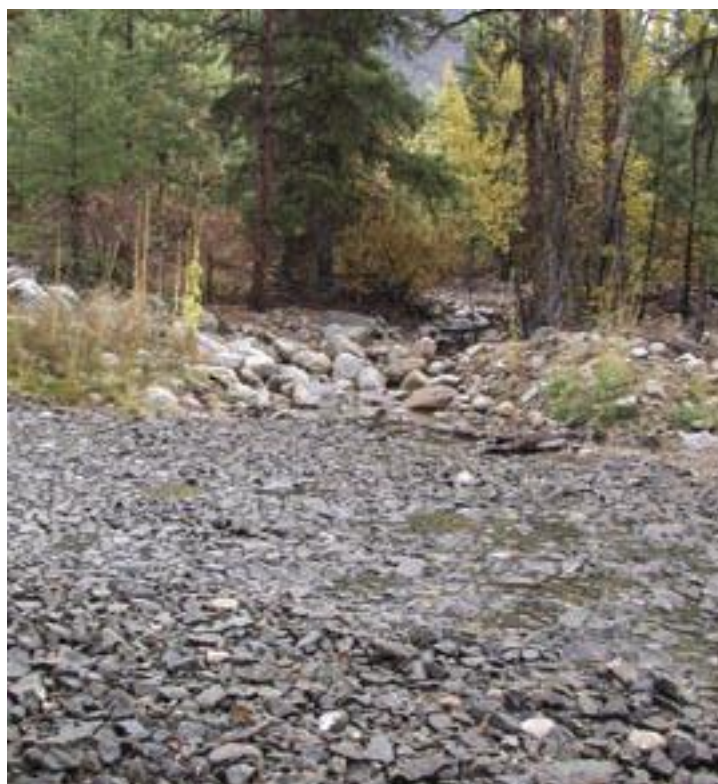
Figure A8—Looking upstream along a distributary channel (hardened dip in foreground).

Channel Description: Twenty-mile Creek begins as a low gradient channel in high-elevation meadows. It descends through a steep canyon before dropping much of its bedload on the alluvial fan. Before the restoration project described above, the slope of the main fan channel exceeded 3 percent, bankfull width was 30 to 40 feet, and the substrate was small to large boulders arranged in cascades and large steps. Fines were being swept through the system and deposited in the mainstem Chewuch River. After the levees were breached and distributary channels began functioning again, the main channel has gained sinuosity, reduced slope, and is retaining more fines. The distributaries are slightly to moderately entrenched (figure A8). They are about 15 feet wide or less, with slopes of around 3 to 4 percent in the vicinity of the road.

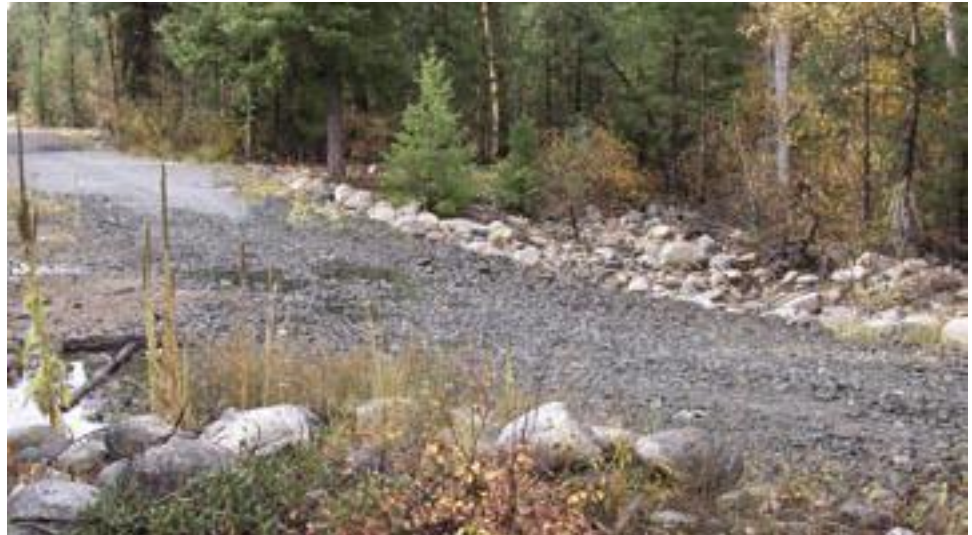
Figure A10. Hardened dip on East Chewuch Road.

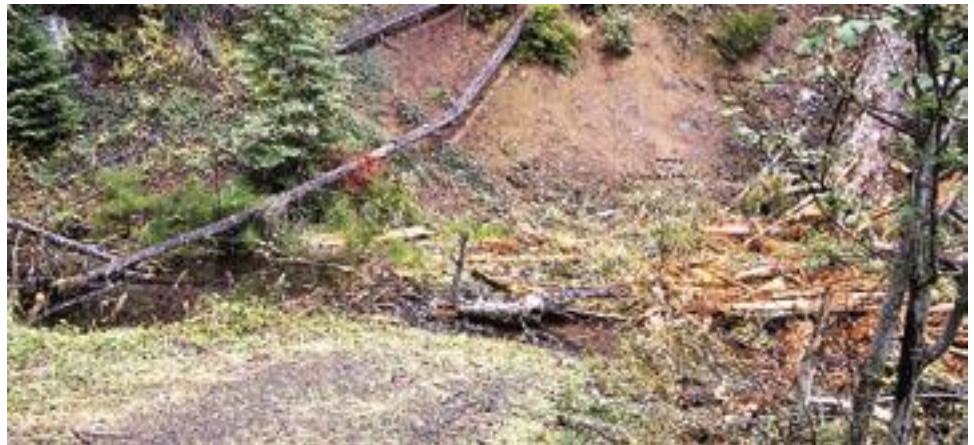
Figure A12. Snag fallen across the ford August 2004. Note beaver dam at upstream end of roadway.

This structure went through large floods in 1996-97 with little or no damage. After more than 20 years and almost no maintenance, water still flows where it was designed to flow and vegetation has grown up all around the ford. Recently, a snag fell over the ford without damaging its function in any way (figure A12). A beaver has taken up residence in the pool at the inlet.

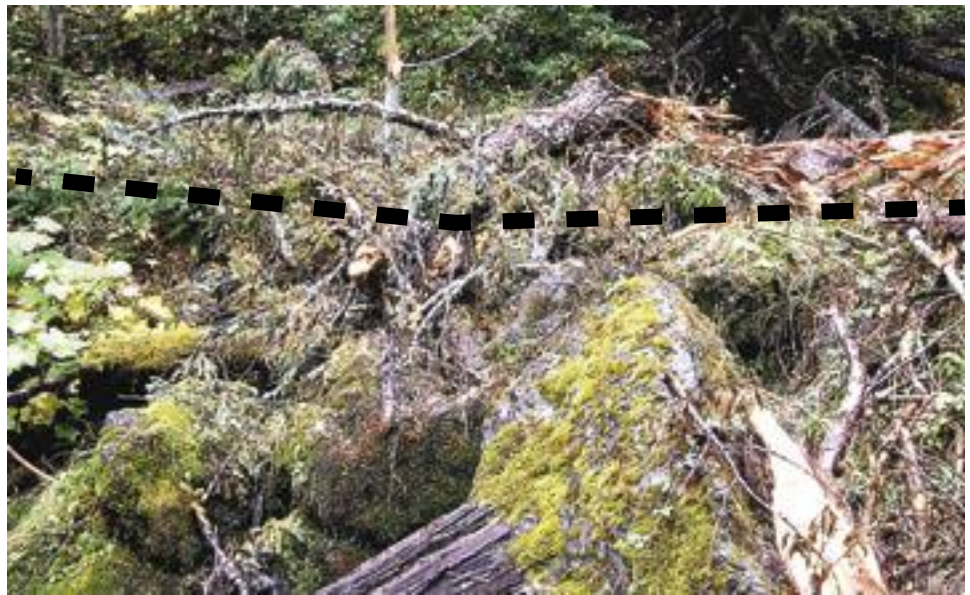
Figure A13. Stable, moss-covered rocks on the splash apron with pieces of fallen snag. Dashed line indicates approximate road surface.

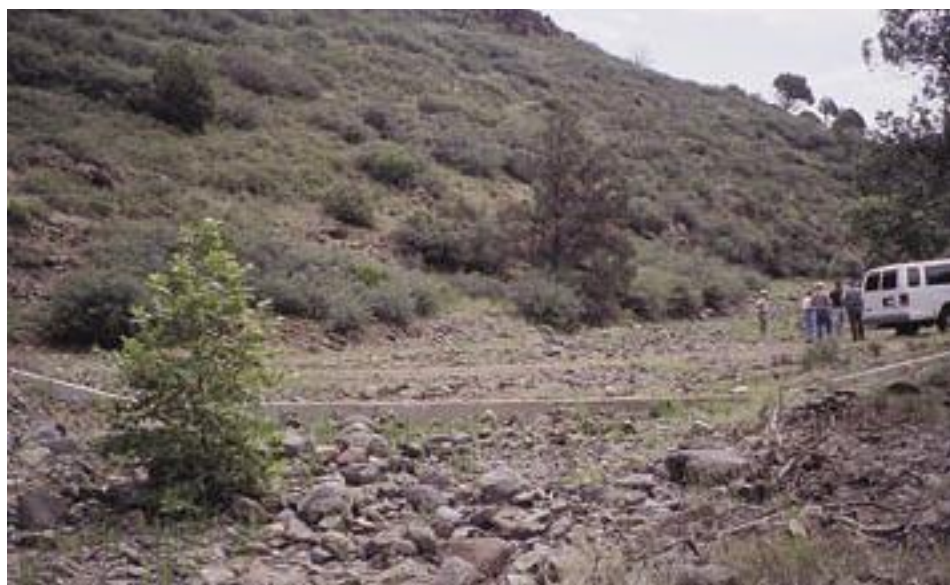
Figure A16. Jersey barrier ford, FR 732.

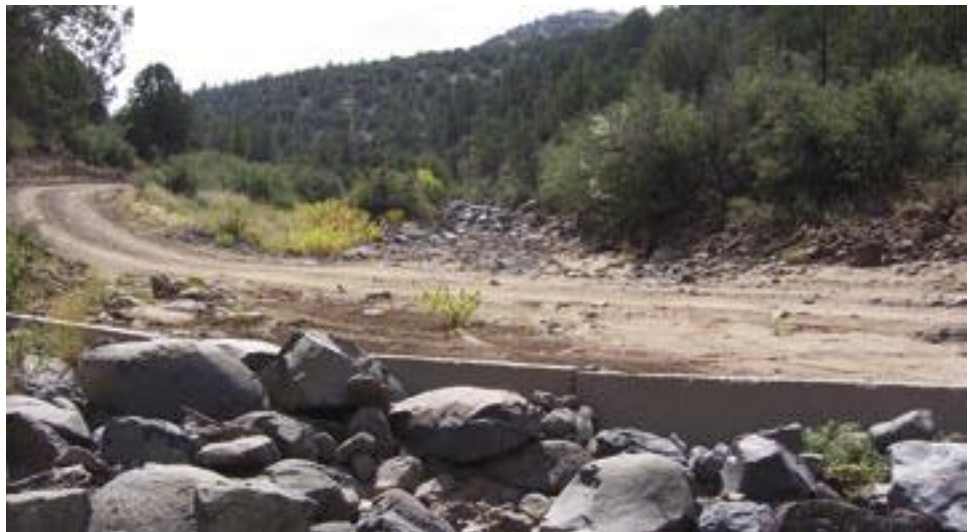
Figure A17. Looking upstream across another jersey barrier ford on FR 732. Sloped road approaches prevent diversion and large rock is placed downstream to prevent scour.

The fords are backfilled with native rock material and large riprap is usually placed downstream to prevent scour (figure A17). Experience has shown that the downstream edge of the jersey barriers should be protected from scour by gabions or an engineered riprap fill (figure A18c) unless the channel is highly resistant to erosion.

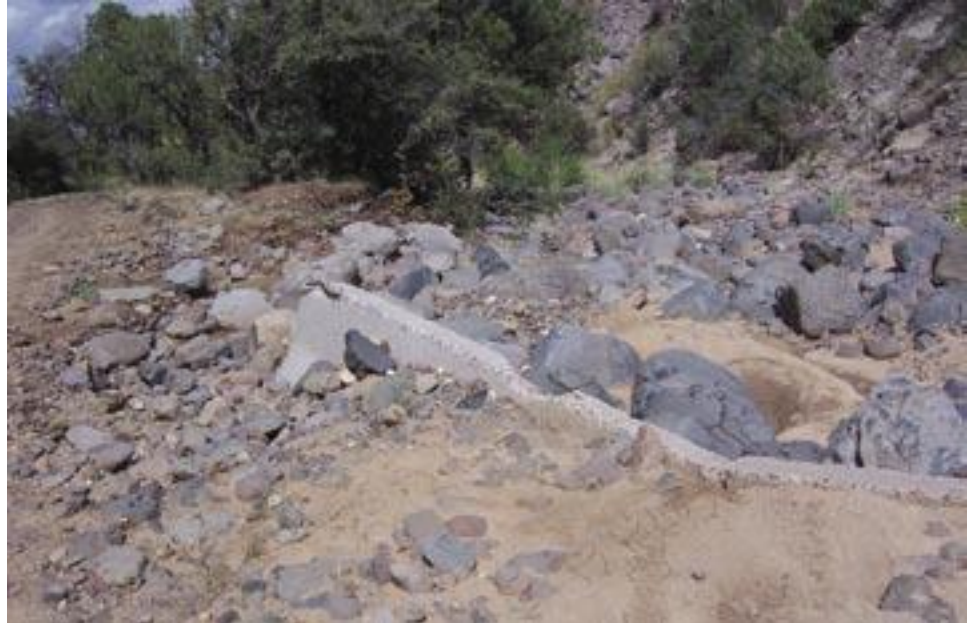
Figure A19. High flows have outflanked one of the ford structures.

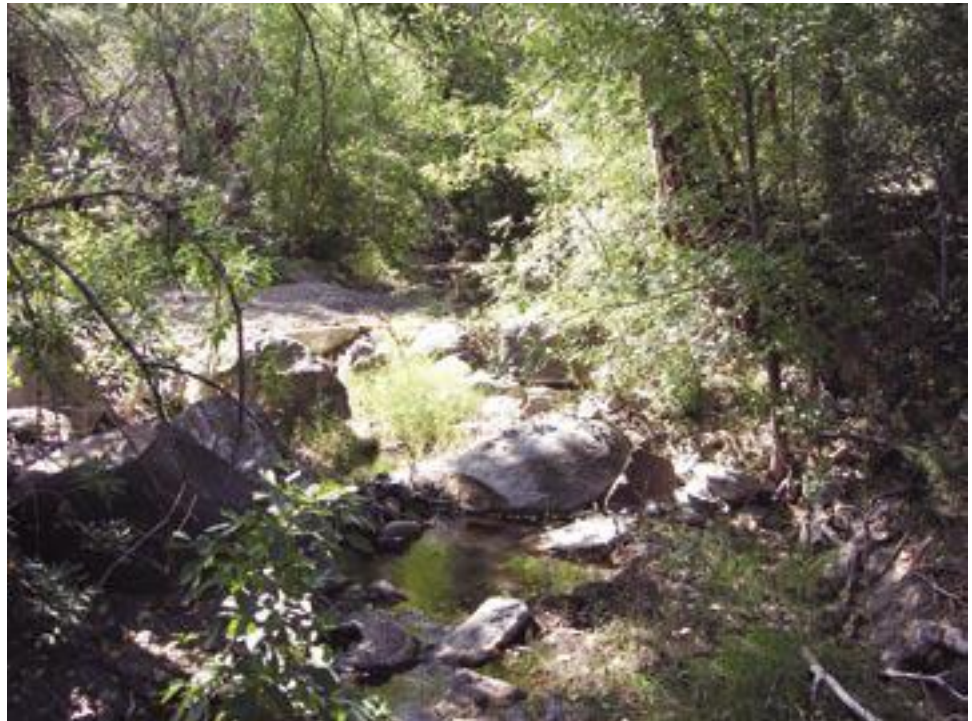
Figure A20. Jersey barrier ford on FR 136 has helped control channel downcutting and restore the riparian area in Copper Canyon. Photo is looking upstream at the ford.

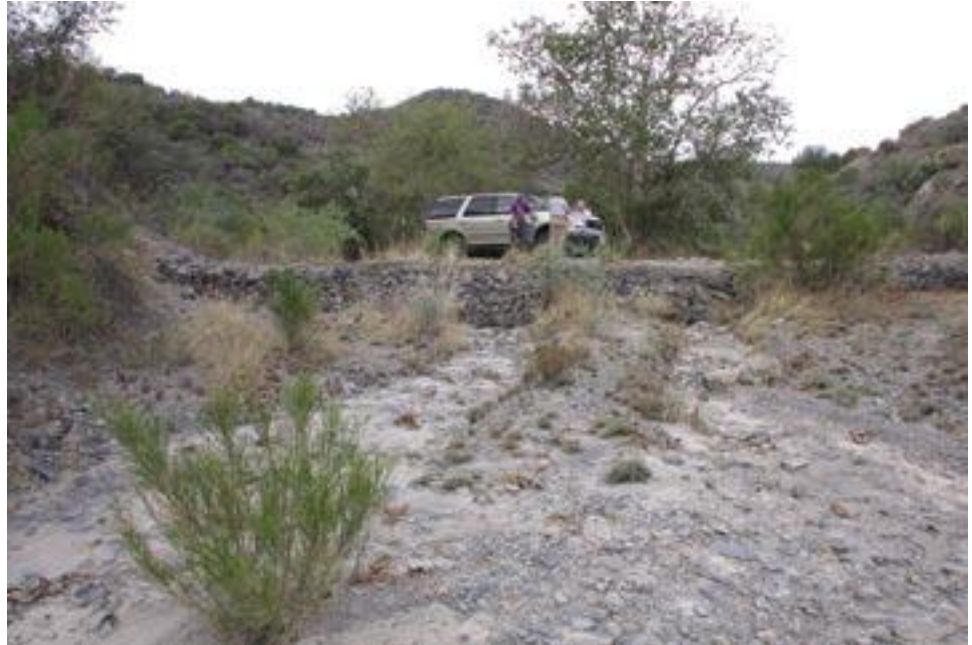
Figure A21. This jersey barrier-gabion ford on the 7-Springs Road on the Tonto replaced a bridge washed out in a flood.

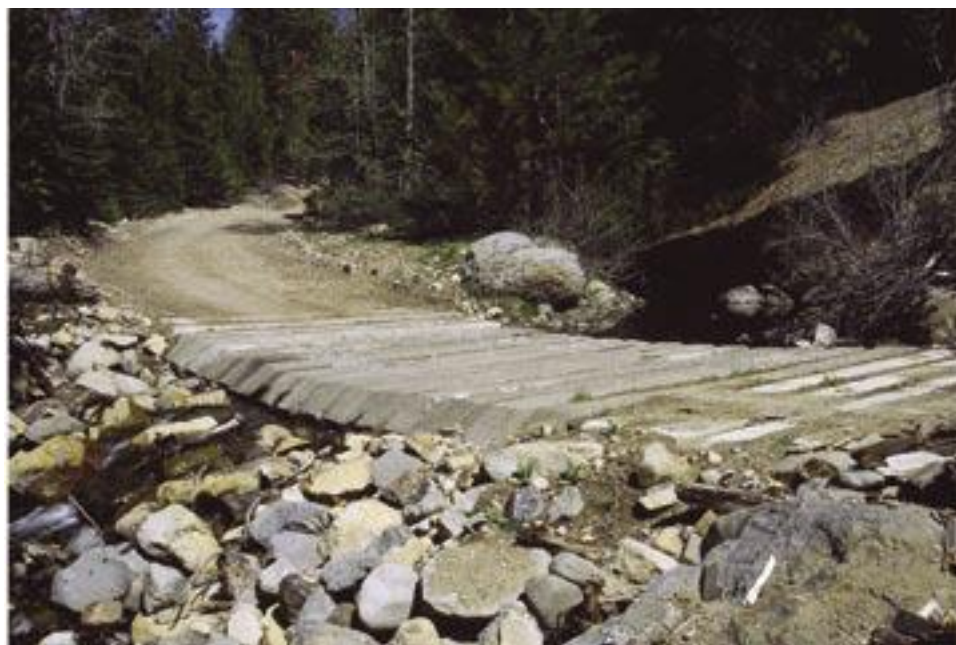
Figure A22. Willow Creek concrete plank ford.

This unvented ford, constructed in the mid 1980s, is on a perennial fisheries stream. Concrete planks form the driving surface. The structure is 31 feet long and the driving surface across the planks is 14 feet wide. There are 21 concrete planks, which are each 12 inches wide, with a 6-inch space between planks. The spaces allow passage of low flows. The planks are set into the streambed 2 inches and rest upon a bed of coarse streambed material and Class IV riprap. The outlet of the structure spills onto Class X riprap. Grades into the ford vary from 7 to 9 percent on both approaches, and the middle of the ford is flat.

Bank stabilization and approaches: Large riprap was added to stabilize the downstream area from the effects of the drop downstream (figure A22). Road approaches dip down into the crossing at 7- to 9-percent slope (see site sketch, figure A25).

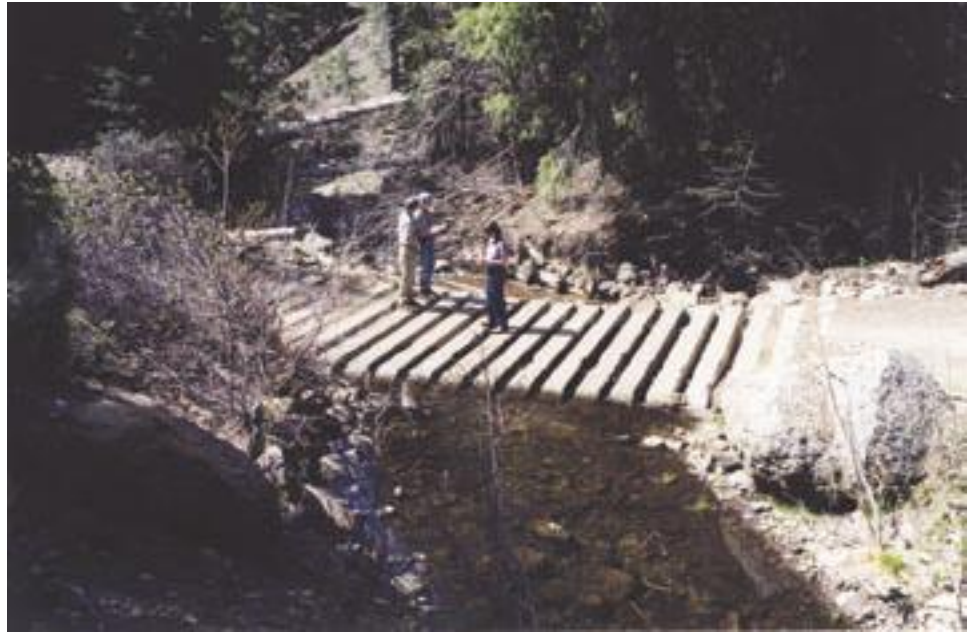
Figure A23. Looking downstream: ford is just above a tributary junction where an old diversion structure blew out and caused streambed to degrade.

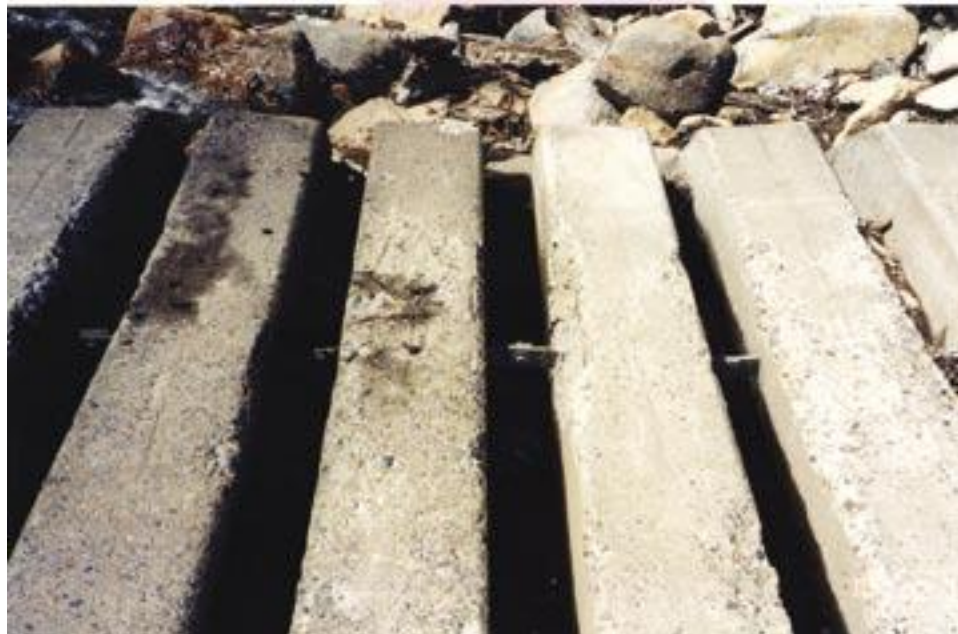
Figure A24. Detail of planks and metal brackets.

Protection of the planks against scour and movement of the material beneath the planks is a key design detail. The bed must be carefully prepared to be smooth, yet made of coarse enough material to resist movement during storm flows.

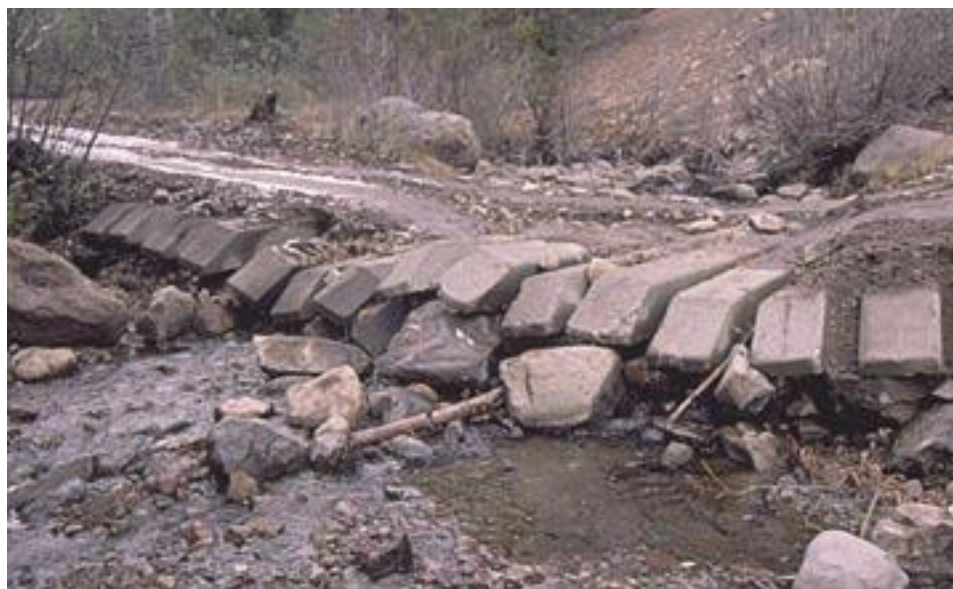
Figure A26. The crossing was damaged in the 1997 flood by scour of fine bedding materials under the planks. The planks had to be reset into coarser materials and the downstream edge protected with riprap.

The structure received only minor damage in the large storms of 1986 and 1995. However, during the major 1997 flood (local storm of record), some of the concrete planks were cracked and steel was exposed (figure A26). Repairs included replacing some concrete planks, rebedding most of those in the middle of the channel, and adding riprap scour protection at the downstream outlet of the structure.

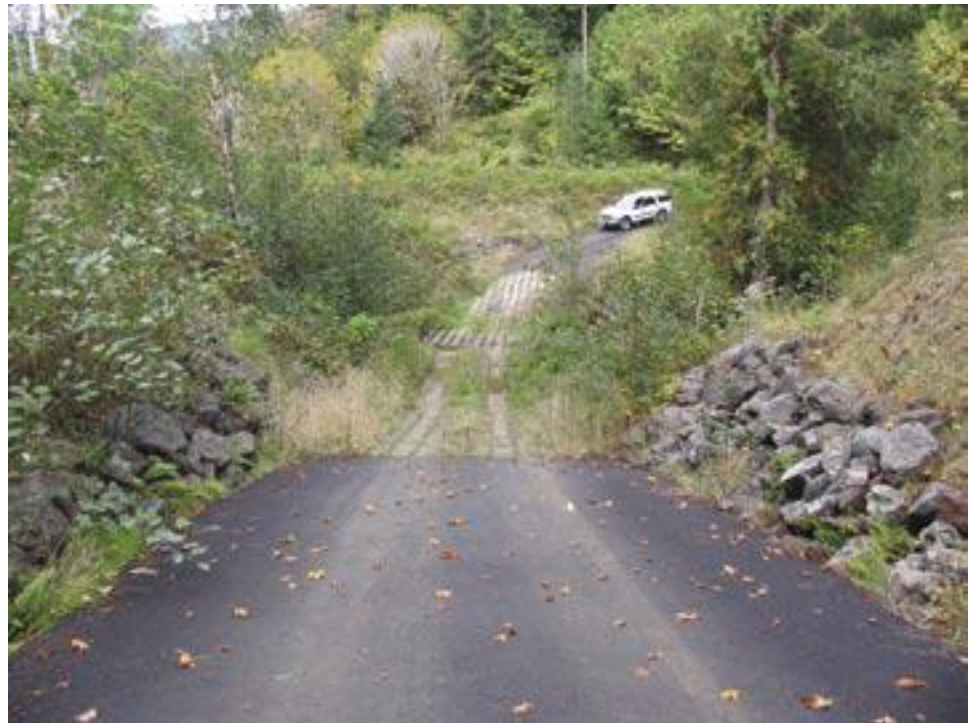
Figure A27. Fitzpatrick cable concrete mat ford.

This ford was constructed in 2000 on a deeply incised perennial stream where passage for salmon/steelhead and woody debris are major issues. Cable concrete block mats and riprap were used to make a stable driving surface that mimicked natural channel characteristics as closely as possible. The crossing is outsloped at approximately the same grade as the stream (4 percent), and the mat was set just under the final streambed elevation, with the expectation that a low-flow channel would develop to promote juvenile fish passage across the structure. Traffic use at this site is low, and occasional log haul is restricted by agreement with the National Marine Fisheries Service.

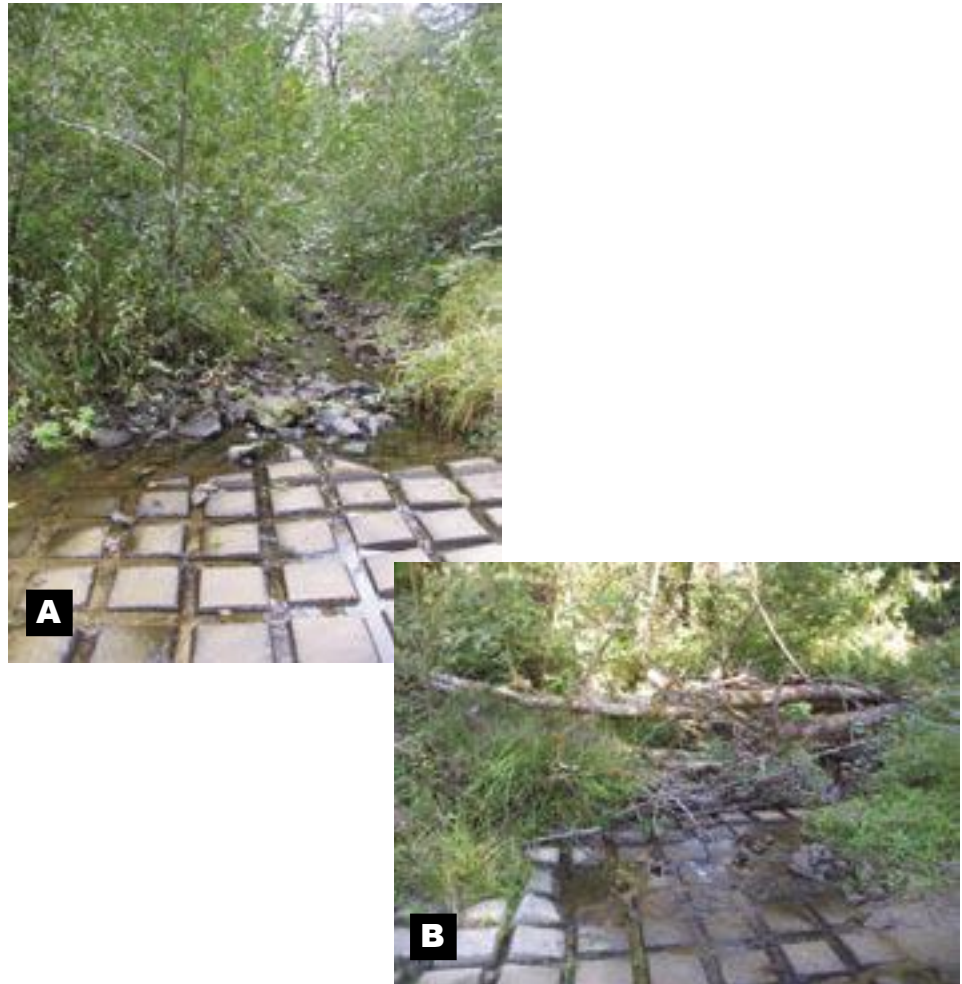
Figures A28a and A28b. Channel character (a) looking upstream (b) looking downstream.

Channel Description: The channel is a Rosgen A3, with a 4-percent slope and low sinuosity. It is confined between stable 25-foot-high slopes that are well-vegetated with deep-rooted shrubs and trees (figure A28). Debris jams are not uncommon. The crossing is located immediately upstream of a bend.

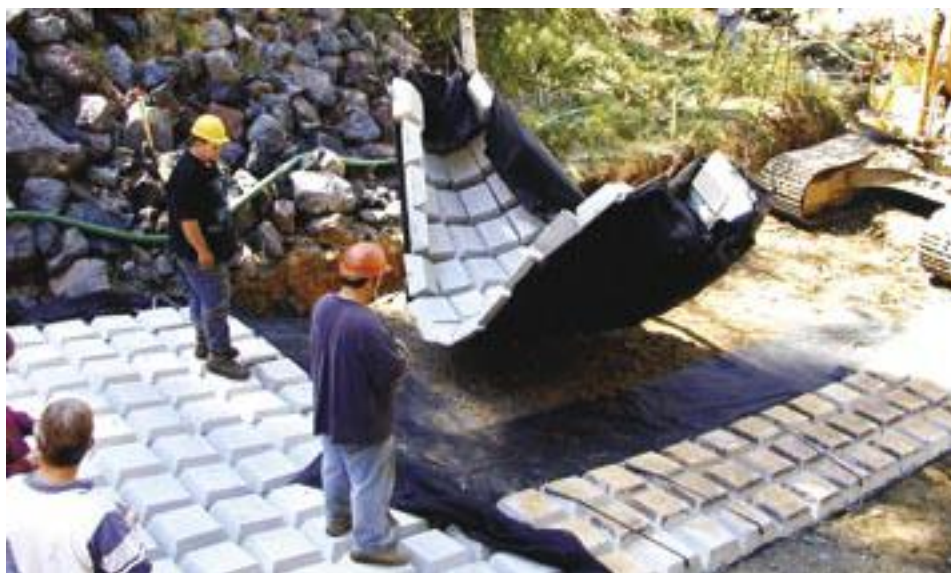
Figure A30. An excavator installs the mats with geotextile backing.

Structure: The cable concrete mat is 16 feet wide and 104 feet long, extending to approximately the elevation of the 50-year flood (figure A29a). The blocks are sized for the 100-year event, according to manufacturer recommendations. Mats are fabricated with stainless steel cables embedded in the blocks to link them together in both directions. Geotextile fabric is attached to the bottom of blocks to prevent blocks from sinking into soft subbase, and to avoid erosion of fine material from the base. Mats were laid out on a 6-inch base of 1½-inch crushed aggregate to provide both support and a level surface (figure A30).

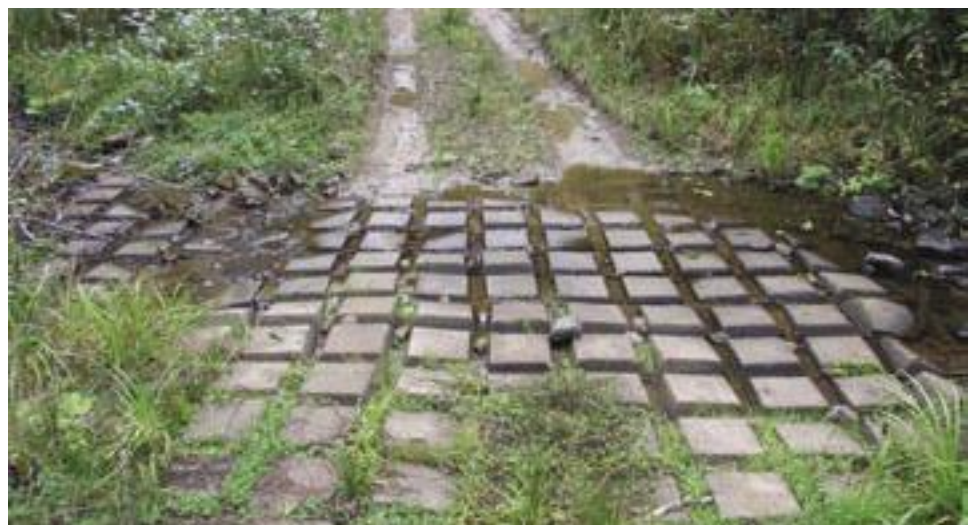
Figure A31. The ford permits low flow passage for aquatic species even though the blocks have settled unevenly.

As originally laid down, the Fitzpatrick Creek mat was uneven. The installers were able to smooth it by running over it with the excavator, but as figure A31 shows, some of the blocks sank unevenly and disrupted the driving surface at the edge of the structure. The Big Horn National Forest sites (see below) are more severe examples of this problem.

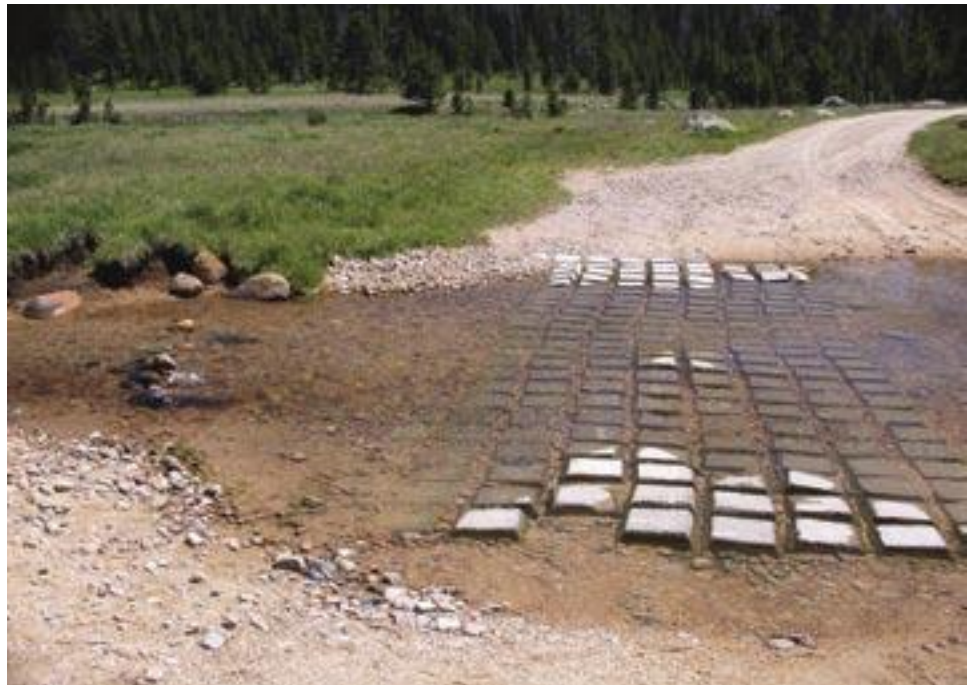
Figure A32. East Fork South Tongue River cable concrete block mat crossing. Note tilted blocks, exposed cables, and short mat length. Traffic is driving around the mat and the river has outflanked it.

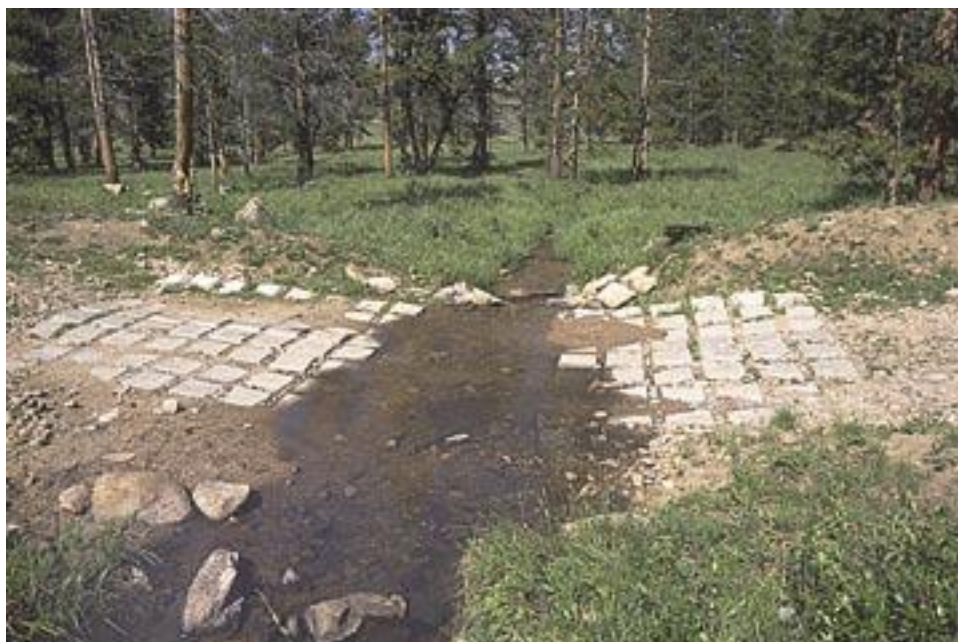
Figure A33. Copper Creek tributary, Bighorn National Forest. At this drier site with less traffic, the mat is considered the best crossing option because of its low maintenance requirement and installation cost.

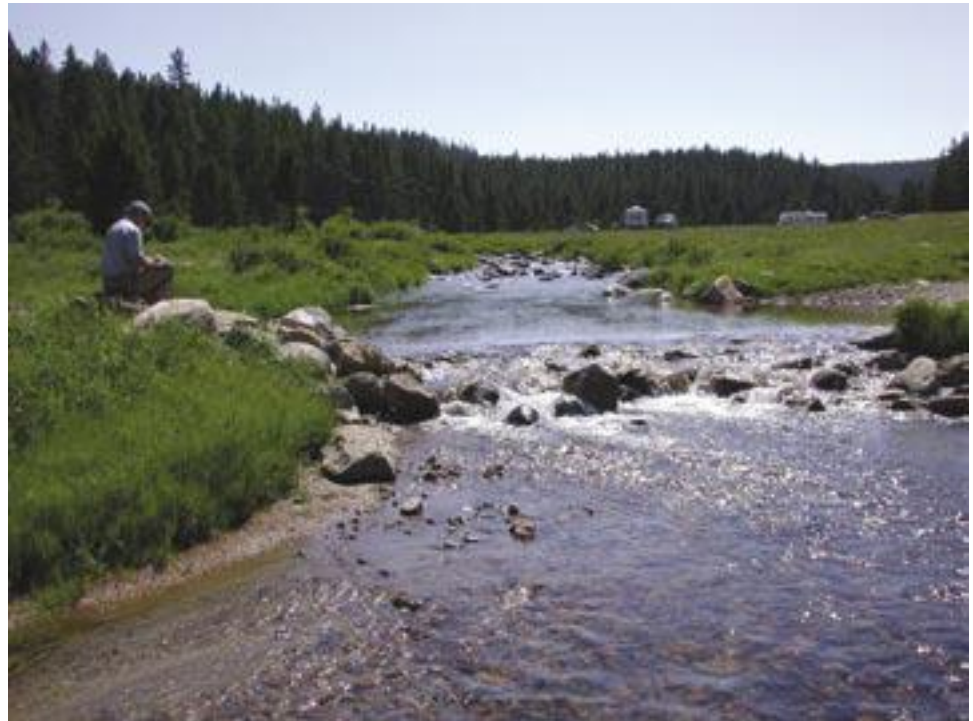
Figure A35. A boulder cascade was constructed at the downstream edge of the ford to control scour caused by placing the GEOWEB very slightly above streambed elevation.

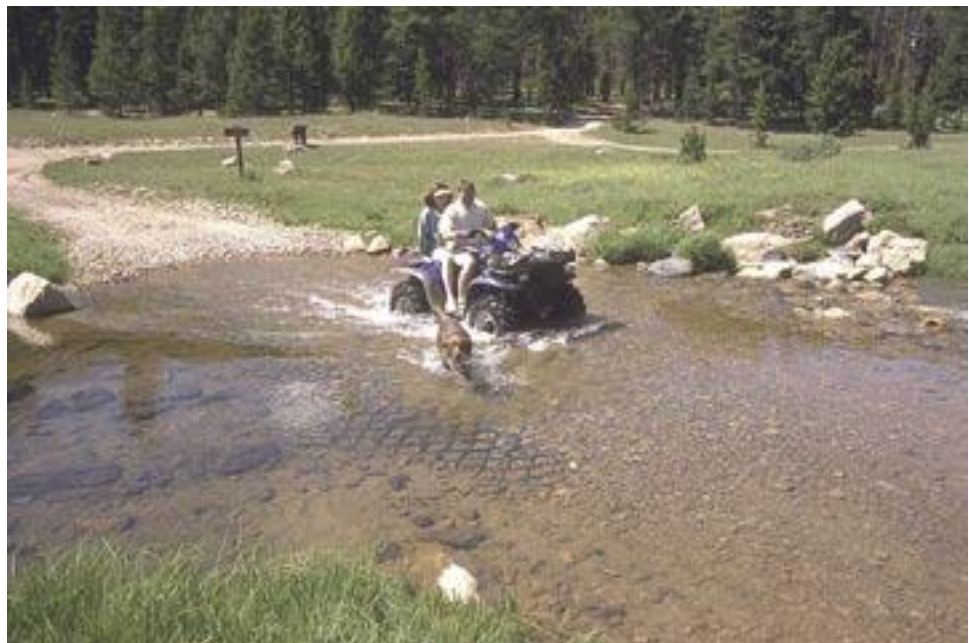
Figure A36. Ford is used by vehicles ranging from ATV's to motor homes.

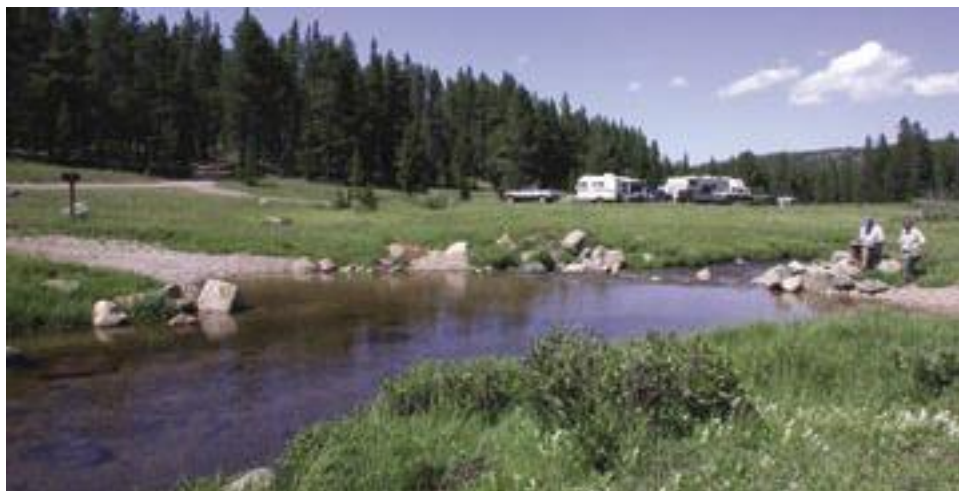
Figure A38. Soil compression on the approaches to the ford causes the stream to widen and lowers the elevation of the ends of the GEOWEB mat. Currently the geocell mat protects only part of the crossing during high flows.

The original intent was to install the GEOWEB to the elevation of the 100-year flood. As can be seen in figure A38, although the GEOWEB originally extended higher, it has settled under traffic loads and probably does not fully cover the bankfull cross section. The stream widens out substantially at the crossing.

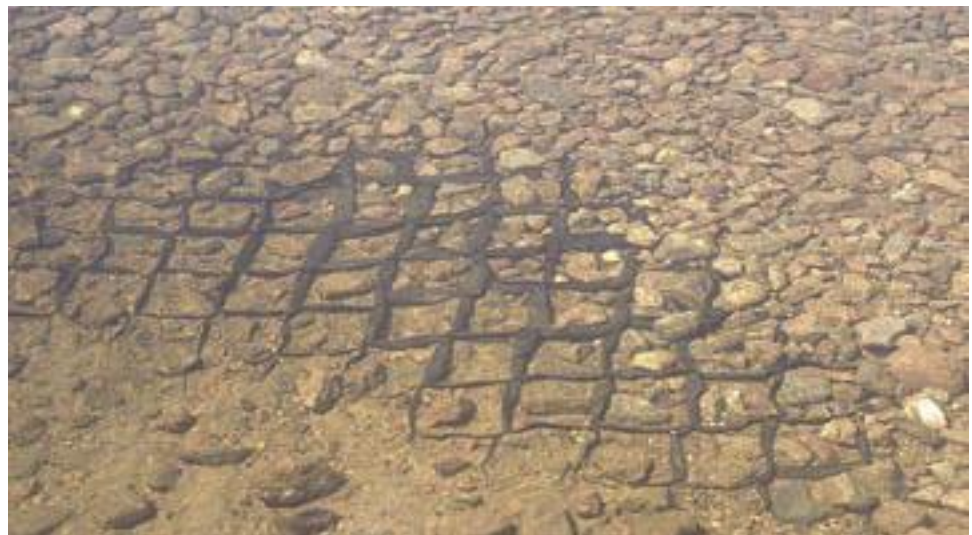
Figure A39. GEOWEB exposed, probably by tire action.

There have been no major floods since the GEOWEB was installed. As noted above, scour due to the fact that the GEOWEB did not perfectly match stream grade necessitated construction of a boulder weir that now backwaters the ford. Erosion and consolidation of the approaches required the addition of rock, but compaction continued, and the crossing shape could not maintain itself. The boulder weir helps to retain the gravel surfacing necessary to protect the surface, but in many places, tire action appears to spin the gravel out of the top of the cells allowing the material to degrade (figure A39).

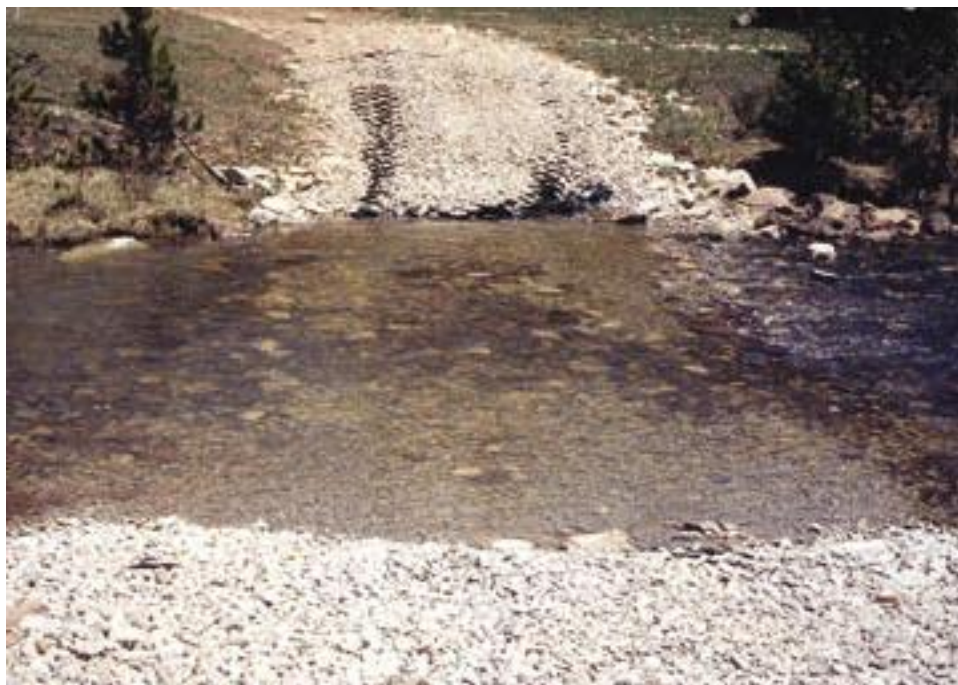
Figure A40. Little Brush Creek geocell ford in June 2002.

The native (darker red) cobbles and gravels deposited on the crossing in Figure A40 show the structure provides free downstream passage for debris and bed material. There is no reason to believe the ford would block fish and other aquatic species at the site going upstream. The forest is satisfied with the ford as a temporary crossing.

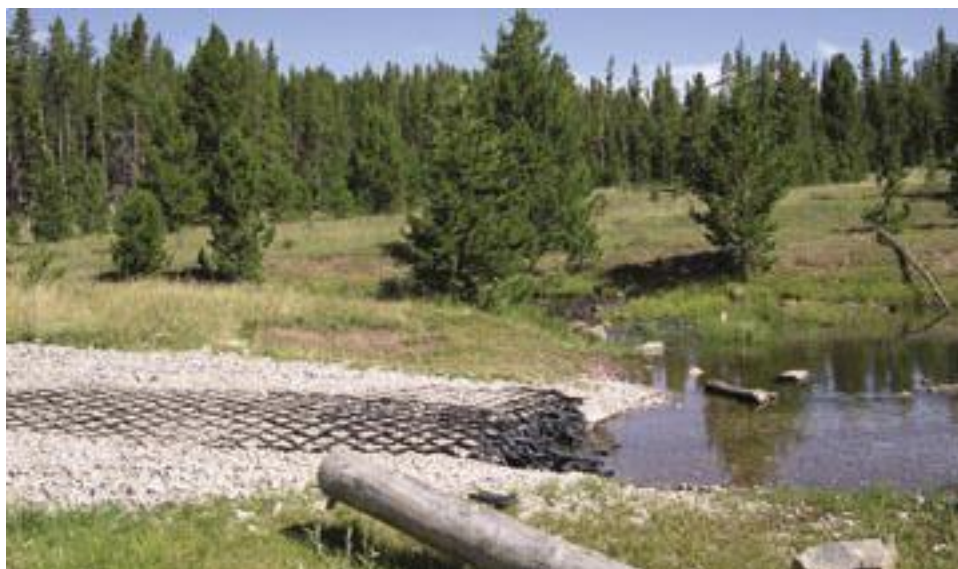
Figure A41. Looking upstream at erosion of one side of the ford in August 2004, 3 years after construction. Probably tire action and high flows have combined to pluck material out of the cells or undermine them. The ford is still intact and the geocells are covered by native bed material in the active channel.

The crossing accesses a road planned for storage within a few years, so the structure needed to last only 3 to 5 years. Traffic is mostly administrative and recreational, and is primarily 4-wheel drive vehicles such as light duty trucks, all-terrain vehicles, and sports utility vehicles. As the photo shows, after only one year, some of the 4-inch minus surfacing had been lost from the geocells on one side of the structure, and the material was deteriorating. Rock was added during the summer of 2002. Nonetheless, in 2004 the site was in a similar condition (figure A41). More material has eroded out from the geocells on one side of the ford and the channel has widened locally.

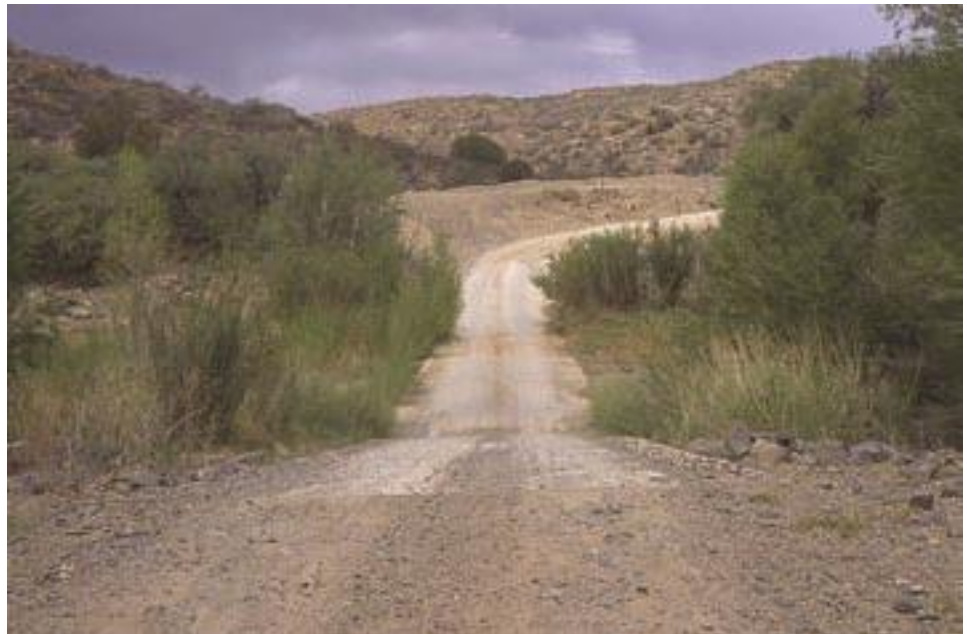
This ford was constructed in 1994 on a perennial to intermittent fish-bearing stream. It is a reinforced-concrete slab with concrete approaches. The surface is slightly raised above the streambed surface, but it allows fish passage when the structure is submerged.

Figure A42. Agua Fria River ford.
