U.S. Department
of Agriculture

Forest Service

October 2006

Low-Water Crossings: Geomorphic, Biological, and Engineering Design Considerations

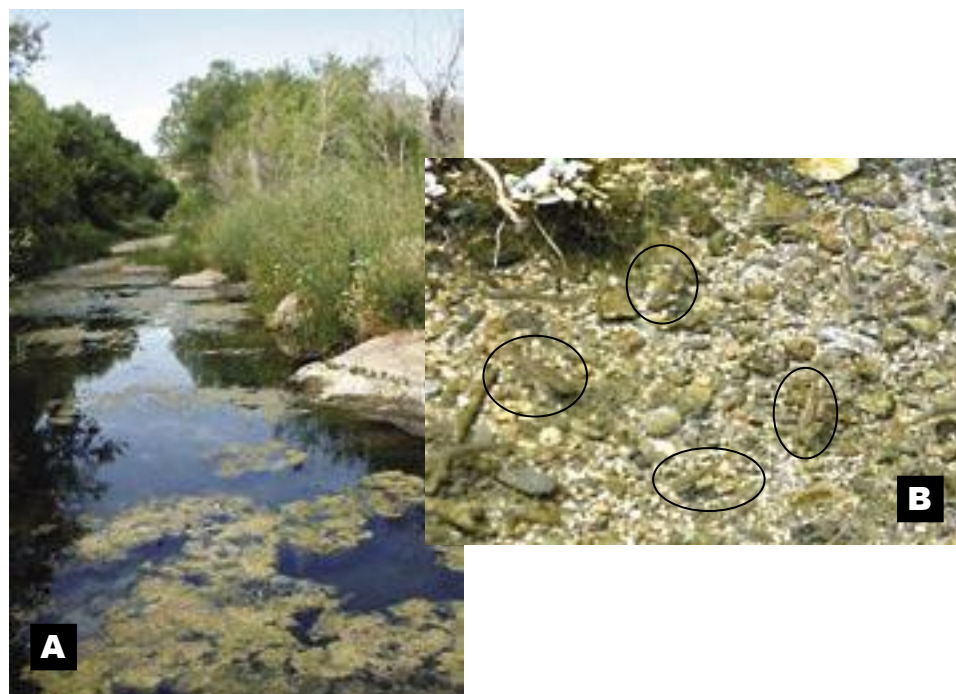
Figure A43a and A43b. Agua Fria River A43a. Pool several hundred feet upstream of ford in August 2003. A43b. Fish are in isolated pools both upstream and downstream of the dry ford.

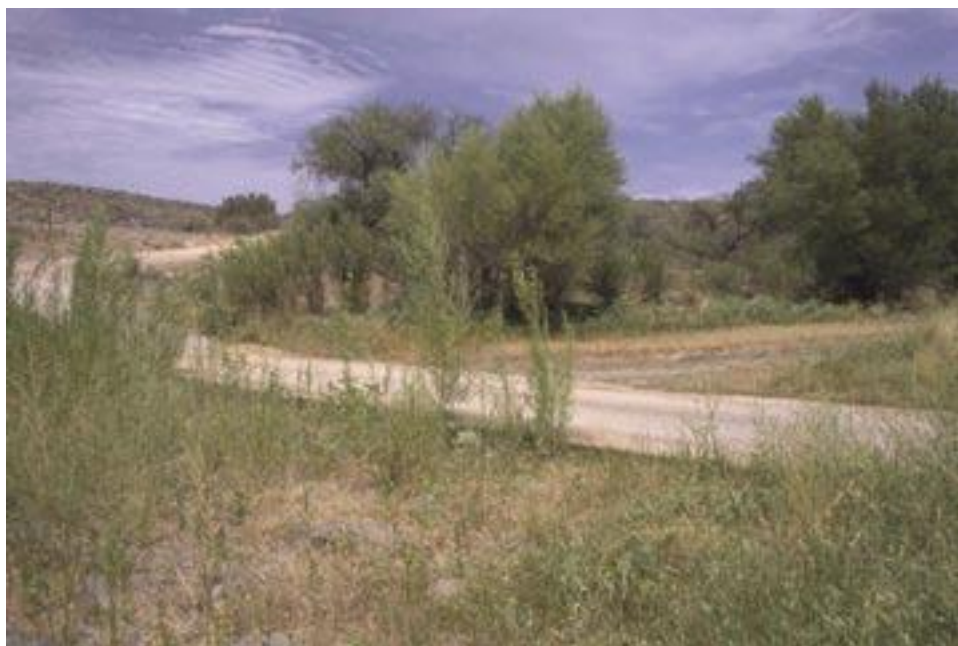
Structure: The ford is an 8-inch thick reinforced concrete slab raised slightly above the bed of the active channel. The driving surface is 15 feet wide and has no curbs. The slab is 65 feet long and flat across the active channel and the lowest flood terrace (figures A44 and A45). Including approaches, the structure extends a total of 170 feet across the channel and flood terraces.

Figure A44. Oblique view of ford and aggraded upstream channel.

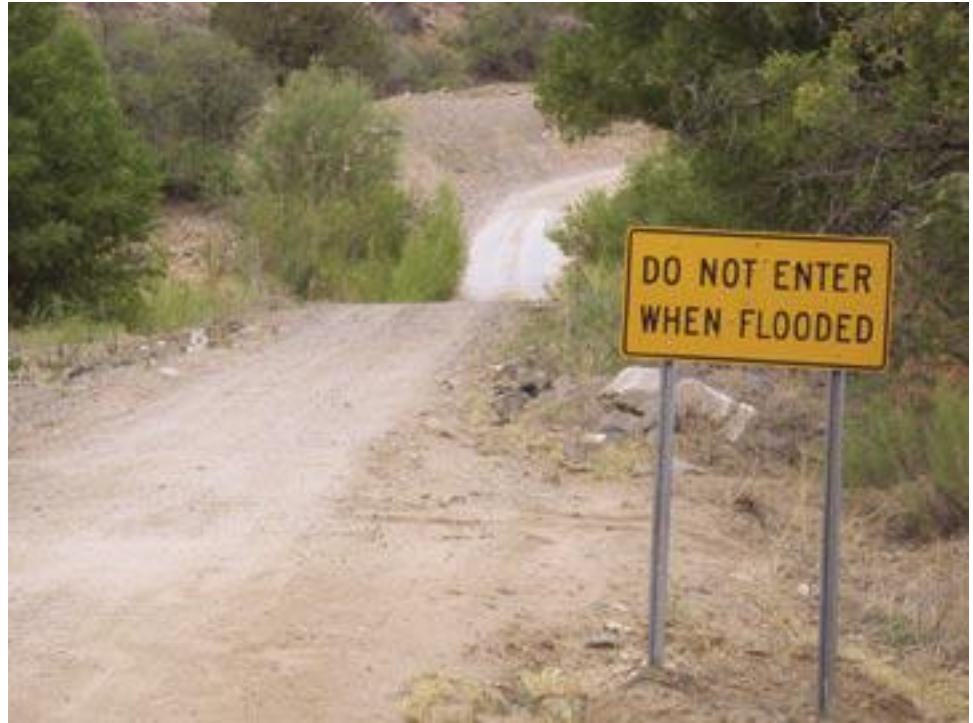
Safety: The crossing is signed before both approaches with “Dip - 5 MPH” and “DO NOT ENTER WHEN FLOODED” signs (figure A46). The road itself is signed as being maintained for high-clearance vehicles only at the junction with the freeway. When water flows over the ford for long times, slippery algae can sometimes be a road hazard.

Figure A46. Warning sign at Agua Fria River ford.

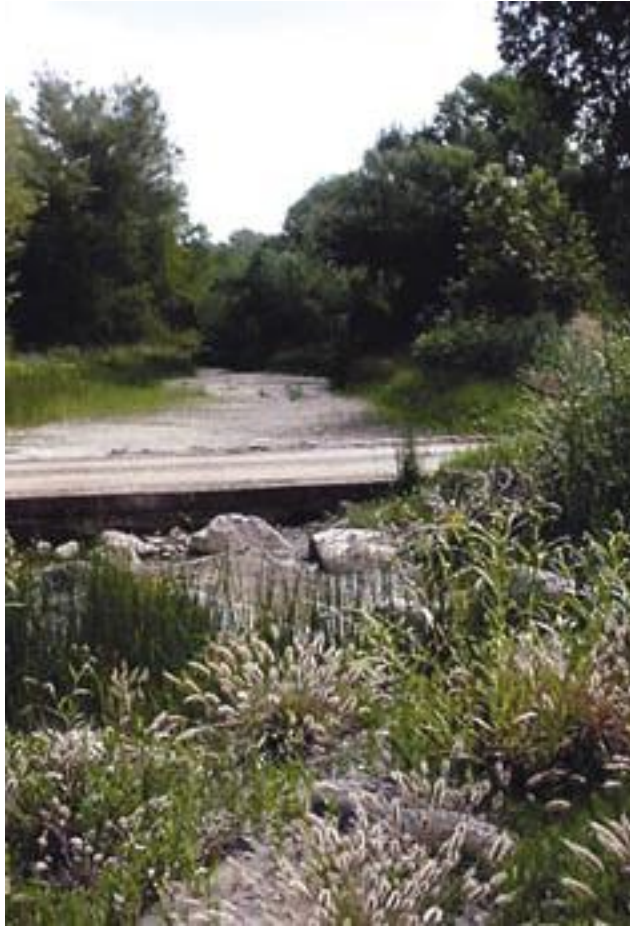
Figure A47. Looking upstream at ford and Agua Fria channel. Fish can move across the ford only when it is submerged.

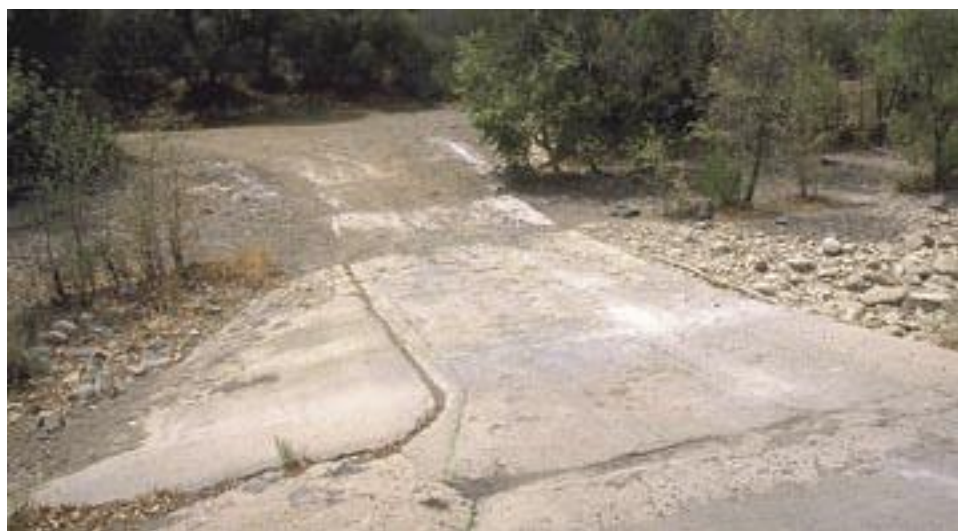
The Ashdale administrative site ford on the Tonto National Forest is another example of an unvented, improved ford with a concrete slab. It is on a very short road (FR24B) that accesses a defunct administrative site, and has primarily light recreational traffic (figure A48). The ford crosses Cave Creek, a moderately entrenched ephemeral to intermittent stream that is closely confined between the valley side walls (figure A49). Channel slope is approximately 3 percent, and much of the bed material is small boulders that are mobile during floods. Annual precipitation in this region is 10 to 25 inches, falling either during the winter or summer monsoon season. Fish or other aquatic organism passage is not a concern on this ephemeral stream.

Figure A48. Ashdale concrete slab ford (downstream is to left).

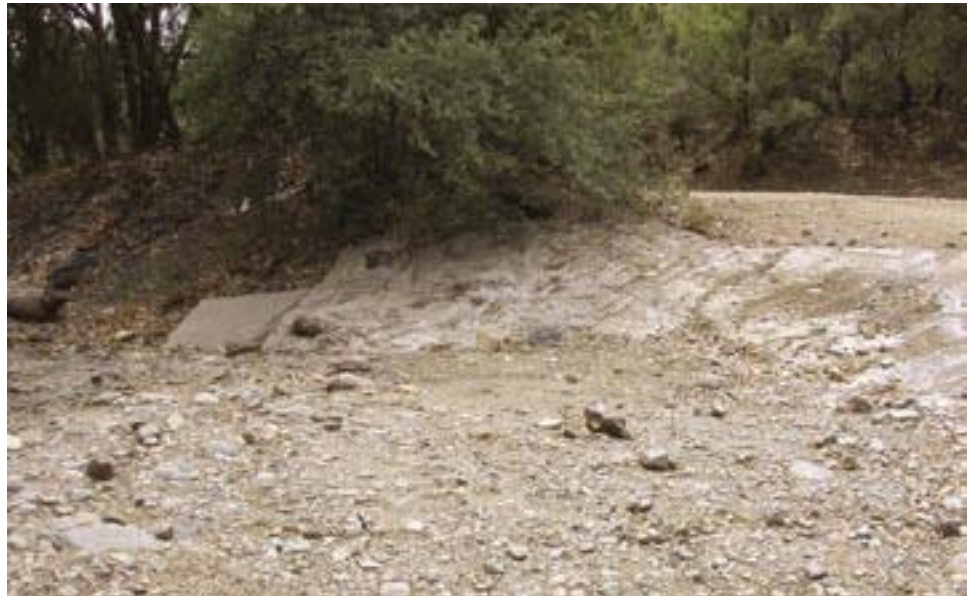
Figure A51. Concrete apron and grouted riprap prevent downstream scour and scour around edges of the ford.

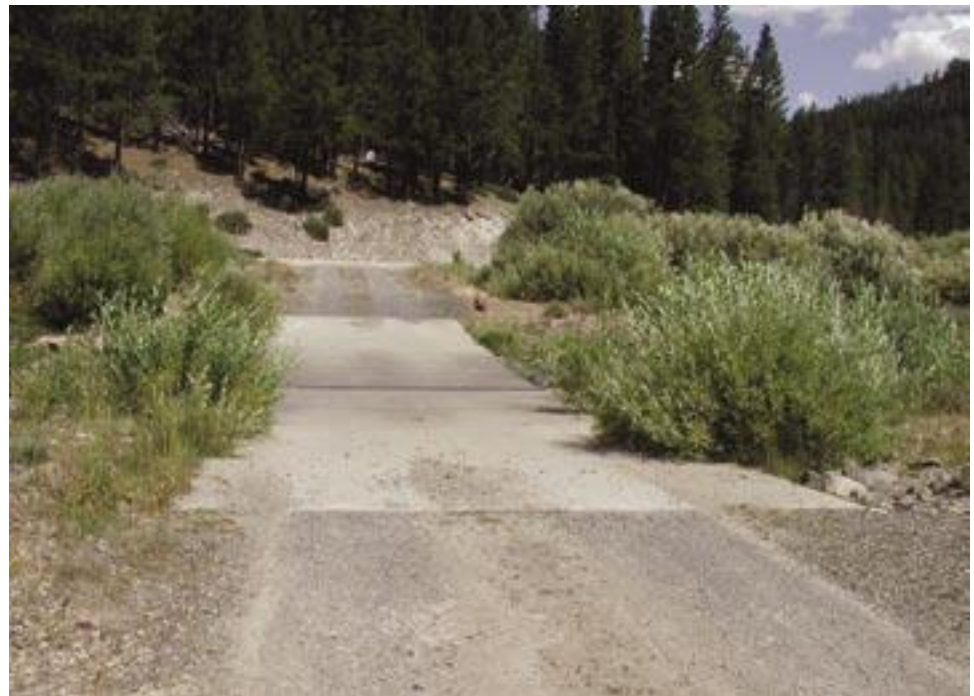
This slotted concrete slab ford was constructed in 1996 on a perennial stream with resident redband trout. Previously at this site, there had been a series of structures that either did not pass fish or were not stable. Fish passage is most important during spring high flows for the spawning migration, and the current structure is low enough that trout successfully swim over it during spring flows. To achieve low flow fish passage, there is a 9-inch box slot with a 4-inch opening at the top (similar to the gap in a cattleguard) crossing the middle of the ford.

Figure A52. Looking north at the Mesman ford.

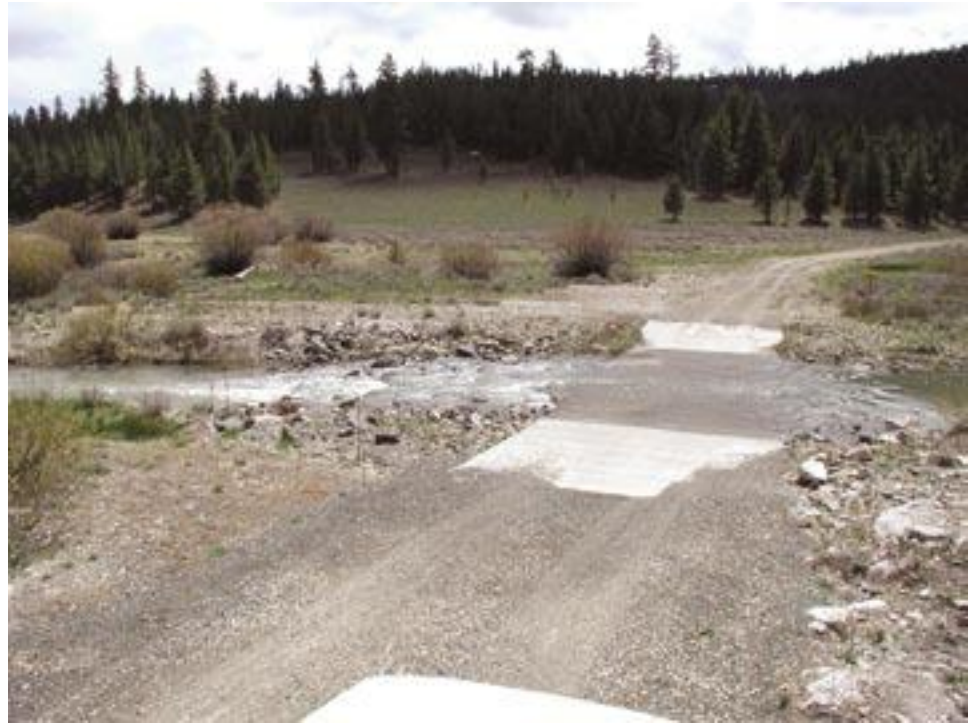
Hydrology: Thomas Creek is a near-perennial stream with peak flows during spring snowmelt runoff, and low summer flows (less than 1 cubic foot per second). Watershed area above the crossing is approximately 20 square miles. Most years, high flows submerge the structure at least 1-foot deep (figure A53).

Figure A53. Spring flow over the Mesman slotted ford.

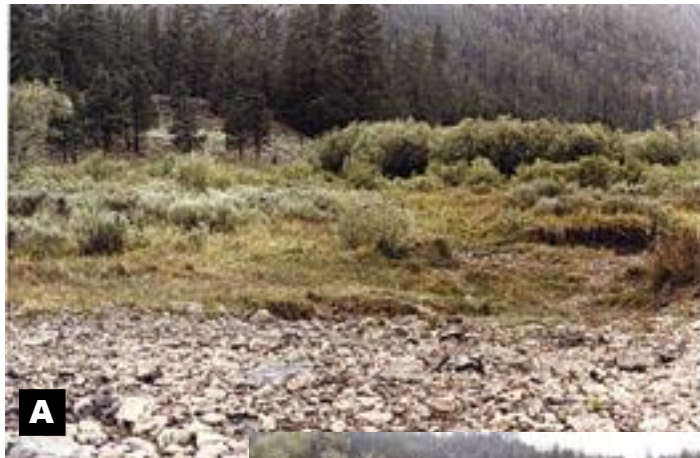
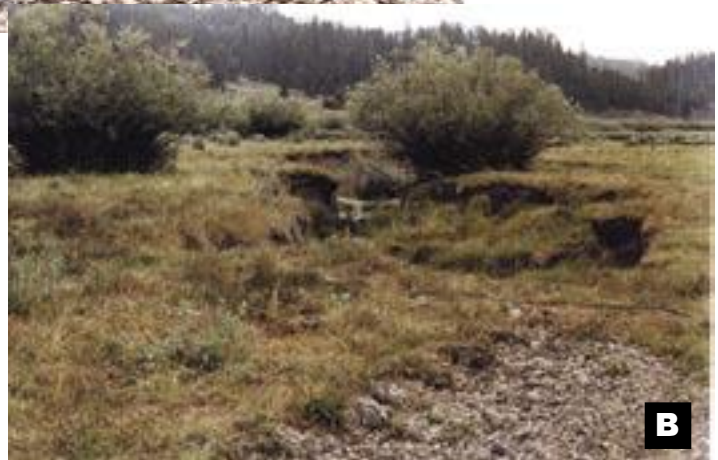
Channel Description: Above the crossing, Thomas Creek is a Rosgen C or E gravel-bed stream (figure A54a). Gravels in transport are mostly smaller than ½ inch and the streambed is mobile (not armored). Channel slope is 1 to 2 percent in the vicinity of the crossing. Bankfull width varies from about 20 feet to 35 feet, and the banks above the crossing are about 2 feet high. Naturally, floodwaters flow in multiple channels across the flood plain or they may cover it completely.

Figures A54a and A54b. Thomas Creek in 1988 as seen from the ford (a) looking upstream of the crossing (b) downstream of the crossing.

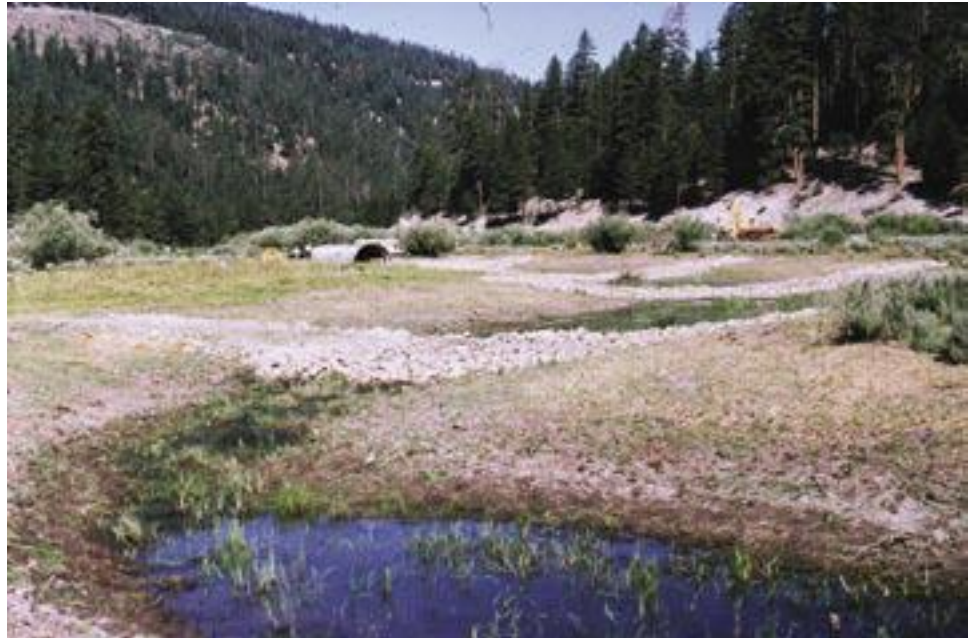
Restoration objectives were to reestablish the natural overbank flow regime, narrow the channel, restore natural vegetation, and improve trout habitat. Shortly thereafter the open-bottom arch culvert that later failed was installed (figure A55).

Figure A55. Looking upstream at the rehabilitated channel during placement of the culvert in 1988.

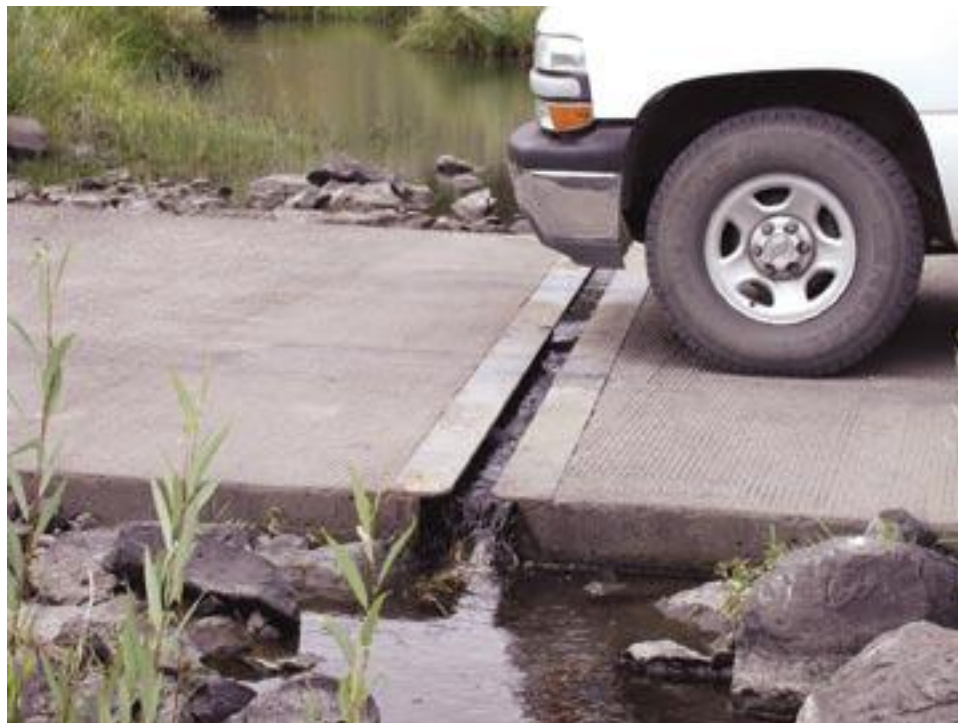
Structure: The driving surface of the ford is reinforced concrete. Two parallel W-flanges with tops set flush into the concrete run across the ford perpendicular to the roadway. These create an open slot box (9½ inches wide by 10½ inches high), with a 4-inch opening at the top to allow cleaning with hand tools. The slot passes low flows, fish, and possibly other aquatic species. It was designed for a velocity of less than 2 feet per second and a depth of at least 4 inches during normal summer flows to allow passage of both juvenile and adult fish. The ford and the slot slope downstream at 0.5 percent, which is flatter than the stream, and sand and gravel retained in the slot provide at least a partial natural bottom (figure A56).

Figure A56. View of the slot with gravel bottom, August 2006.

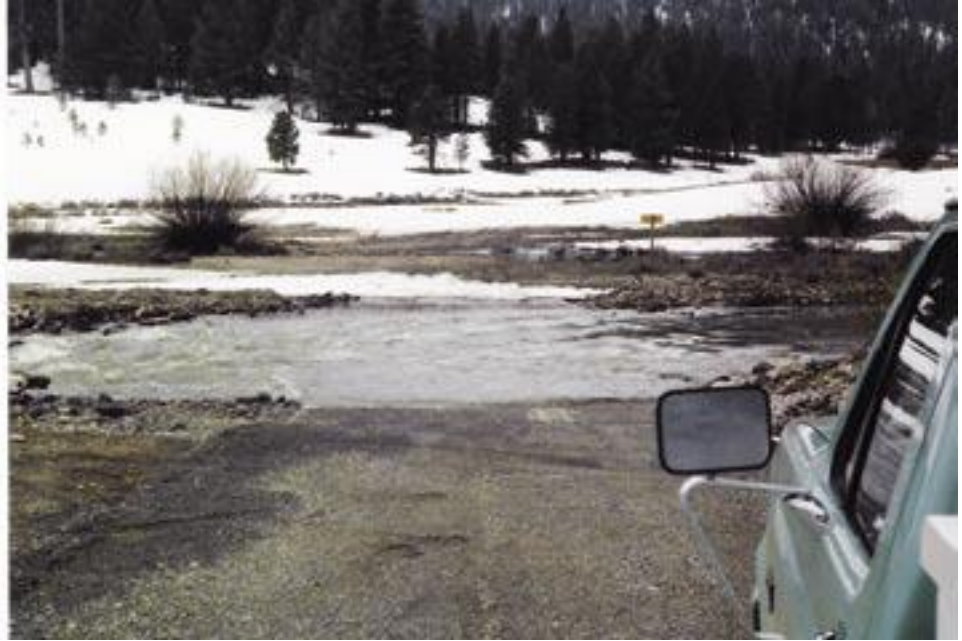
crossing, a flood plain overflow channel was rerouted toward the ford. There is a flood-plain culvert under the road in that vicinity in case ditch capacity is exceeded. About 150 feet south of the crossing, there is a grade sag in the road surface to permit flood plain flows to overtop the road (figure A58).

Figure A58. Looking south across the submerged ford in January 1999. The road dip beyond the ford is conveying flood plain overflow.

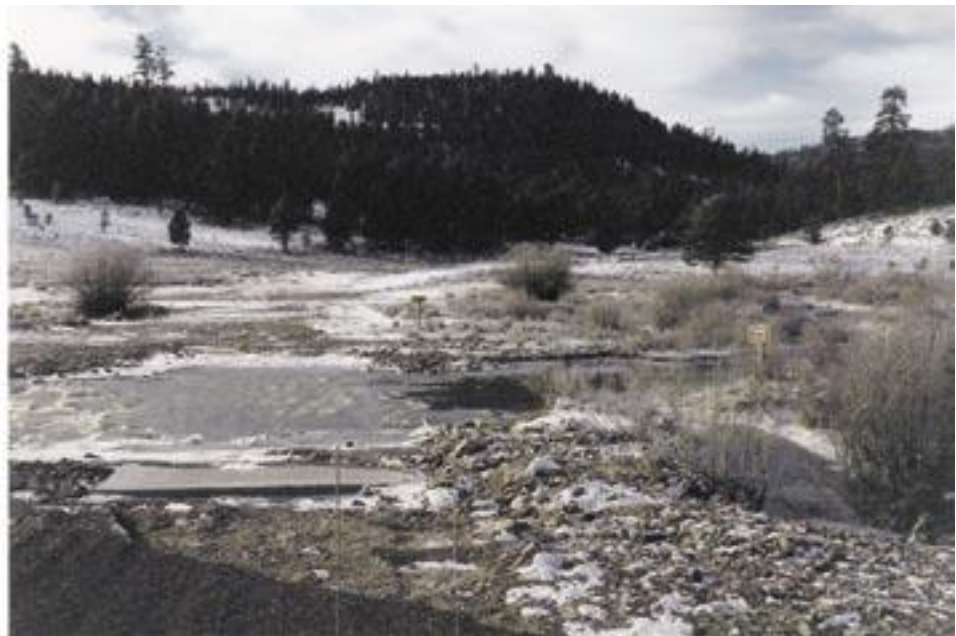
Figure A59. Shortly after the 1997 New Year's Day flood. Some gravel washed from the approaches (in foreground) was the only damage from the largest flood on record.

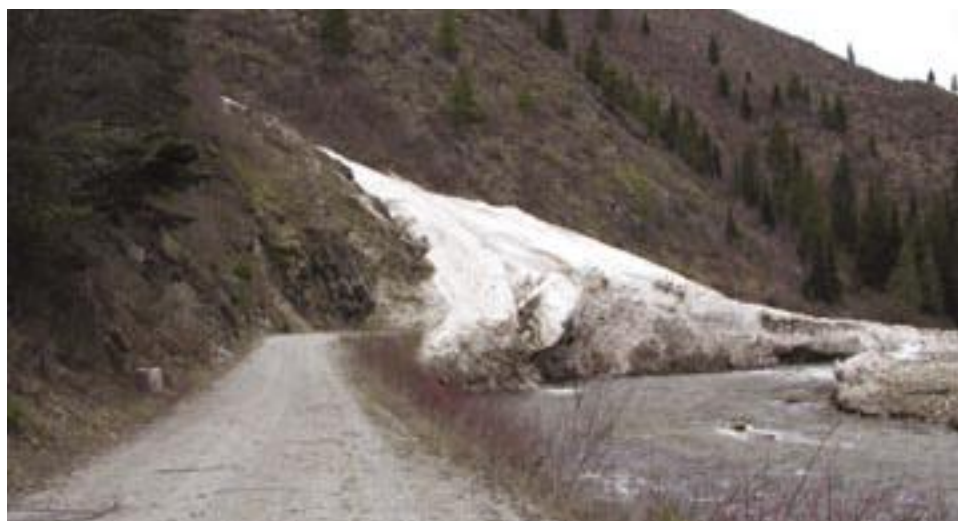
Hydrology: The North Fork Clearwater River is a steep perennial river. The side drainages experience massive snow slides most years (figure A61). Summer low flows on the side drainages are generally about 1 to 2 feet wide and a few inches deep.

Figure A61. Spring snow slide on top of ford, April 2003.

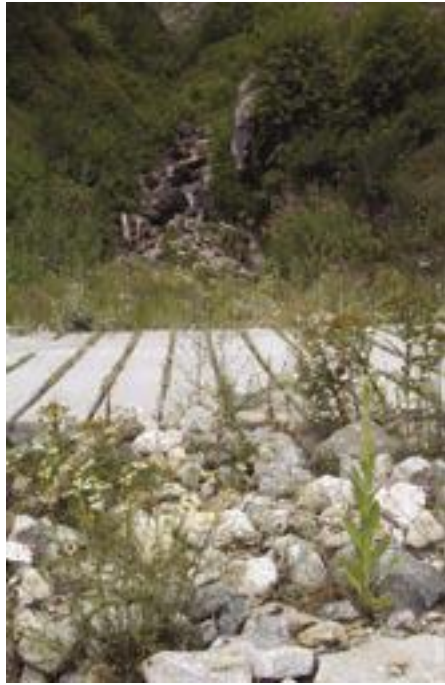
Channel Description: The ford is located on a steep tributary channel, a Rosgen A1a+ in a bedrock avalanche chute (figure A62). Drainage area is approximately 320 acres, and near the bottom of the slope the channel is approximately 6 feet wide. Banks are not well vegetated or particularly stable.

Figure A62. Looking upstream across the ford to the channel. The culvert is to the right out of the frame.

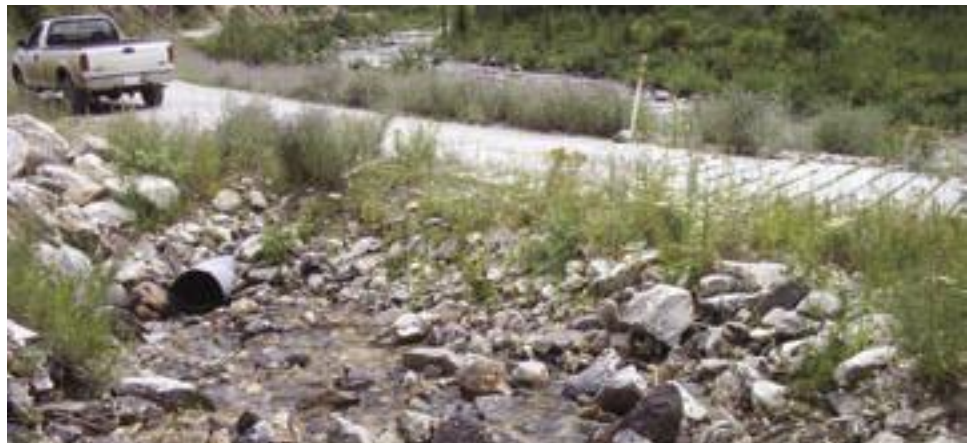
Structure: The concrete planks are 8 inches by 14 inches by 15 feet with steel rebar reinforcement. Planks are separated by 1 to 2 inches. The planks were cabled together and laid over a 1-foot thick foundation of crushed aggregate that was compacted in two 6-inch layers. A 24-inch culvert is located below the planks (figure A63). Riprap was placed at the outlet end of the ford with the top elevation of the riprap conforming to the top elevation of the concrete planks.

Figure A63. Looking downstream toward the North Fork Clearwater River. Note the sediment catch basin in foreground.

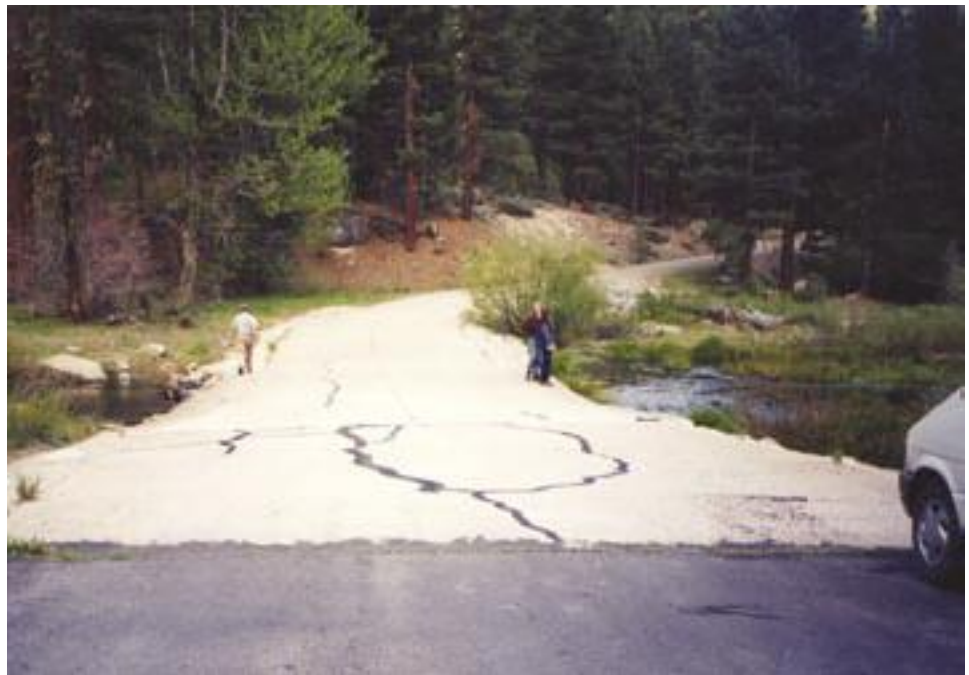
Figure A64. Babcock crossing roadway has a slight vertical curve.

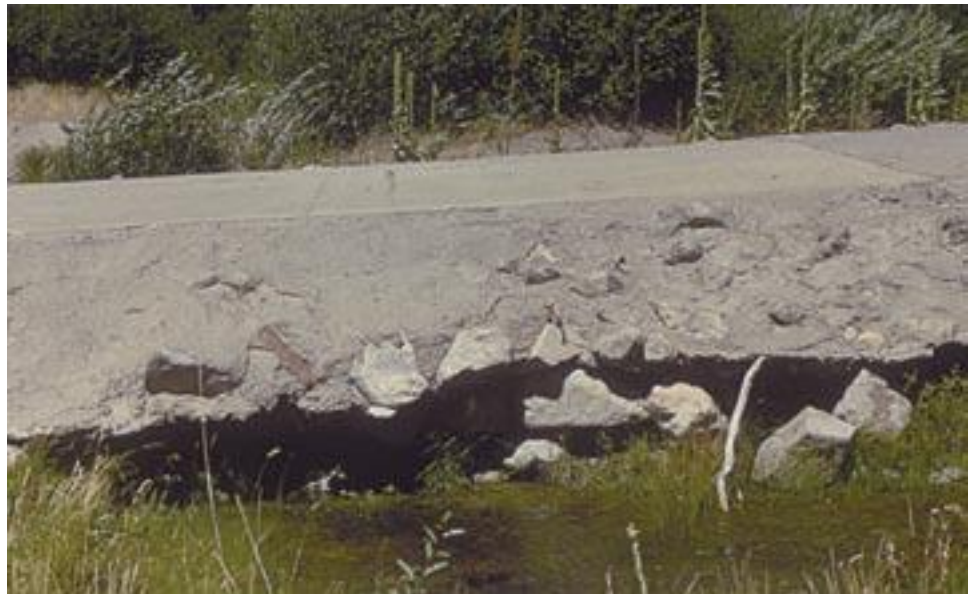
Figure A65. Downstream scour under the slab after the 1982 flood. The repair was to add a 5-foot-deep vertical concrete cutoff wall.

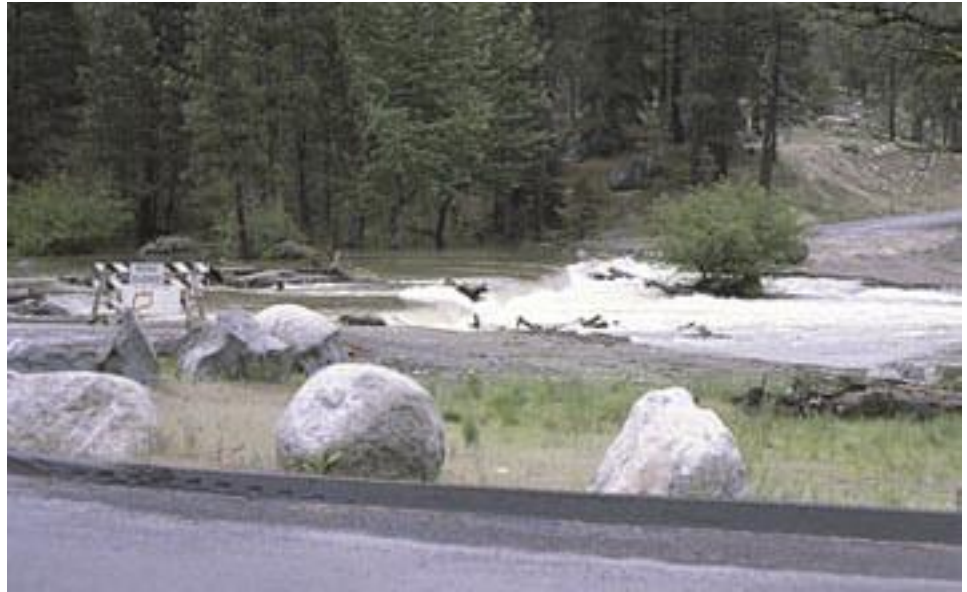
This is a gravel-surfaced road maintained for passenger vehicles (maintenance level 3). It provides access to the Babcock Peak area and the east side of the forest and is not kept open in the winter. Use is a mix of occasional logging traffic during a timber sale, USDA Forest Service administrative traffic, and the general public. Traffic volume (average daily traffic is 50 vehicles) and type are such that occasional interruptions are acceptable. Also a longer but alternate route is available if necessary to access the area. Traffic interruptions lasting several days can occur up to two times per year after moderately large storm events (figure A66). When the reservoir water level is being lowered, traffic interruption can last several weeks.

Figure A66. Crossing during a flood event. It is clearly not passable at this time. Note the amount of energy and “scour power” where the flow drops several feet over the structure.

Note the bank erosion and widened channel downstream of the structure (figure A71b). As figure A70 shows, the ford is nearly flat across the stream, and when it overtops flow can go around the ends of the structure, eroding the banks. The same type of turbulence shown in figure A66 at the Babcock crossing undoubtedly happens here during overflow, with similar results. Scour protection at this ford consists of a concrete splash apron (figure A72) and riprap. The riprap is placed in a trench just downstream of the apron.

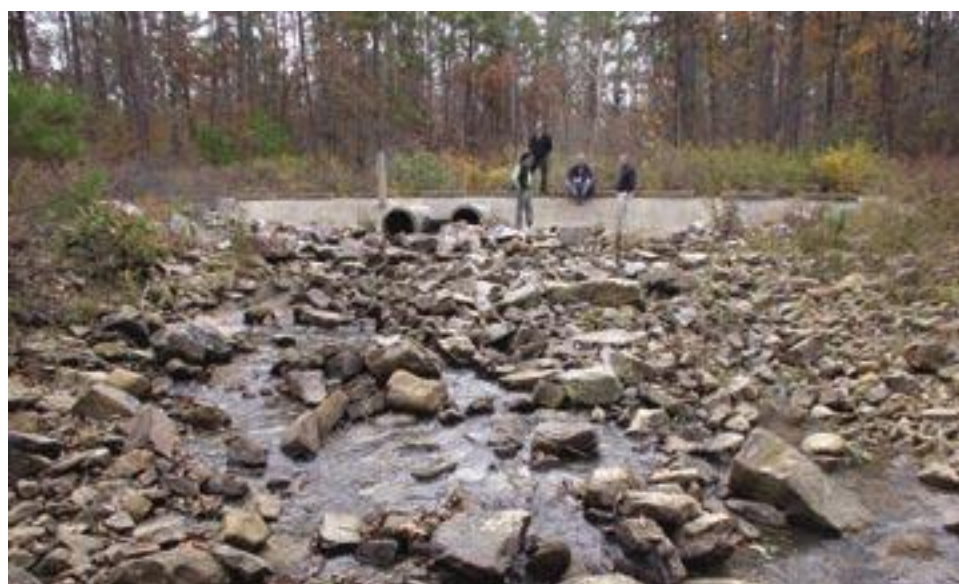
The Ouachita National Forest in west central Arkansas has traditionally made frequent use of concrete vented fords with round concrete culverts on second- and third-order streams. The crossing on lower Harris Creek on the Ogden Ranger District is a good example (figure A70).

Figure A70. Lower Harris Creek concrete vented ford.

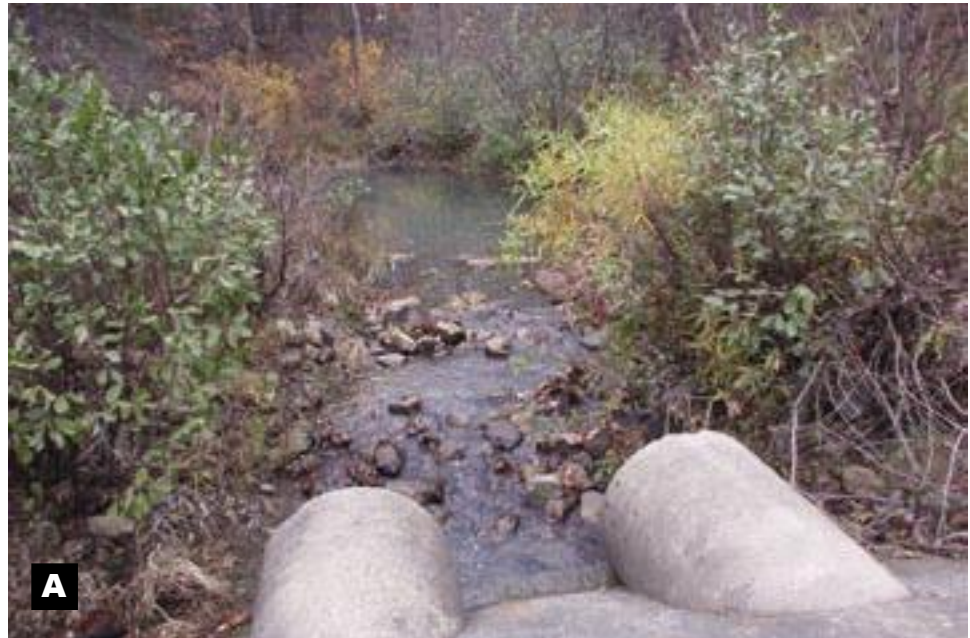
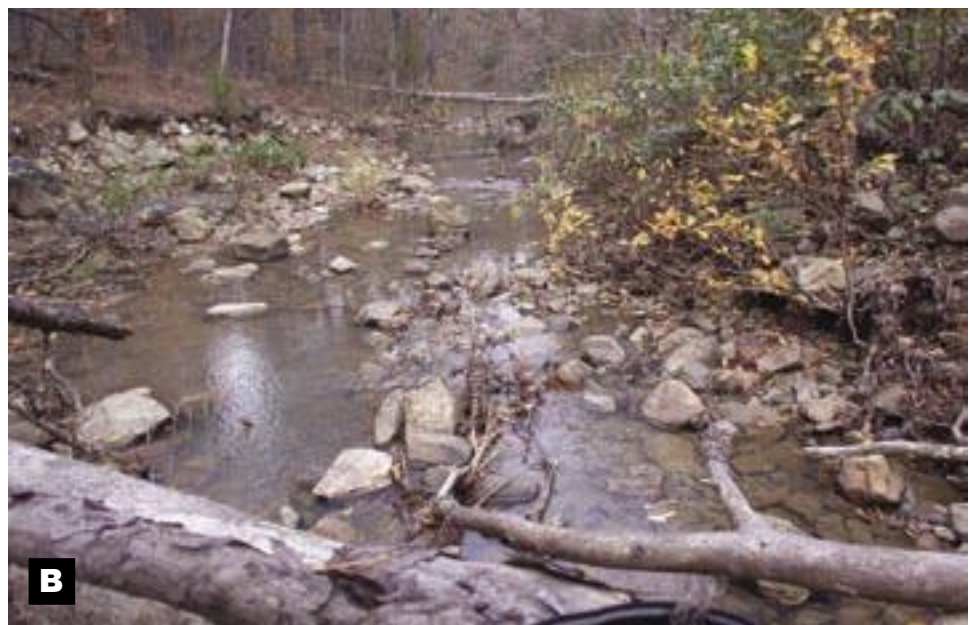
Figures A71a and A71b. Figure A71a. Harris Creek upstream of ford. Figure A71b. Downstream of ford.

The forest plans to replace this structure with a high vent-area ratio concrete box culvert that provides darter passage during low flows, like the crossings in case study 14.

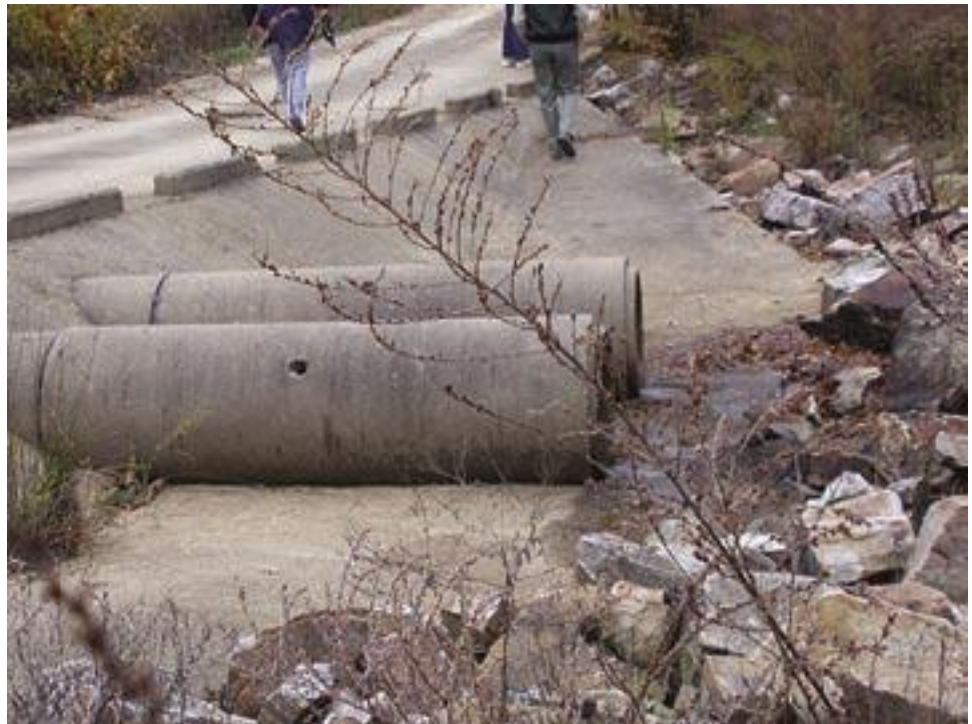
Figure A72. Concrete pipes outlet on splash apron with riprap downstream. Fillslope is also protected by concrete. Note erosion to side of fillslope concrete armor.

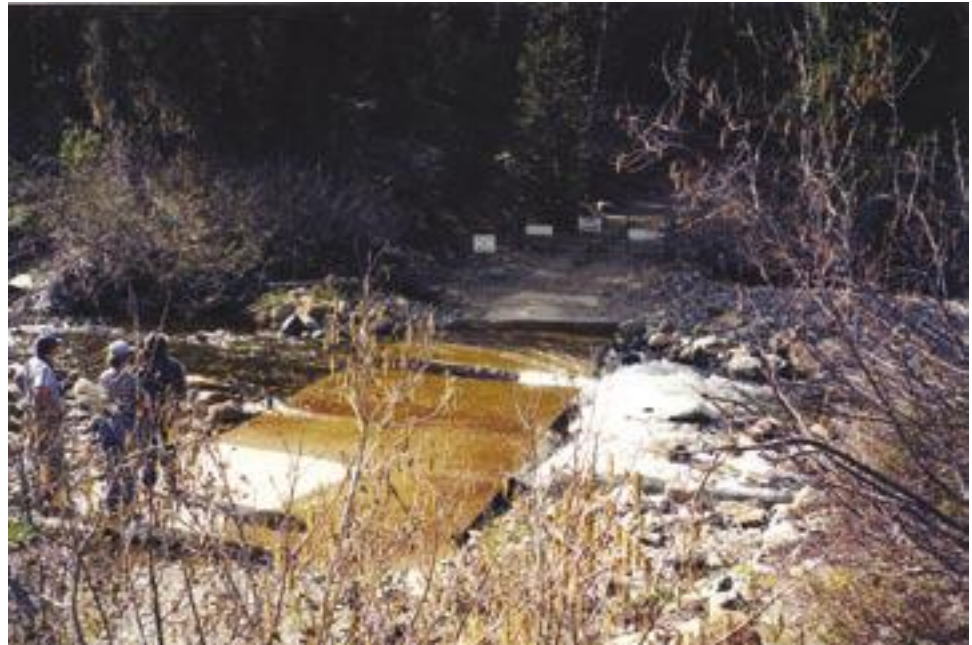
This partially vented ford is a massive concrete slab that was constructed in 1986 on a 55-foot-wide high-energy perennial stream. The channel is not steep at this site (approximately 2 percent), but it is immediately downstream of steeper, unstable terrain, and it moves boulders up to about 1½ feet in diameter during floods. The ford consists of a 65-foot long reinforced concrete slab about 1-foot above channel grade with one opening for fish passage: an embedded 3-foot-wide concrete-walled box covered with a cattleguard grating (figure A73). The opening frequently plugs with debris and boulders, and upstream fish passage is questionable most of the time. The downstream edge of the structure is protected against scour with gabions. The structure withstood the major 1996 flood with no damage.

Figure A73. Grubbs crossing on Grizzly Creek, May 2002.

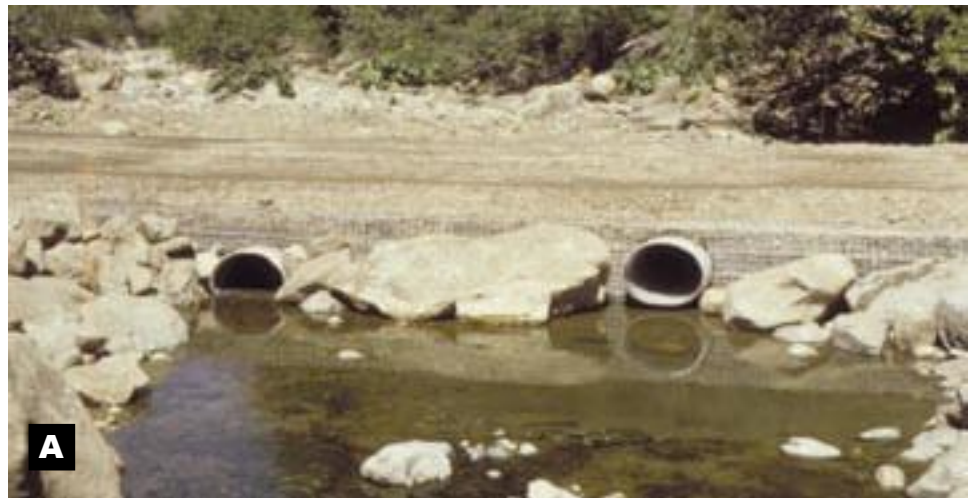
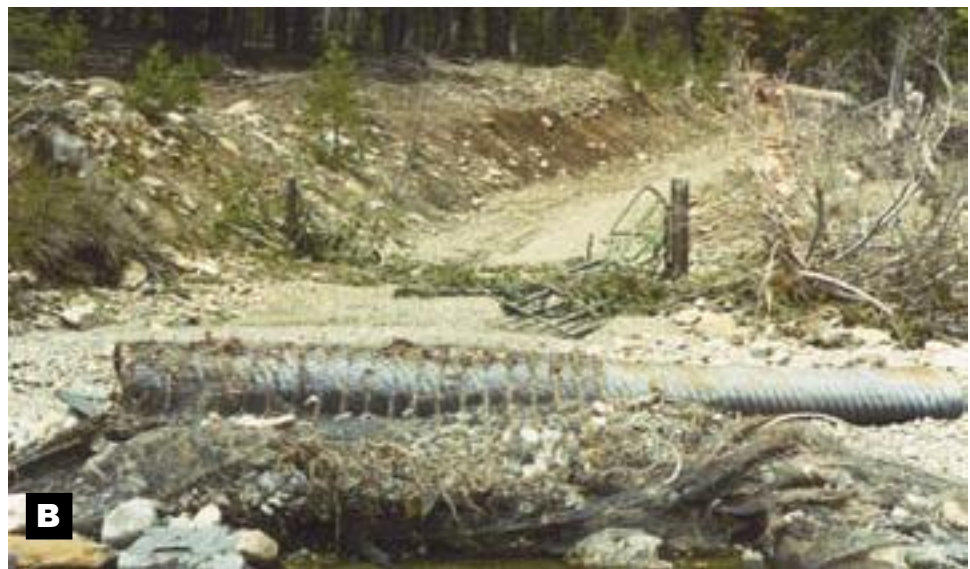
The previous crossing structure was a vented ford constructed in 1984 to provide access across the stream during a timber sale. It was a gabion-type structure fabricated from surplus pieces of welded wire from a retaining wall, and had two corrugated metal pipes as vents. It was too weak for the dynamic forces of the stream at this site, and was destroyed in 1986 (figure A74).

Figures A74a and b. The original gabion vented ford. (a) as built and (b) after the 1986 storm.

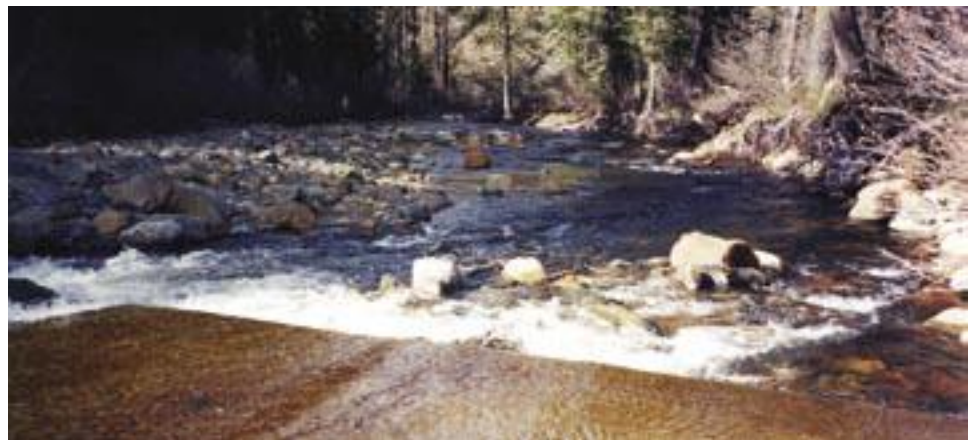
Figure A75. Grizzly Creek downstream of the ford, May 2002.

Channel Description: At the site, channel slope is 2 to 2½ percent, and the substrate is a well-graded mixture of gravels, cobbles, and boulders to a maximum size of about 18 inches. The bankfull channel is about 55 feet wide, and is slightly entrenched (figure A75). Streambanks are fairly stable, and riparian vegetation includes willow, alder, fir and cottonwood.

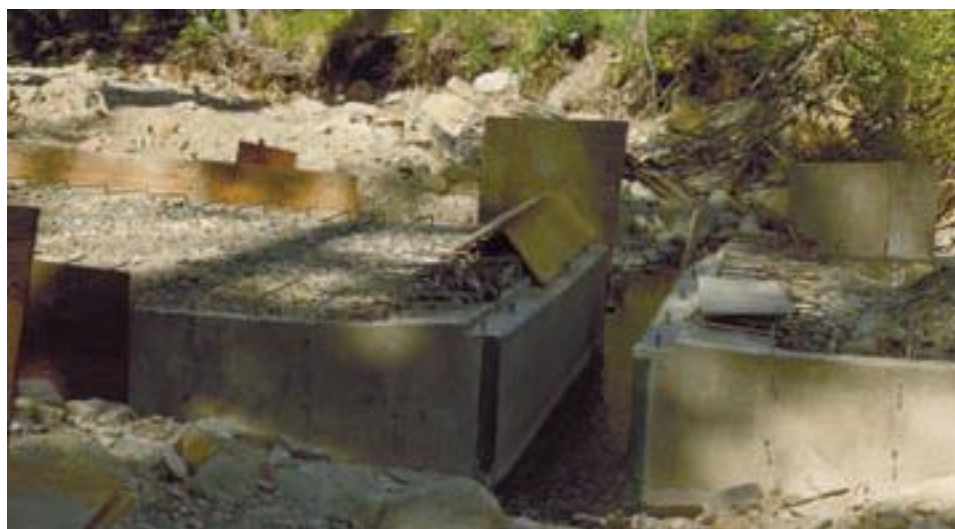
Figure A76. A 3-foot wide gap left between the two sides of the ford forms a narrow concrete-floored vent.

Between the two concrete boxes, a 3-foot-wide embedded box culvert was constructed for fish passage (figure A76). A steel Irvine Type “HV” bridge decking with welded metal grating bridges the box to connect the driving surfaces.

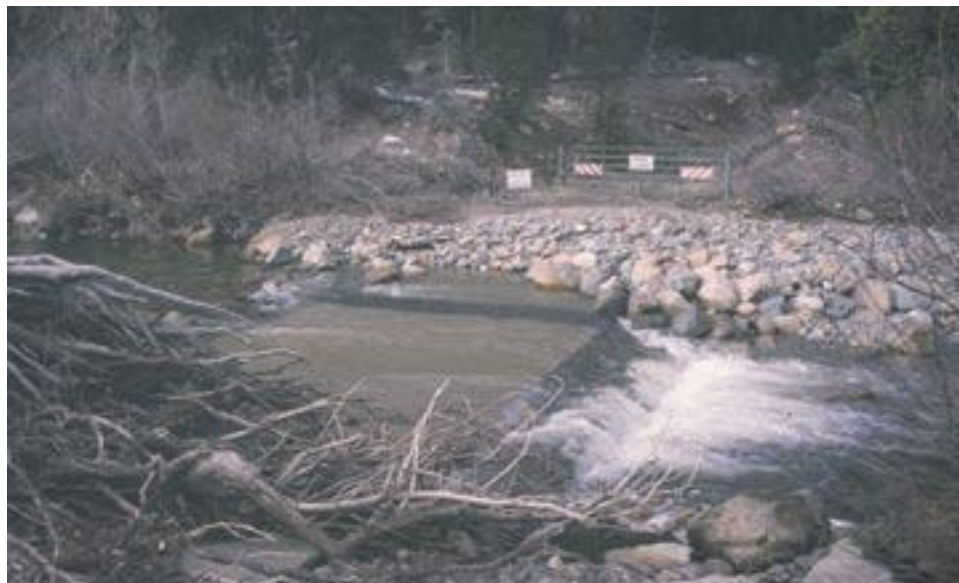
Figure A78. After a major storm, medium and large boulders and large root wads cover the ford, but the structure is undamaged.

This massive reinforced concrete structure survived the major 1997 flood event with no damage (figure A78). Minor maintenance is frequently required to remove rocks and boulders off the slab and from the concrete box. Boulders moving in the channel during high flows are not much smaller than the box width, and in conjunction with small debris they tend to keep the box plugged most of the time. Some of the downstream gabions will need replacement soon due damage and abrasion of the wire.

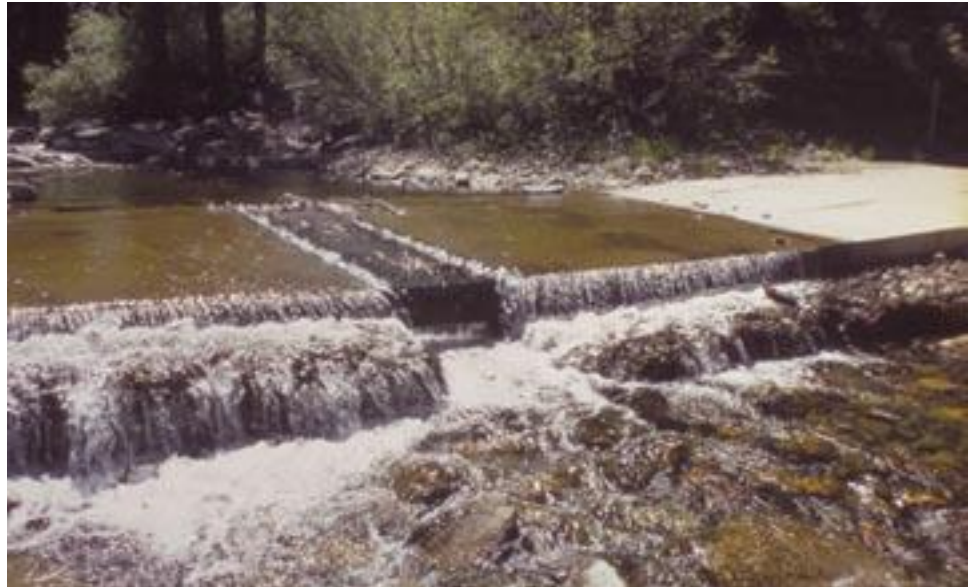
Figure A79. Grubbs ford immediately after construction in 1986. The vent appears to be a velocity barrier when it is not plugged.

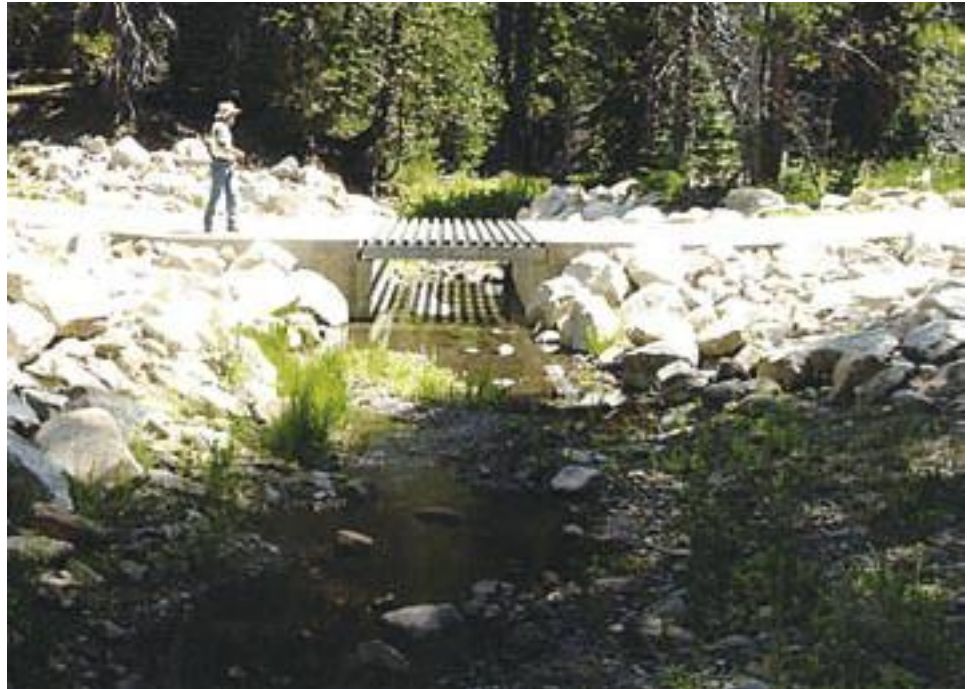
Figure A80. One of several grating-top box culvert fords on tributaries of the North Fork Consumnes River.

These structures are concrete boxes with removable grate tops, designed to permit removal of bedload and woody debris that could jam the opening. The example here has slab approaches, upstream and downstream cutoff walls, and a sloping concrete floor intended to concentrate low flows along one wall for fish passage (figure A80). The box is set at natural stream grade and slope. At that slope, flow across the smooth concrete floor is too fast to allow fish to swim up. Riprap protects all four cutoff walls. There are several of these structures along Forest Road 52 near the Capps crossing (case study 21).

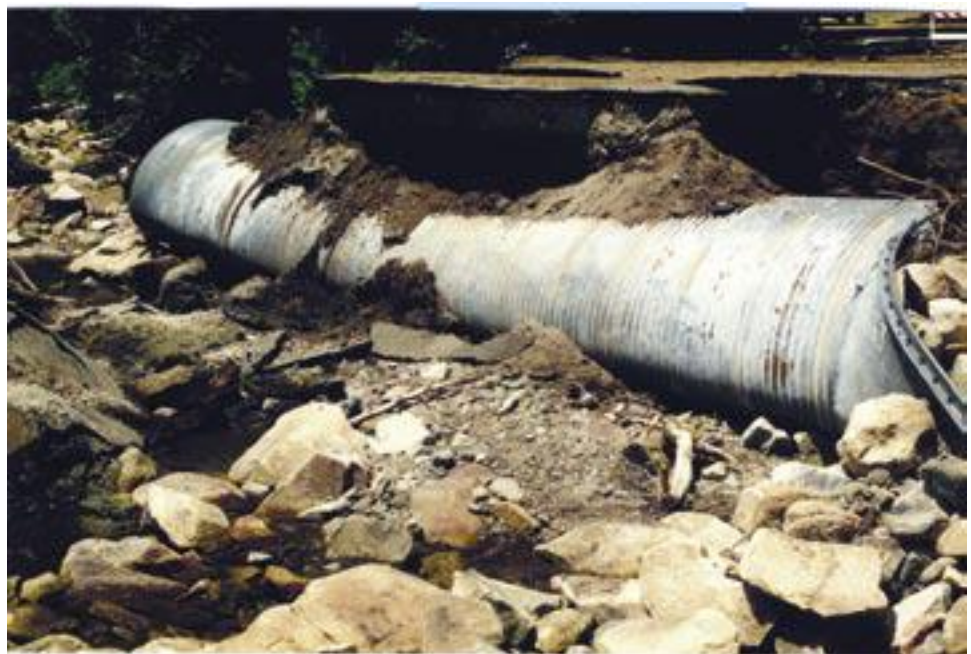
Figure A81. Typical flood damage at edge of North Fork Consumnes River valley after 1997 rain-on-snow flood.
