U.S. Department
of Agriculture

Forest Service

October 2006

Low-Water Crossings: Geomorphic, Biological, and Engineering Design Considerations

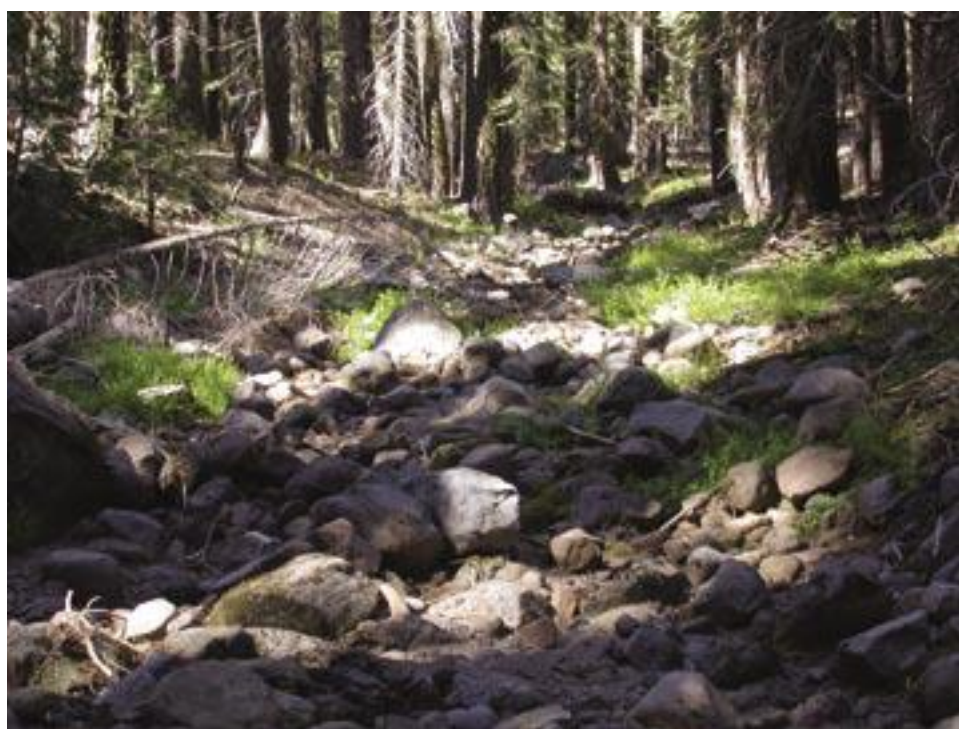
Figure A82. Aggraded boulder-bed intermittent tributary of the North Fork Consumnes River, July 2002.

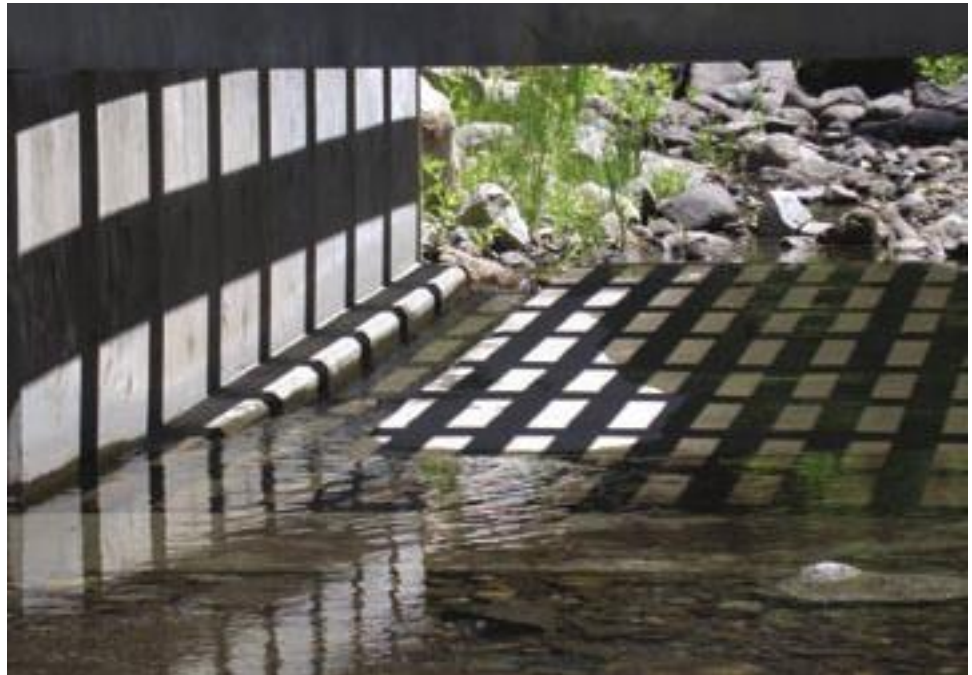
Figure A83. Vented ford showing low-flow trench at left and partial backwatering. Fish were attempting to move upstream in July 2002, but flow in the trench was too shallow and too fast.

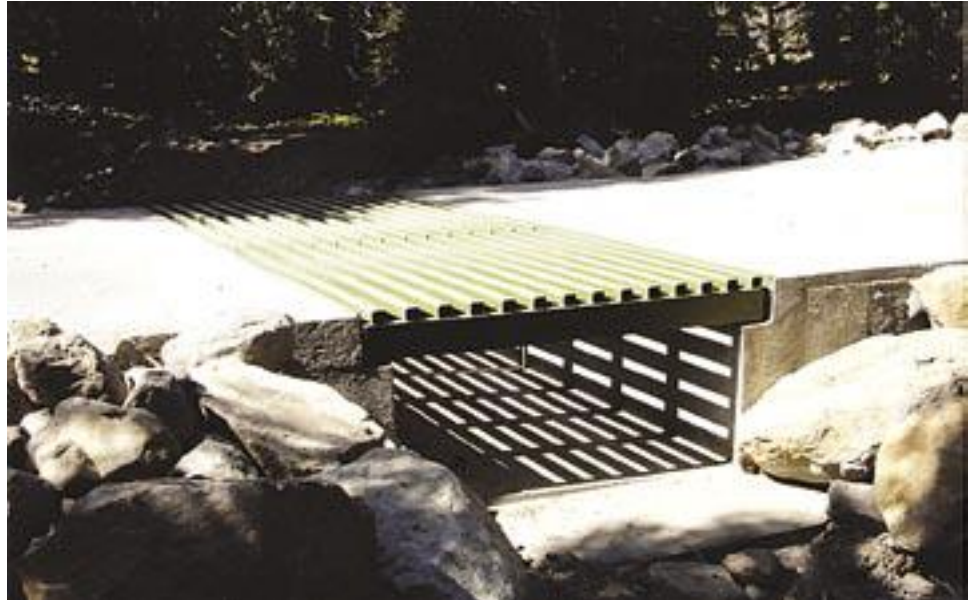
Figure A84. Close up of grated-top vented ford.

Structure: The structure is a small box culvert with an open top and cattleguard driving surface that can be removed for cleaning (figure A84). Concrete approaches dip into the ford, which has a total length of 75 feet (figure A85). The concrete box is 8 feet wide and 4 feet deep. The box floor slopes slightly perpendicular to the direction of flow to force low flow to concentrate in the trench at one side of the box. An upstream cutoff wall 9 inches deep runs the full length of the ford and is heavily riprapped.

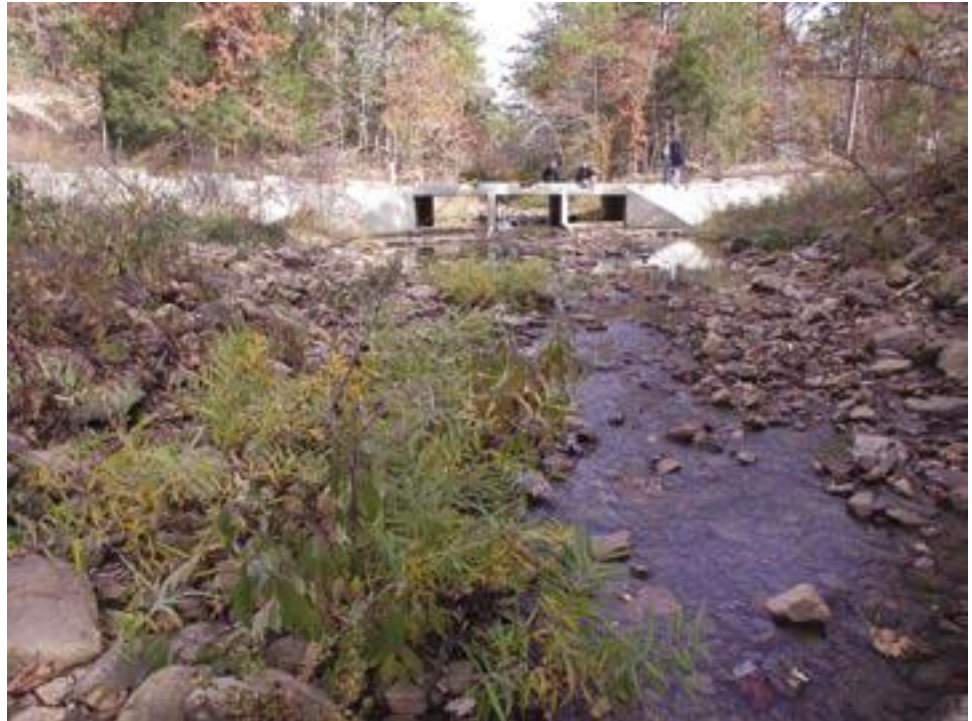
Figure A86. Looking upstream at the concrete vented ford and splash apron.

This is a concrete vented ford on a perennial stream that provides habitat for several fish and mussel species. The structure consists of three 6- by 3-foot concrete box culverts, with a splash apron extending downstream of the roadway (figure A86). Six-inch curbs focus water into the center culvert for low-flow passage for weak-swimming fish and boulders embedded in the concrete provide resting areas for them .

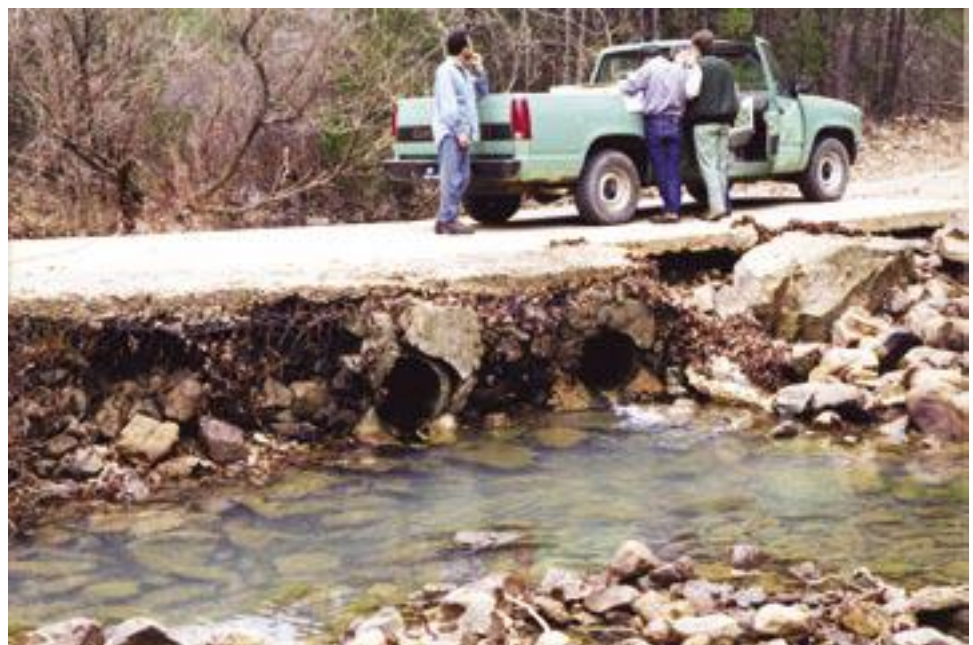
Figure A87. The previous crossing on road 887 at Rocky Creek was a gabion-culvert structure that was frequently damaged during high flows.

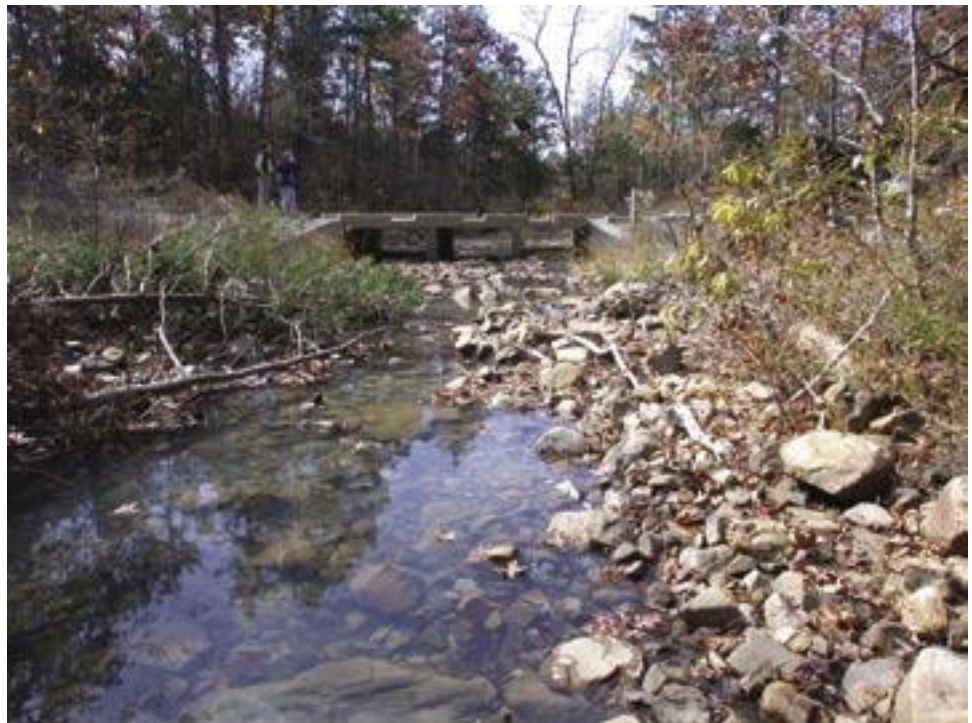
Figure A88. Looking downstream at the crossing on Rocky Creek.

Channel Description: Rocky Creek at the site is moderately entrenched between terraces about 5 to 6 feet above the streambed. Stream substrate is small boulders and large cobbles, with some larger boulders and bedrock outcrops. Channel slope is approximately 2.5 percent, bankfull width is about 15 to 20 feet, and depth at bankfull is 2 feet. The flood plain is narrow, about 2 feet wide. Banks are rocky and well-vegetated upstream of the structure (figure A88). Downstream, banks are scoured and the stream is wider, but the effects of the crossing on channel stability appear to be restricted to the immediate vicinity of the crossing.

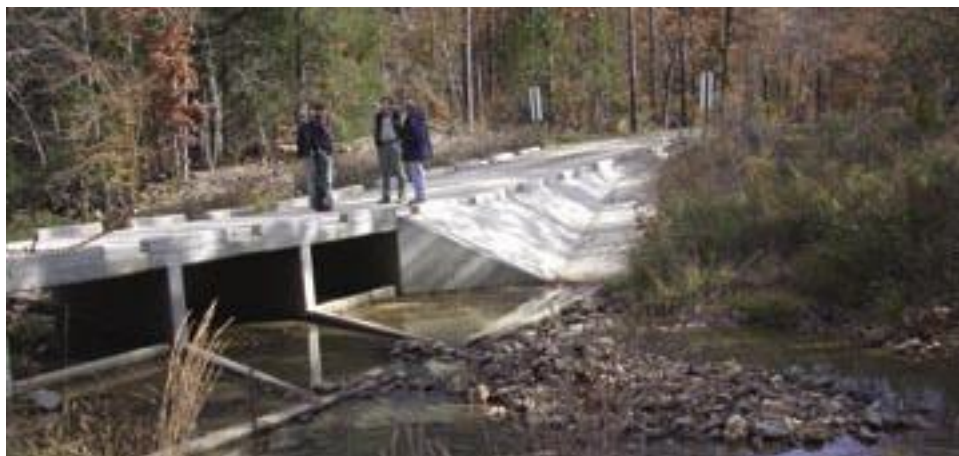
Figure A90. Looking upstream at the splash apron and backwater curbs.

Structure: The structure consists of three 6- by 3-foot concrete box culverts set at streambed elevation (figure A89). A 10-foot long splash apron protects the structure against scour during overtopping flows, and a 6-inch curb at the apron's downstream edge is intended to prevent formation of a plunge there by creating a reverse eddy. Curbs under the roadway backwater flows in the side culverts and concentrate water toward the center box (figure A90) for low flow fish passage. The curbs help to retain some bed material in the floor of the culverts, which is also expected to help aquatic species passage through the culvert. Four- to 6-inch boulders embedded in the concrete floor further assist fish passage by providing resting areas.

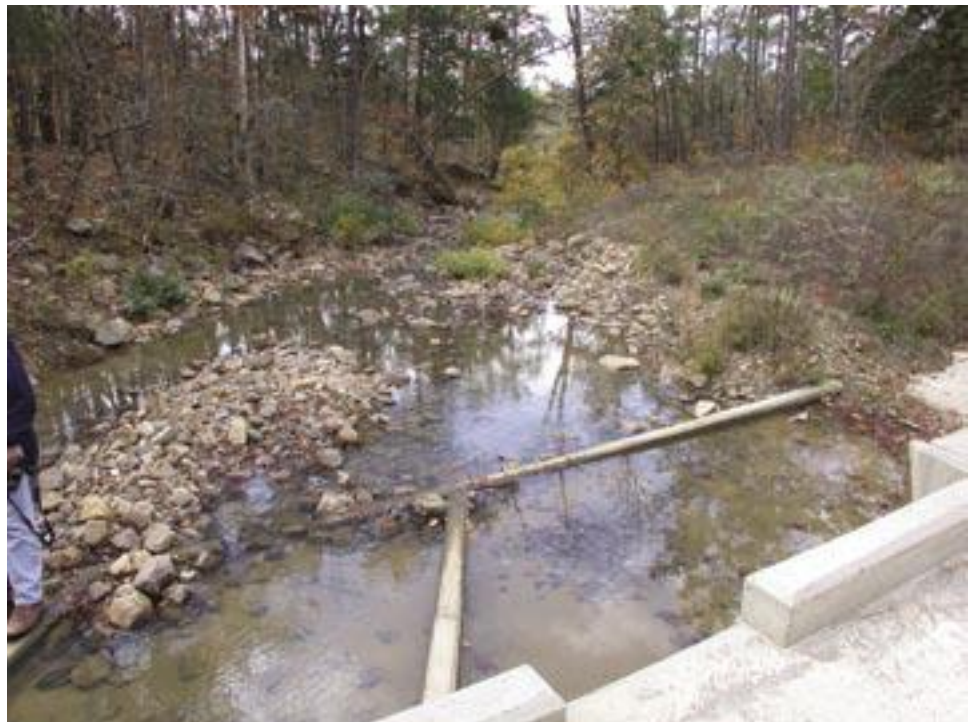
Figure A91. Looking downstream from ford. Note local channel widening.

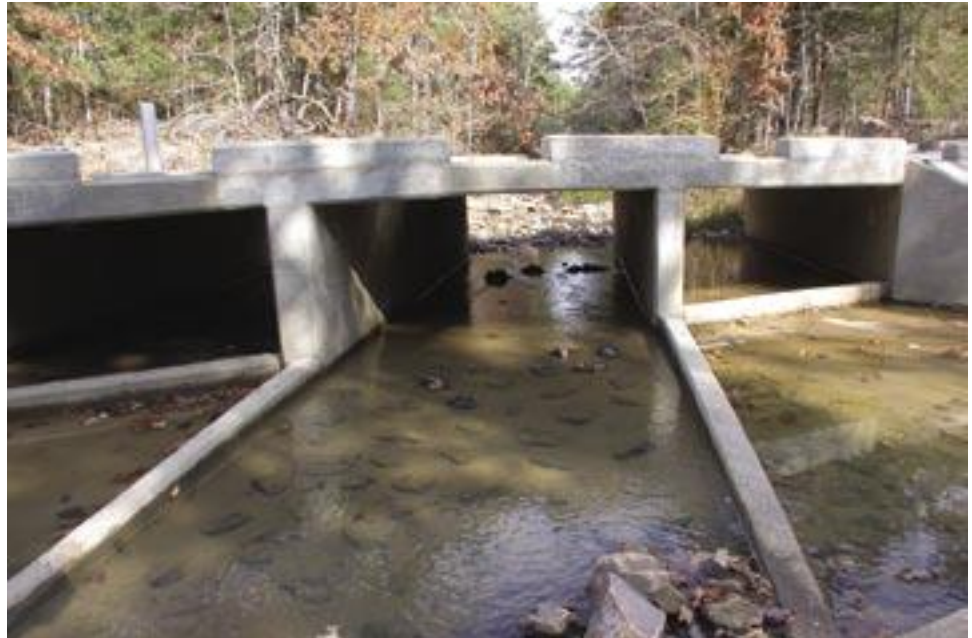
Figure A92. The floor of the central box has a thin veneer of sediment at low flow.

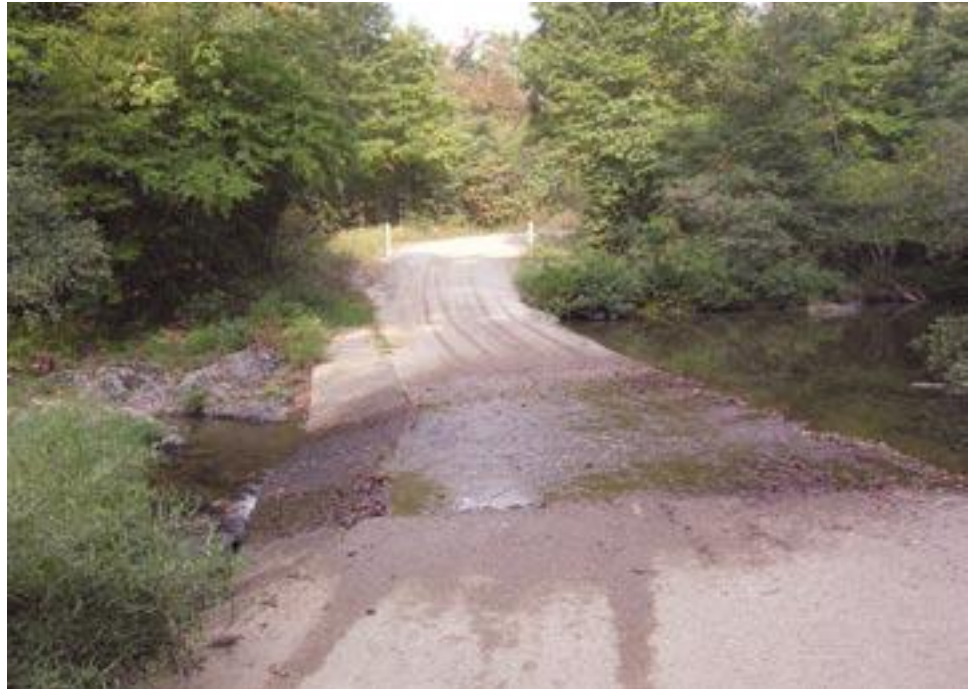
Figure A93. Unvented ford similar to the one replaced at FR 512 crossing on Long Creek, Ouachita National Forest.

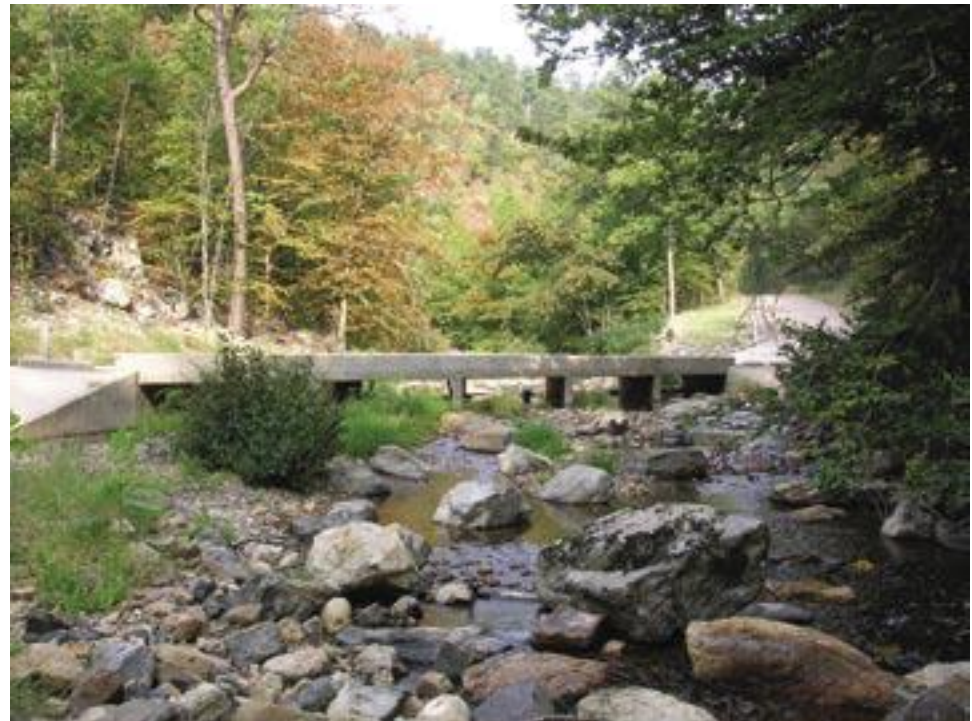
Figure A94. Looking upstream at the embedded box culverts that replaced the unvented ford in 2004.

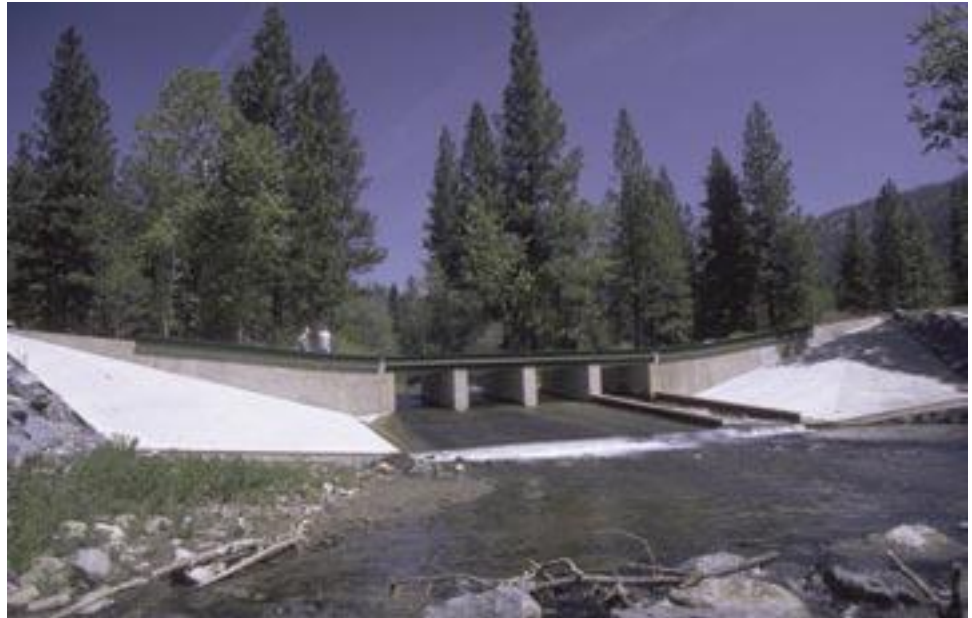
Figure A97. Moonlight crossing with fish ladder 2001.

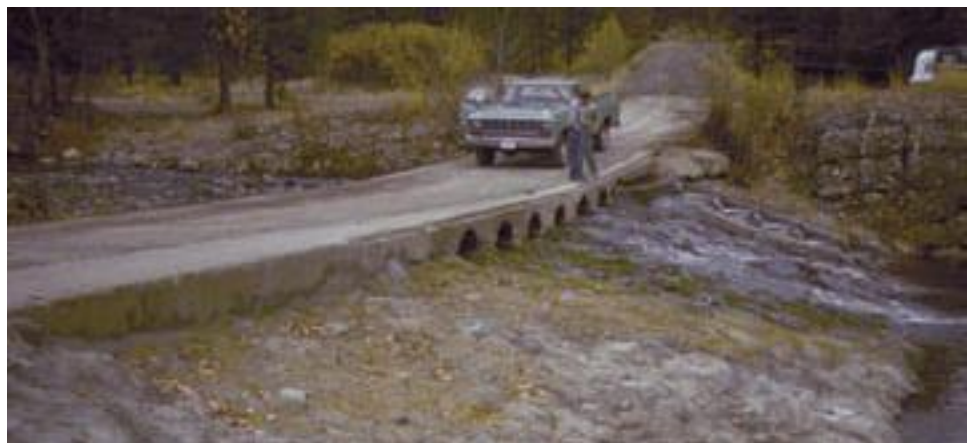
Figure A98. Moonlight Crossing prior to the 1997 flood. Note the weakly grouted small riprap armoring the downstream apron. There is no cutoff wall.

The previous, possibly original structure was a lightly constructed concrete slab over seven 24-inch culverts. The culverts exited onto a grouted rock apron that sloped down to the much lower streambed. During the major 1986 storm event part of the downstream apron was undermined and new large boulders and concrete grout (figure A98) were placed at that time. Also a small fish ladder was built on the east side of the structure below one culvert pipe. This structure again washed out in 1997, undermining the concrete slab (figure A99). Most likely the downstream depth of riprap was inadequate and the toe of the apron was undermined by scour, leading to progressive failure of the entire apron (figure A100). Also during the low-flow years the pipes tended to plug up because of their small size and the high sediment load in Lights Creek.

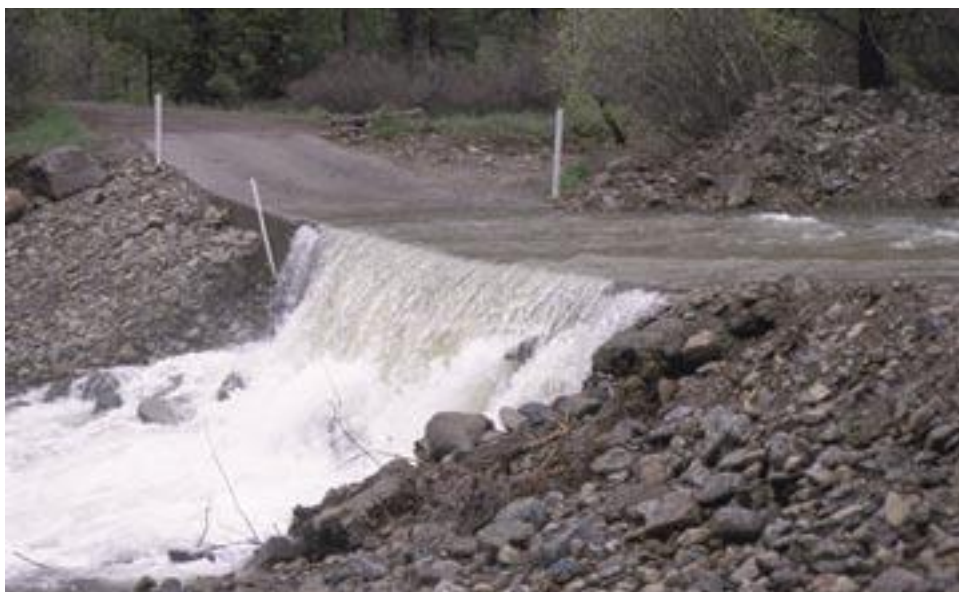
Figure A99. Damage to the Moonlight low-water crossing after the 1997 flood. The downstream rock armoring was undermined and washed away, partially undermining the concrete slab driving surface.

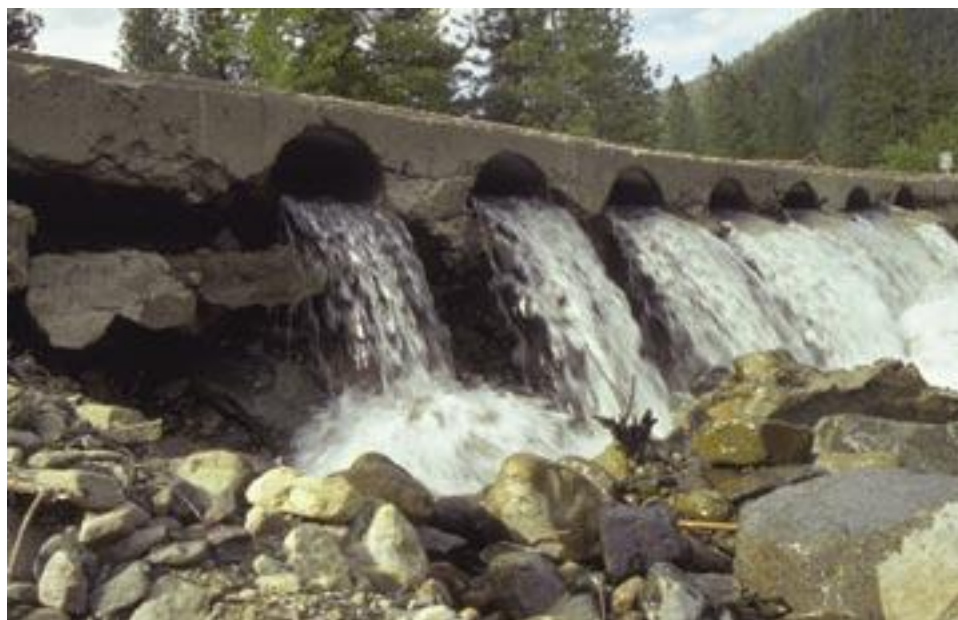
Figure A100. Moonlight crossing in 1999 prior to construction of new structure.

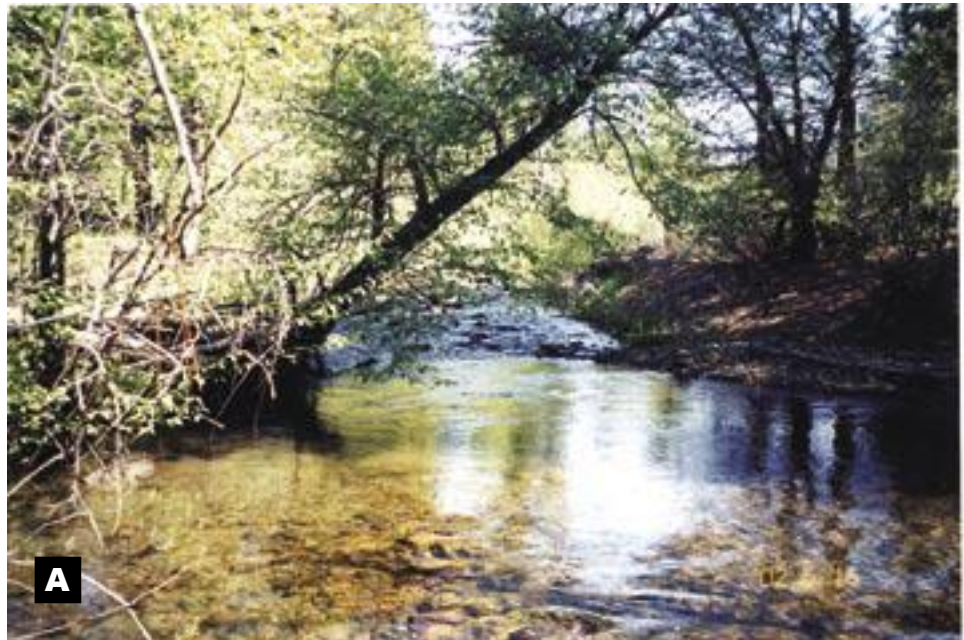
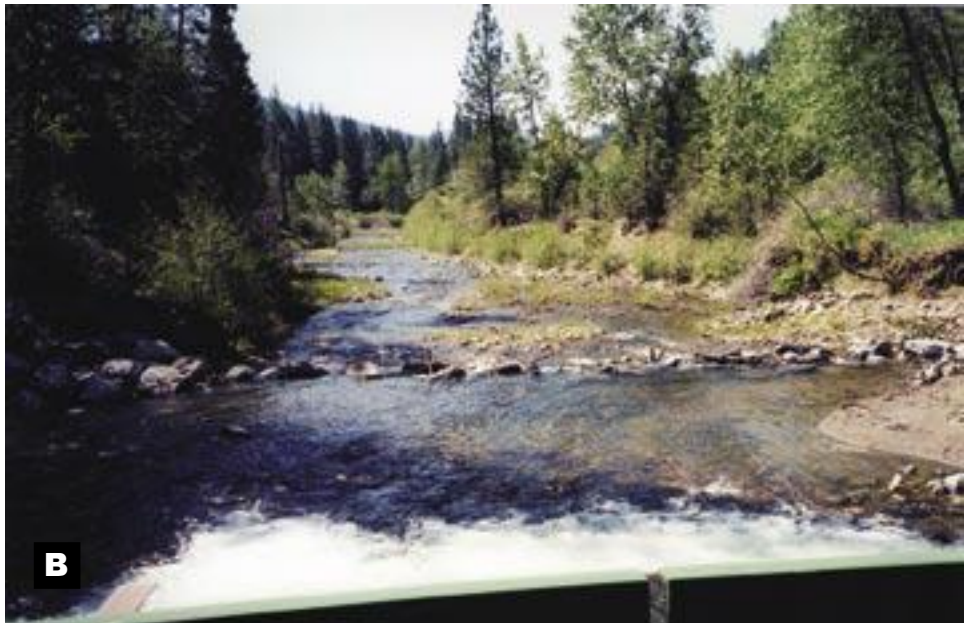
Figures A101a and A101b. Lights Creek a) upstream and b) downstream of the ford.

Channel Description: Lights Creek underwent severe downcutting prior to the installation of this grade control structure, and some aggradation has occurred upstream. The upstream banks are about 2 feet high and stable, with riparian vegetation including willow, cottonwood, alder, and pine trees as well as some shrubs (figure A101a). The channel is narrow with easy access to a wide flood plain on the right-hand bank. Downstream, the banks are over 8 feet high, nearly vertical, and subject to scour and raveling. The channel is 40 to 50 feet wide and widening, forming mid-channel bars, without flood-plain access (figure A101b). Channel slope was measured to be about 1 percent. The streambed is made of a well-graded mixture of sands, gravels, and cobbles. Occasional boulders exist to a maximum size of 8 inches.

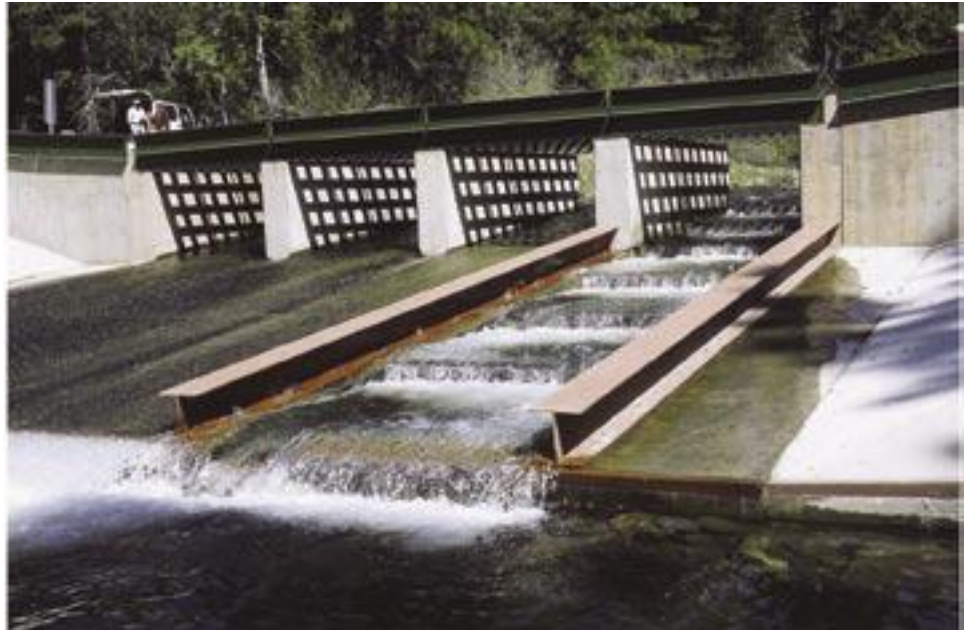
Figure A102. Detail of the fish ladder built into the Moonlight Crossing.

Aquatic Organisms: Providing passage for fish is a key issue at this location. This section of stream provides habitat for nonthreatened native brown and rainbow trout, as well as nongame species. How effective the fish ladder is in providing passage for all fish and lifestages in the stream is unknown. The large pool downstream of the structure aids fish passage through the structure by providing a resting area and take off point for the jump into the ladder (figures A102 and A103).

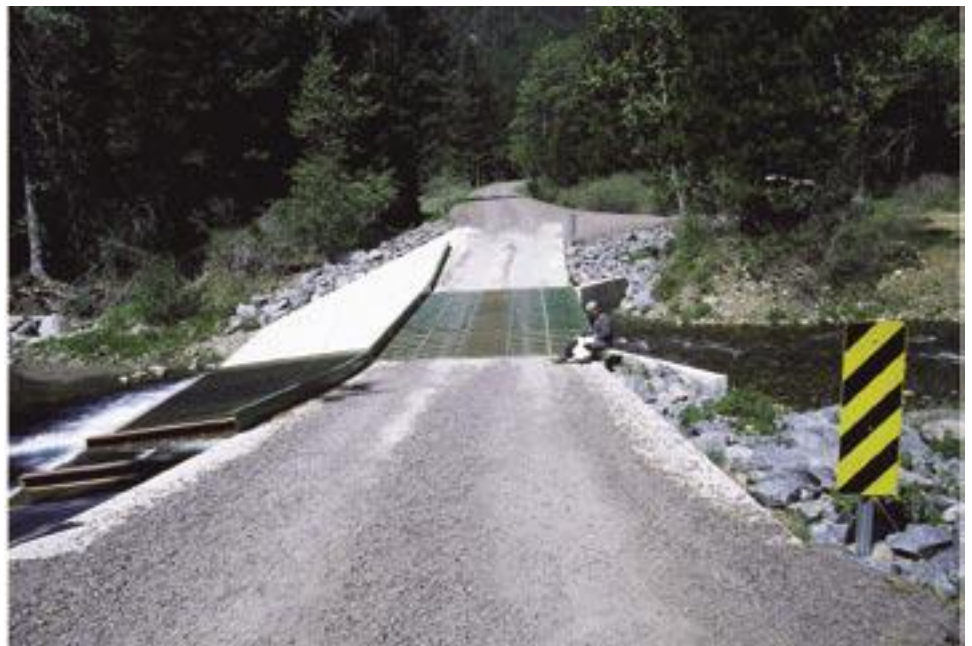
Figure A103. Roadway across the Moonlight ford.

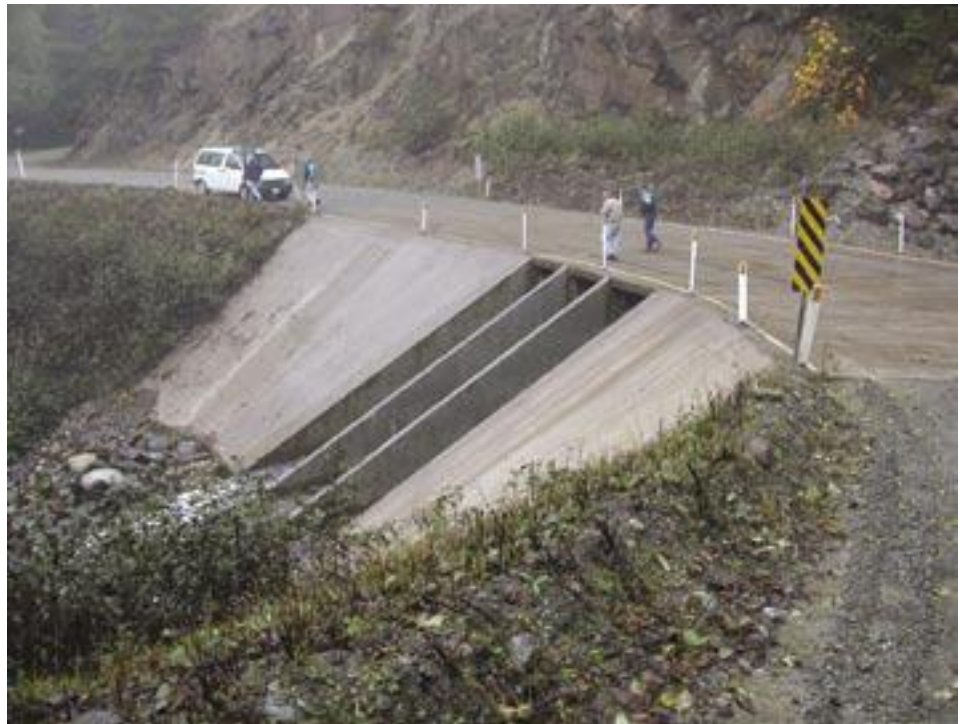
Figure A105. Sibley Creek vented ford.

This massive vented ford was constructed in 1997, after rain-on-snow floods washed out the crossing. The stream is very steep and prone to debris torrents, and previous drainage structures have failed repeatedly over the years. The road is closed in winter, but is a major access route to North Cascades National Park, and long-term traffic interruptions (which occur when this crossing washes out) are not desirable. The structure is a large concrete edifice with three box culverts with removable concrete tops (figure A105). The design allows it to pass large rocks and debris over the top, and to withstand the high stream power at this location.

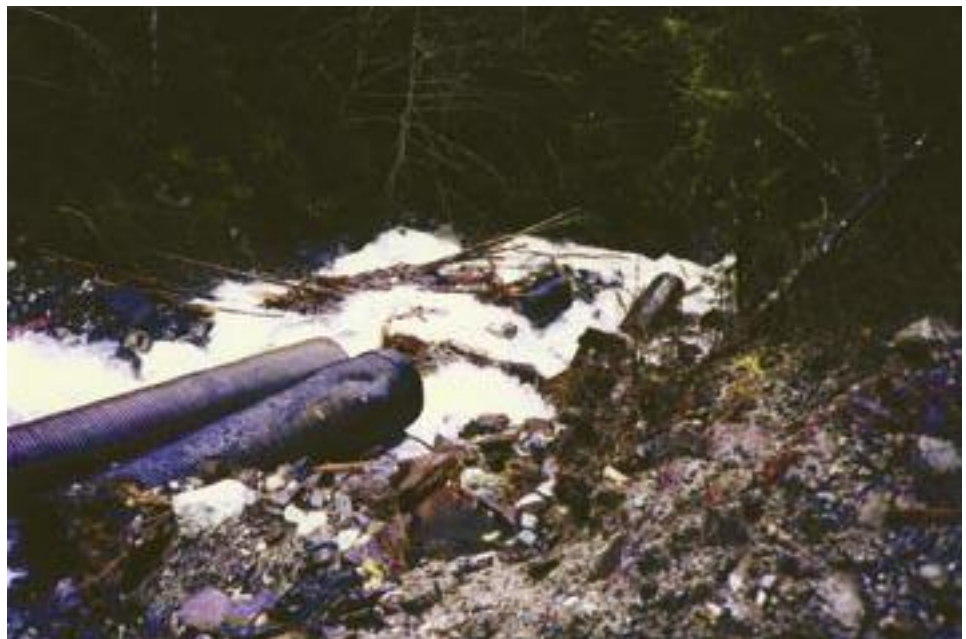
Figure A106. Two-culvert crossing on Sibley Creek blew out in November 1995.

Previous structures at this site have included multiple culverts, which have been washed out at least 6 times since 1960 (1962, 1976, 1988, 1989, 1990, and 1995) (figure A106). Those events had resulted in significant sediment deposition of roadfill material in coho salmon spawning areas in lower Sibley Creek, as well as temporary loss of public recreation access.

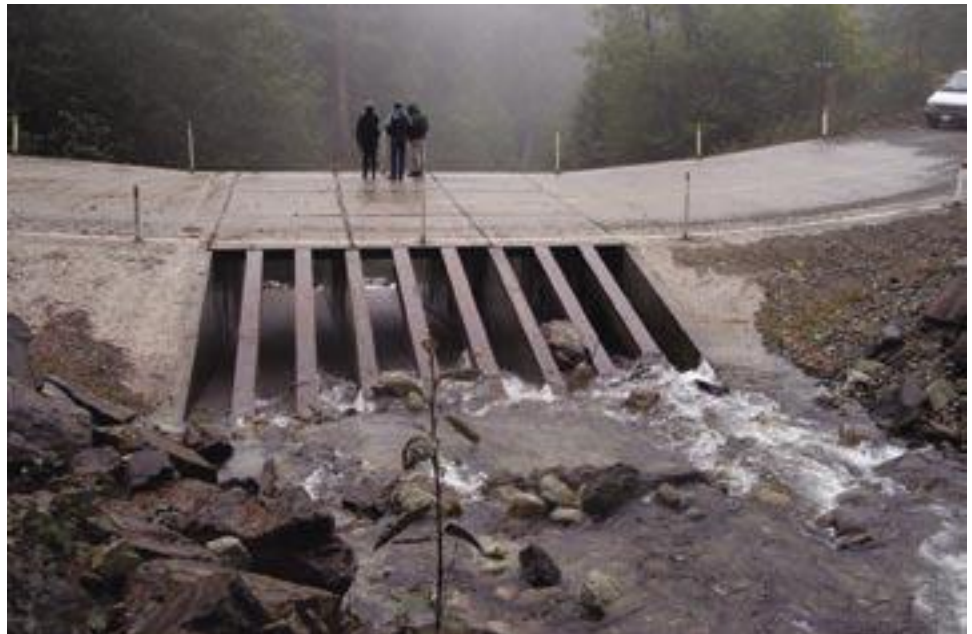
Figure A108. Looking downstream at the ford.

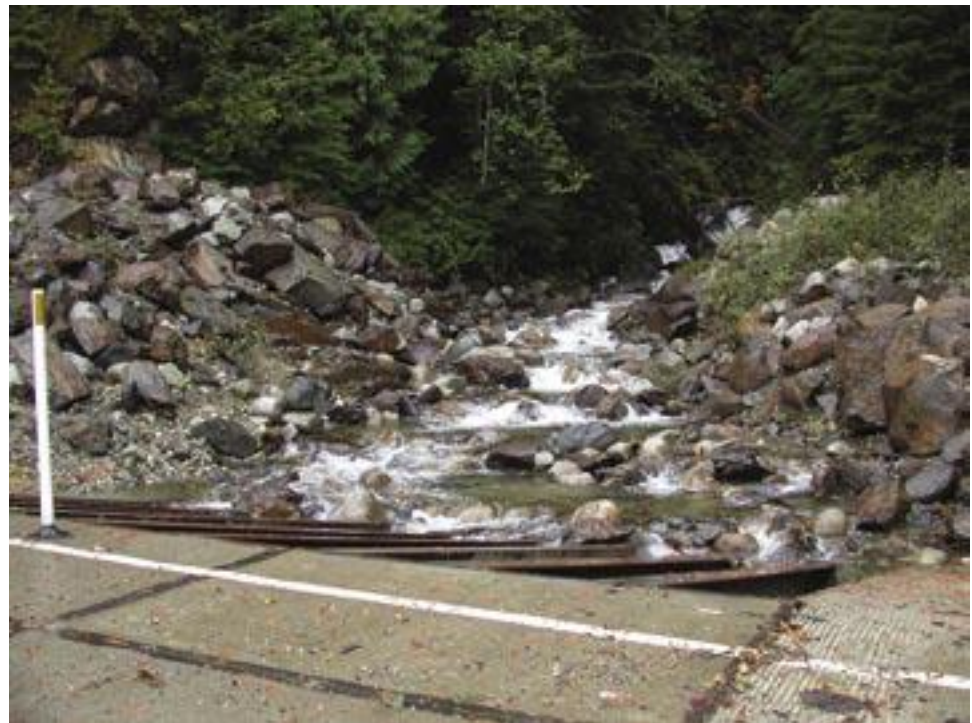
Figure A109. Sibley Creek currently approaches the inlet at a slight angle.

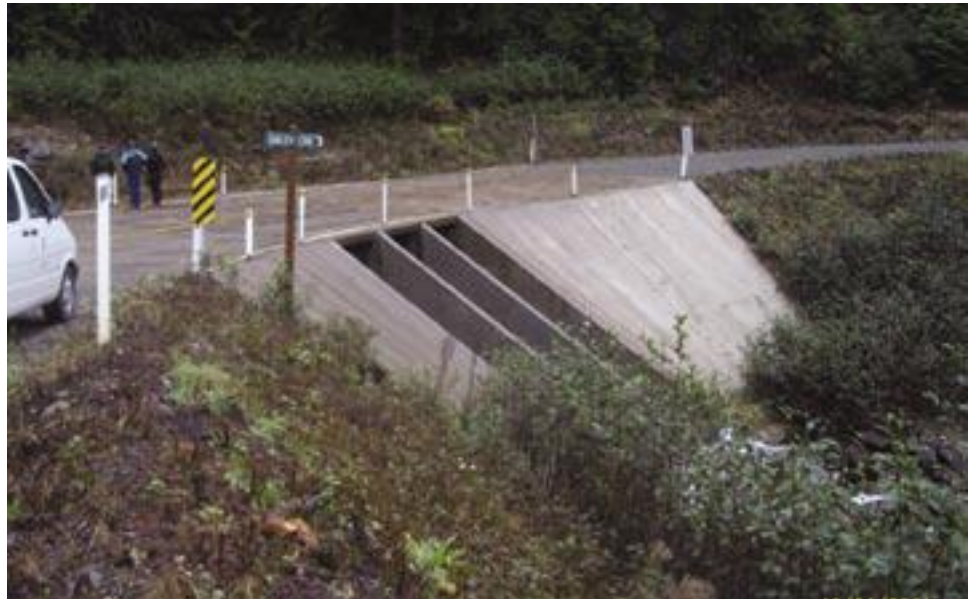
Figure A110. Safety markers on ford and approaches.

Safety: Delineator posts define the road edges and type III object markers are at both ends and both sides of the ford to focus traffic toward the road center (figure A110).

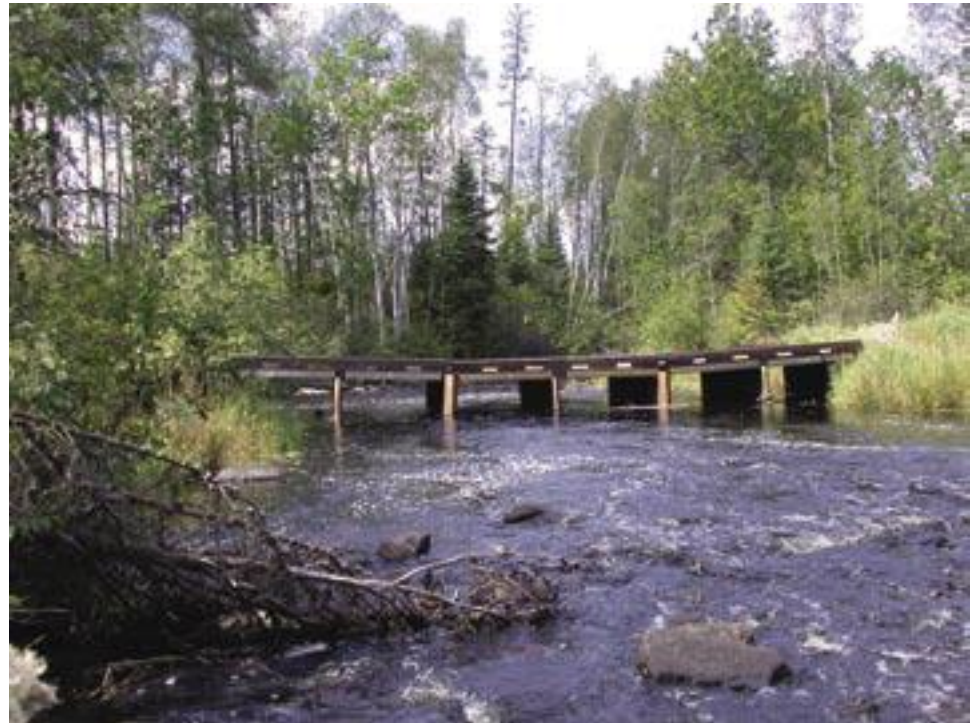
Figure A112. Stony River box culvert ford.

This structure was constructed in 1984 on a perennial fish-bearing stream (figure A112). It is a series of treated timber box culverts embedded into a cobble-boulder streambed. The opening is about 85 to 90 percent of bankfull width on a relatively straight pool-riffle channel. Low-flows pass through the structure at similar velocities and depths as in the channel itself, and the structure appears to be passable to fish most or all of the year. The ford was designed to pass the 25-year flow under the bridge deck, and to resist common ice jams. Water has barely overtopped the deck twice, and the structure has required only occasional debris removal and some reinforcement of the joints and connectors.

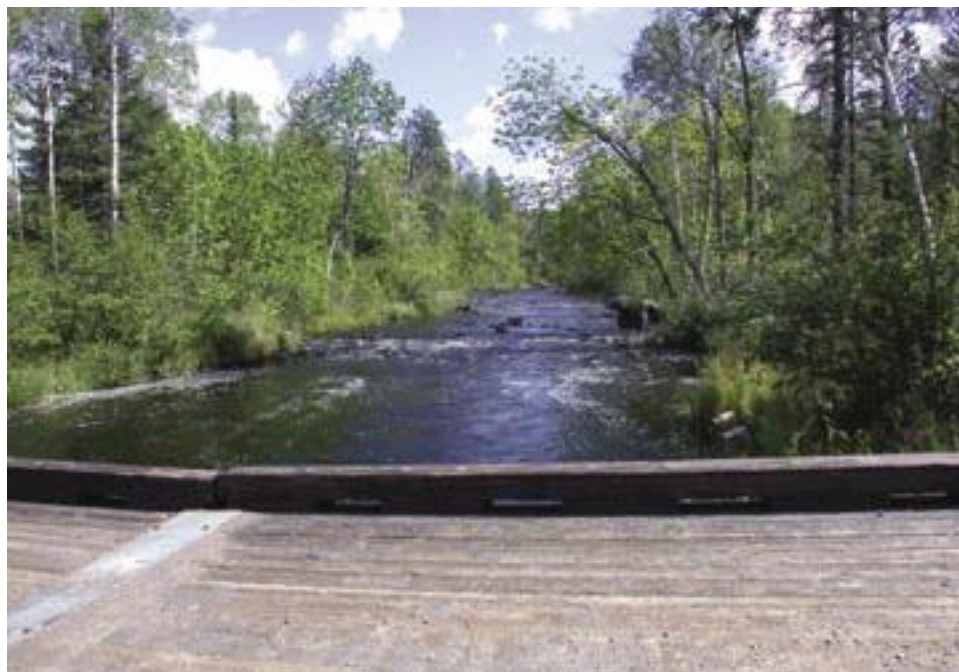
Figure A113. Stony River looking upstream from the ford.

Channel Description: Stony River is low sinuosity pool-riffle channel (a B2c or C2 stream type) about 50 feet wide. Boulder riffles provide streambed structure, and pools are quite shallow. Slope near the site is approximately 1.25 percent. Boulders vary from large to small, with a predominance of small to medium sizes. The adjacent riparian area has some tree cover, with dense shrub and sedge vegetation, and the potential for large woody debris recruitment to the channel is low to moderate. Boulders, wood, and vegetation provide good bank stability. The channel is moderately entrenched to unentrenched at the site, with a 5-foot terrace on one bank, and a narrow flood plain on the other (figure A113).

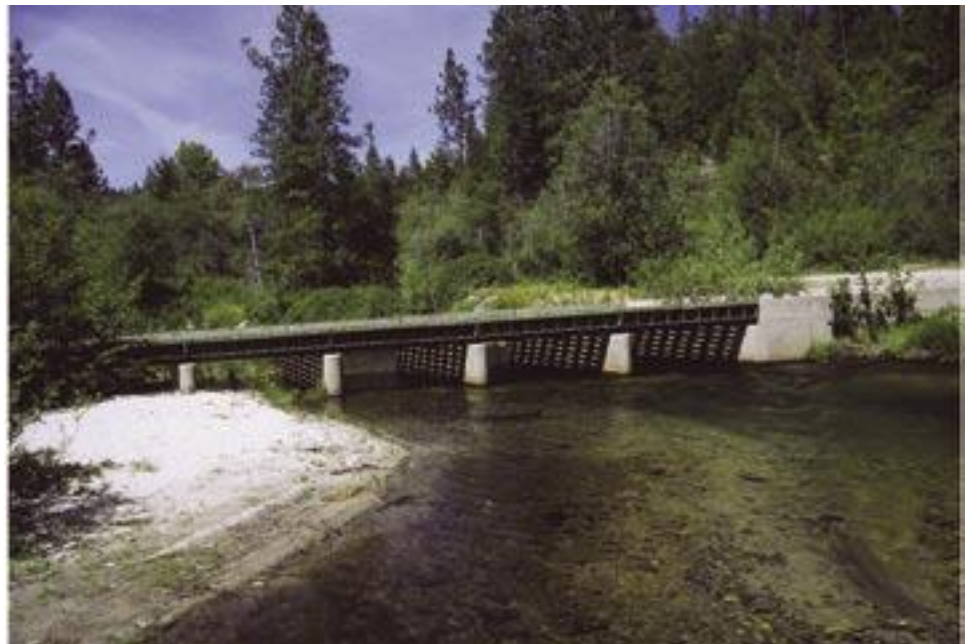
Figure A114. Looking upstream at the French Creek vented ford.

This structure, constructed in 1981, is located on a perennial stream where fish passage and woody debris jams are issues of high concern. The structure has a long, low profile. It is a 15-foot-wide, 240-foot-long concrete structure with five concrete boxes across about 50 feet of active stream channel (figure A114). The boxes are set just below the streambed elevation and native streambed material covers most of the floor. The top of the ford, about 5 feet above the channel, has a metal grating driving surface. The structure required minor repairs and lengthening of part of the armored driving surface after some large storm events when large amounts of debris accumulated behind and on top of the structure. Due to flow acceleration over the smooth concrete surface through the boxes, a large plunge pool has formed downstream of the ford. To prevent the ford from being undermined, a long gabion “mattress” has been placed across the channel at the downstream edge of the structure .

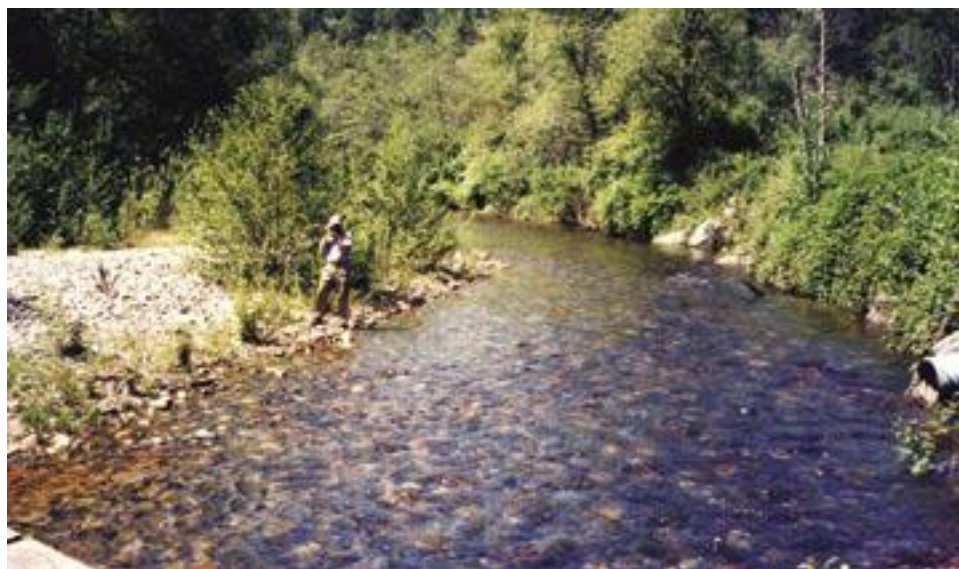
Figure A115. Looking upstream from the ford at French Creek.

Channel Description: French Creek is an unentrenched C4 channel; bankfull width and depth are about 55 feet and 2 feet respectively (figure A115). The substrate is a well-graded mixture of sands, gravels, and cobbles, and there is considerable bed movement during storms. Channel slope is less than 1 percent. The crossing is located on a broad bend, and the ford crosses French Creek from a low terrace on the east side across a point bar-flood plain sequence on the west side. Heavy riparian vegetation, including willow, alder, and blackberry vines stabilizes the 8-foot high terraced banks. The five boxes match the stream bed width so that low flows pass the structure freely. However, to keep vehicles out of the water during normal high flows and maintain a level driving surface across the point bar, the slab is raised 2 to 3 feet above the point bar. This induces some scour immediately downstream of the structure as water pours over the raised slab.

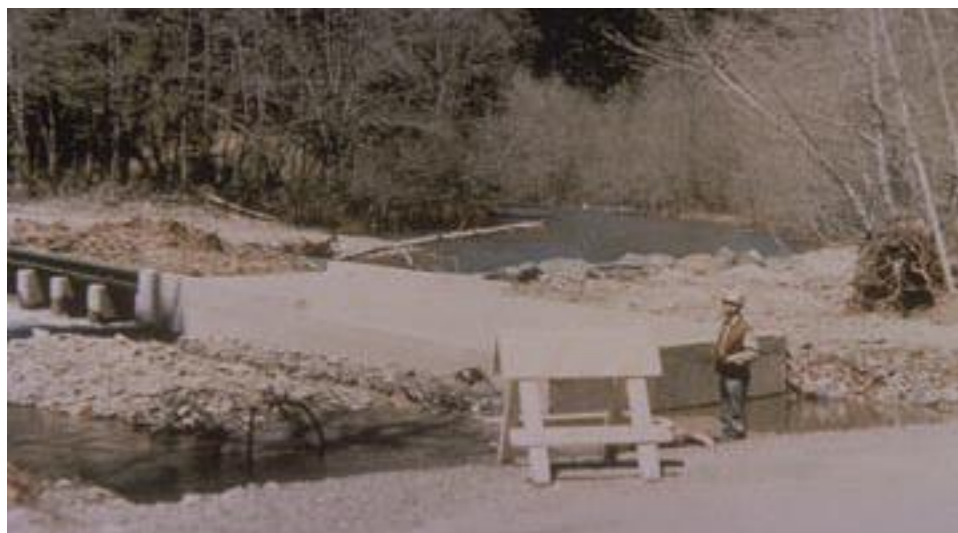
Figure A117. Scour around the east end of the structure after the 1986 flood. The concrete driving surface was then extended 50 feet.

The vented ford was slightly damaged by scour in 1982, the year after it was constructed, and again during a flood in 1986. In 1986, the structure was overtopped and a scour hole formed in the roadway where the original concrete armoring ended (figure A117). The concrete roadway surface with 3-foot deep cutoff walls was extended 50 feet on the east side, covering the area of scour. Also some energy dissipation measures were added along the downstream edge of the structure where the water flows over the concrete slab roadway. Large articulated concrete blocks were used, as well as some additional large riprap (figure A118b).

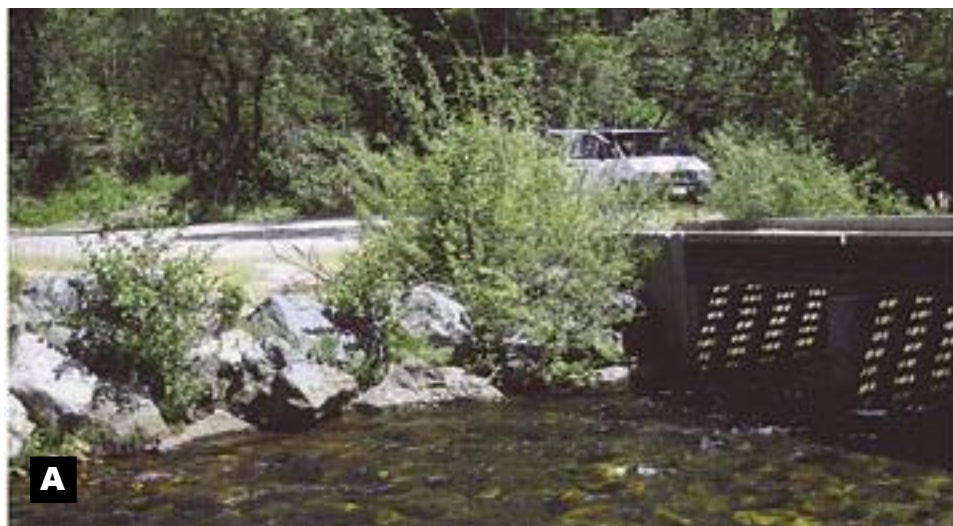
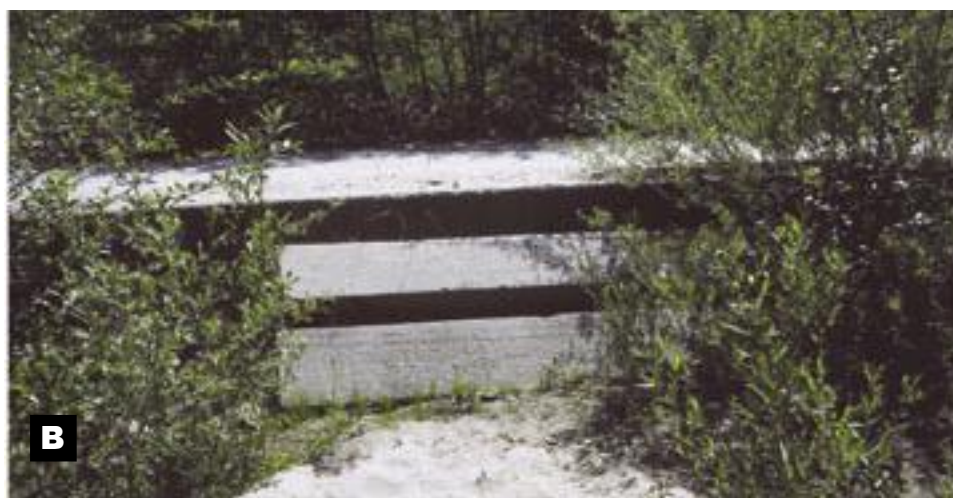
Figures A118a and A118b. Scour protection measures a) using riprap with vegetation along the channel (left) and b) concrete blocks and gabions along the elevated roadway (right).

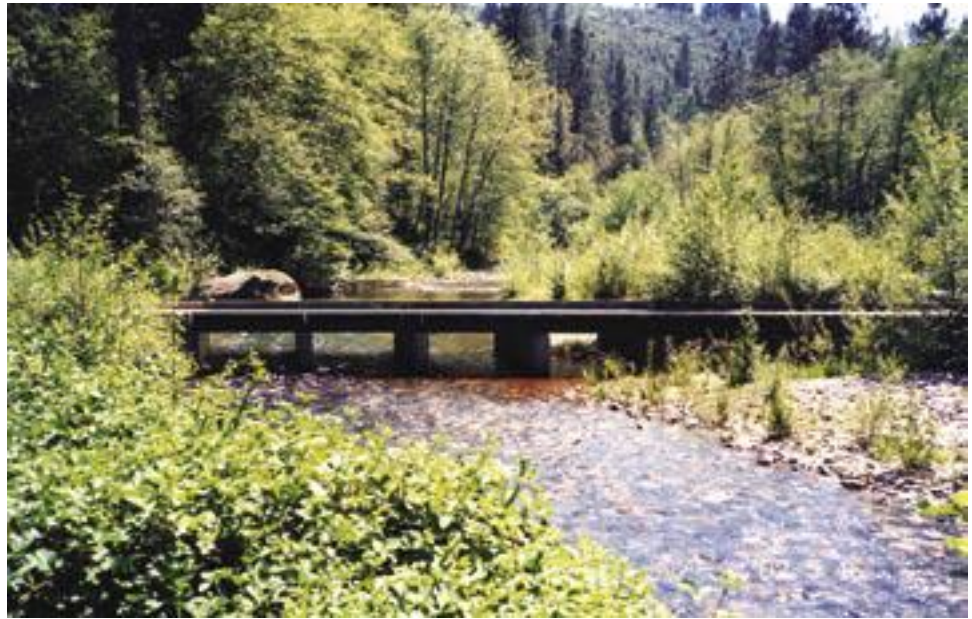
Figure A120. Looking downstream at the vented ford with point bar on right.
