U.S. Department
of Agriculture

Forest Service

October 2006

Low-Water Crossings: Geomorphic, Biological, and Engineering Design Considerations

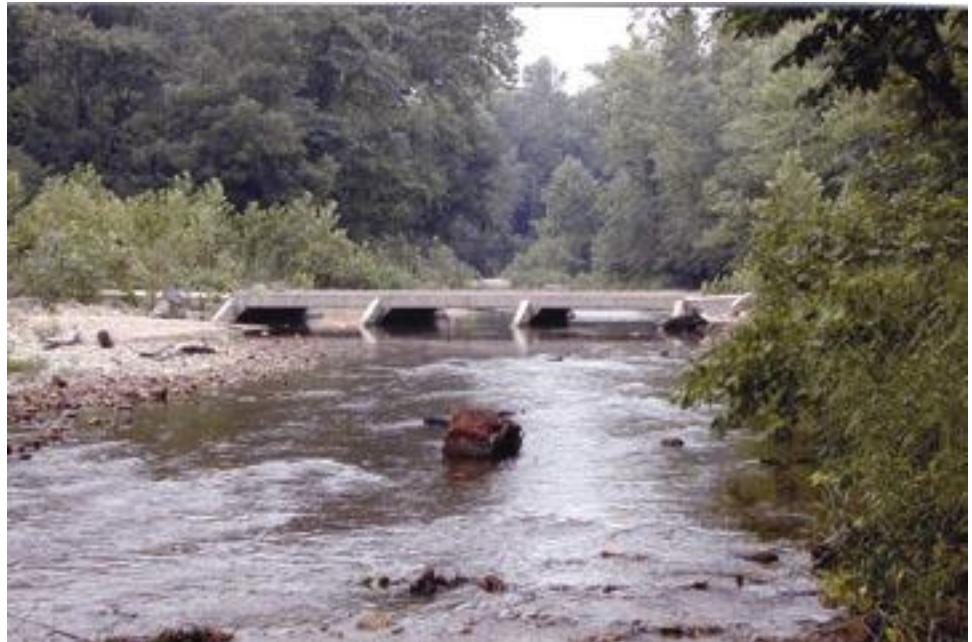
Figure A121. Looking upstream at Mill Creek box culvert vented ford, 2002.

The current structure was built in 1994 in a State-designated wild trout management area. Traffic access is required year-round for private residences and recreation; fish passage is also required. The structure is a set of three box culverts that overtops at least once per year on average. The boxes are embedded about 1 foot so that the natural streambed is continuous through the structure (figure A121). The supports slope up toward the deck to facilitate large debris riding over the structure rather than damming it during overtopping flows.

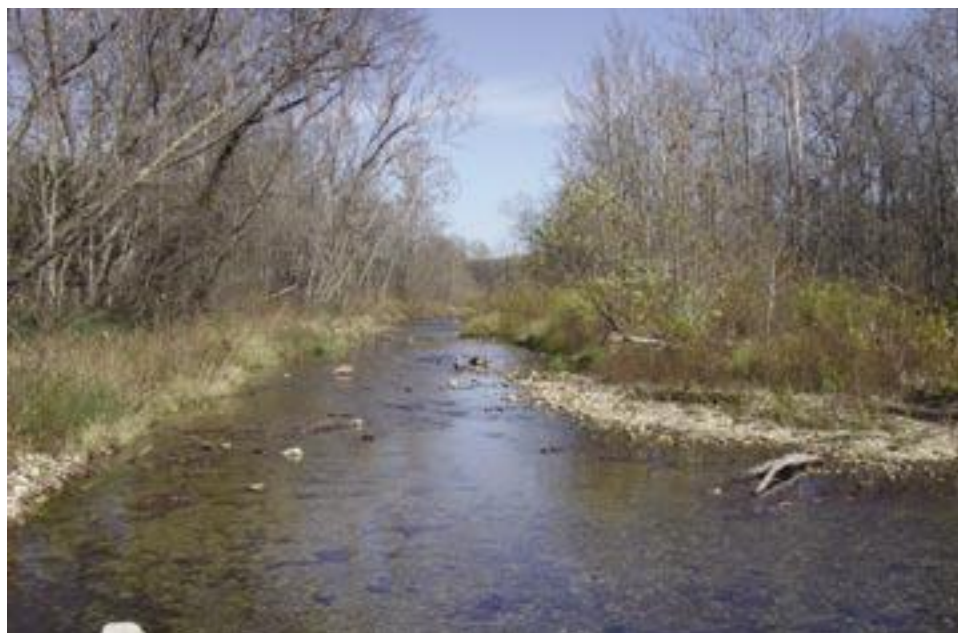
Figure A123. Looking downstream on Mill Creek from the box culvert ford.

Channel Description: This reach of Mill Creek is a pool/riffle, gravel bed stream with an estimated gradient of 2 percent. It is about 40 feet wide away from the widened section at the crossing, and banks are 2 to 3 feet high (figure A123). The well-vegetated flood plain is about 3 feet below the wooded terrace that forms the broader valley floor. The channel appears to be vertically stable, but has at least moderate potential to migrate laterally. The crossing is on a slight bend, and crosses a gravel bar on the right bank (bar is on left side of figure A121). Historical land use in this area of the Ozarks, especially riparian grazing and stream channelization, affected streams by removing riparian vegetation and inducing bank erosion. This mobilized large volumes of gravel, and streams responded by widening and shallowing (Jacobson and Primm, 1997). Bank erosion is prevalent on some reaches of Mill Creek.

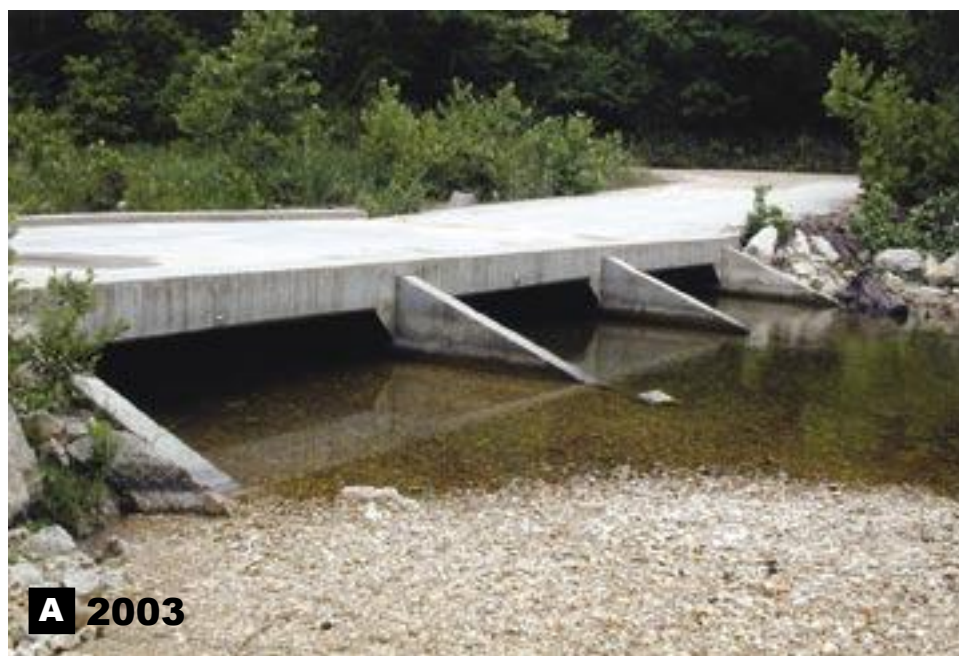
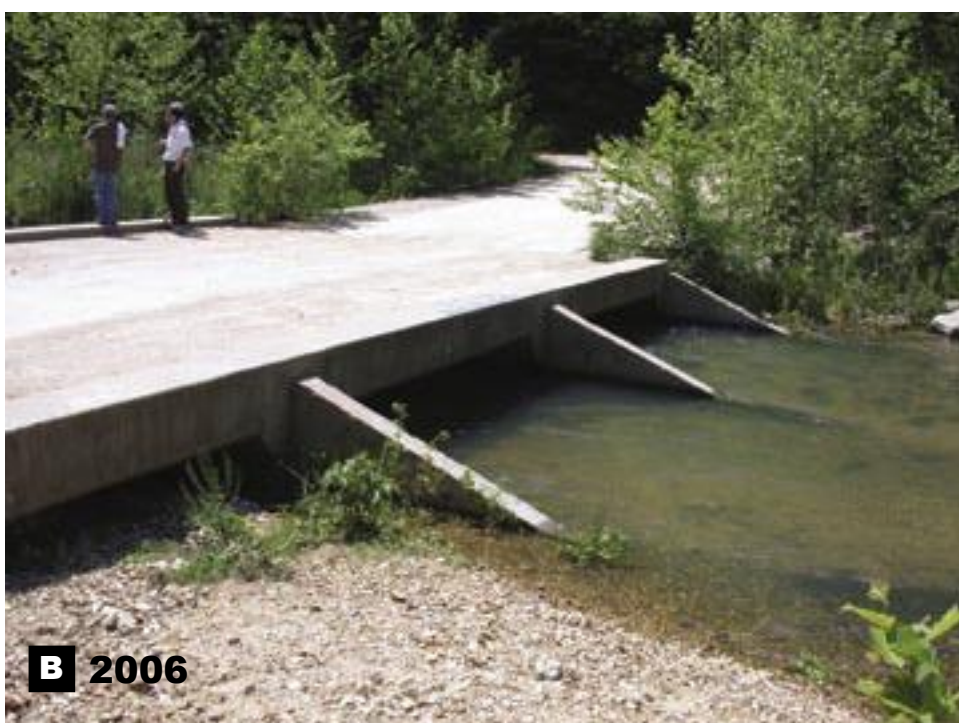
Figures A124a and A124b. Downstream side of the box culvert crossing. Between 2003 and 2006, gravel bar enlarged to block one box.

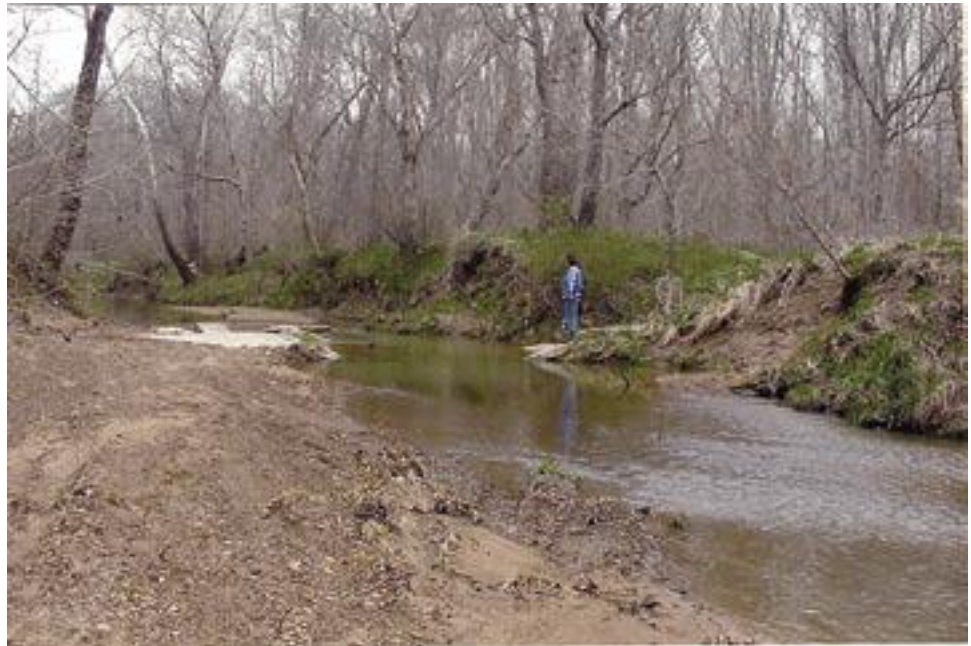
Figure A125. Looking upstream at failed Kinkaid Creek crossing, 2000. Stream slope is 0.3 percent.

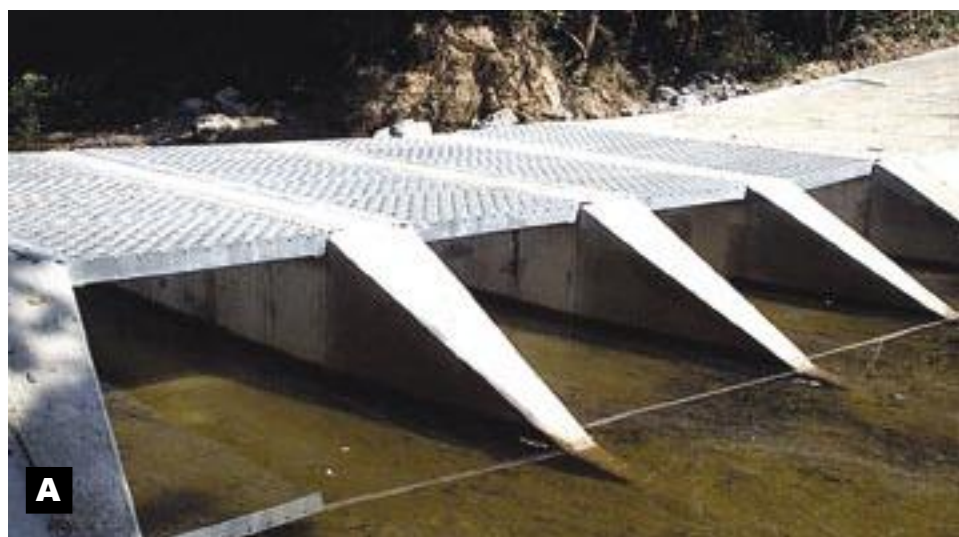
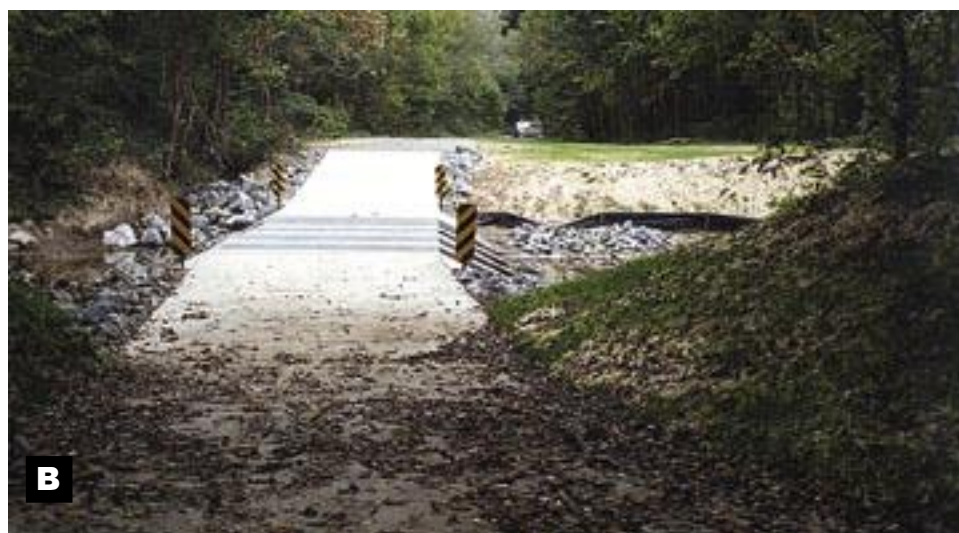
Figures A126a and A126b. Kinkaid crossing just after construction in 2001. A126a. Close up of embedded boxes; A126b. View along vented ford showing riprap.

Sustained concentrated rainfalls of several inches per day cause peak flows in this area, and peaks on Little Kinkaid Creek are very flashy. Since traffic use is low and would be interrupted only a few hours during any one runoff event, a low-water crossing was a desirable and cost-effective solution here. However, the design had to account for the unstable, erodible banks and tendency for debris and bedload plugging. The designer selected a very low-profile structure to encourage woody debris to go over the top and to avoid large changes in flow width that would put pressure on the banks at bankfull and higher flows. The structure is a set of four 5-foot wide concrete boxes with metal-grate decking that can be removed to clear the boxes. The box walls slant out and down, as at Mill Creek, to help debris slide over the top (figures A126 and A127).

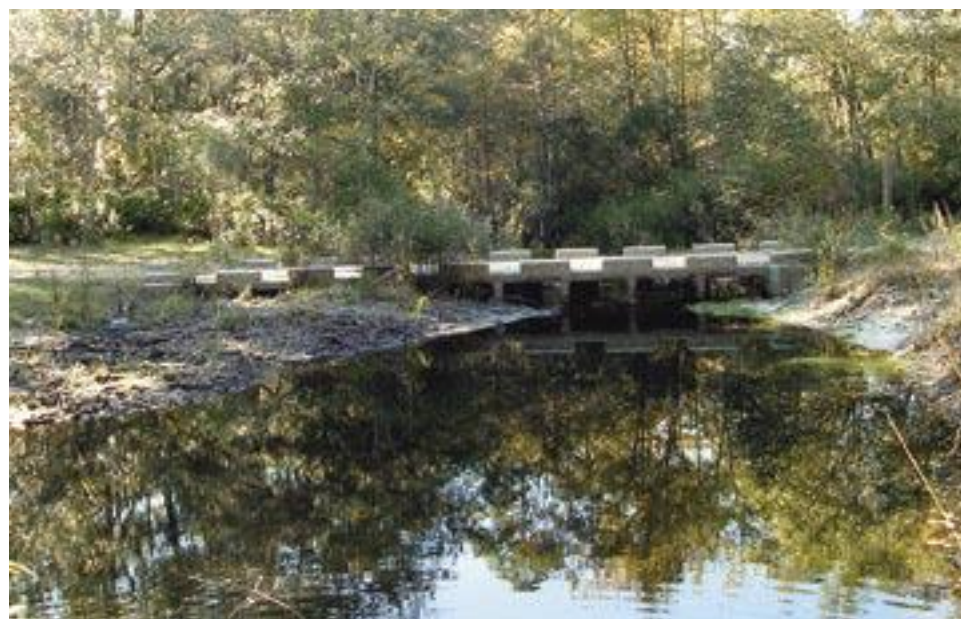
Figure A128. Looking downstream at the low-water bridge, November 2003.

This low-water bridge was constructed in 1991 (figure A128). It is built of preformed concrete T-sections set parallel to the direction of streamflow. The T-sections are supported by two concrete mud sills placed on the sand and clay streambed. The channel and surrounding area are quite flat and the flood plain is several hundred feet wide. The bridge approximates the channel dimensions, and it does not alter flow velocities and sediment transport enough to cause significant channel changes. When water overtops the bridge, there is virtually no plunging flow (the site is backwatered) and velocities remain moderate. Periods of submergence typically last for 1 to 2 weeks.

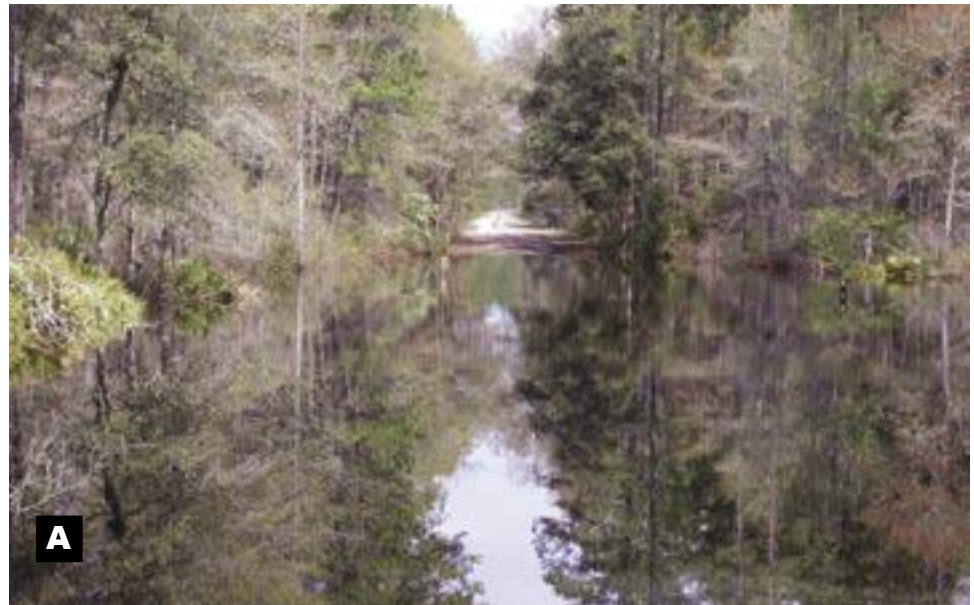
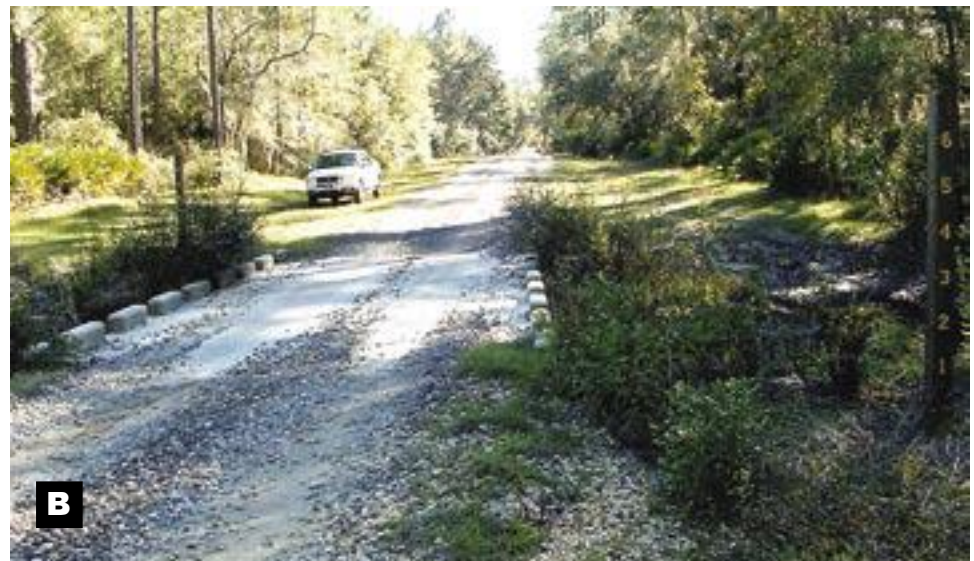
Figures A129a and A129b. A129a. March 13, 2003. Bridge is under approximately 6 feet of water. Note depth markers in center. A129b. Looking opposite direction along bridge, November 2003.

to utilize the entire width of the flood plain and to flow freely down the valley. The stream is about 10 feet wide where it flows through undisturbed forest, with nearly vertical 2-foot-high banks stabilized by an intertwined mass of roots. At the crossing site, the stream is about 40 feet wide, and the bridge matches this width. Soils in the area, including the streambed and banks, are mixed sand and clay. Because of long periods of very low surface flows, vegetation overgrows much of the streambed and tends to stabilize sediment deposits. During overbank flow in March 2003, water velocity in the thread of fastest flow was estimated at between 1 and 2 feet per second (figure A129).

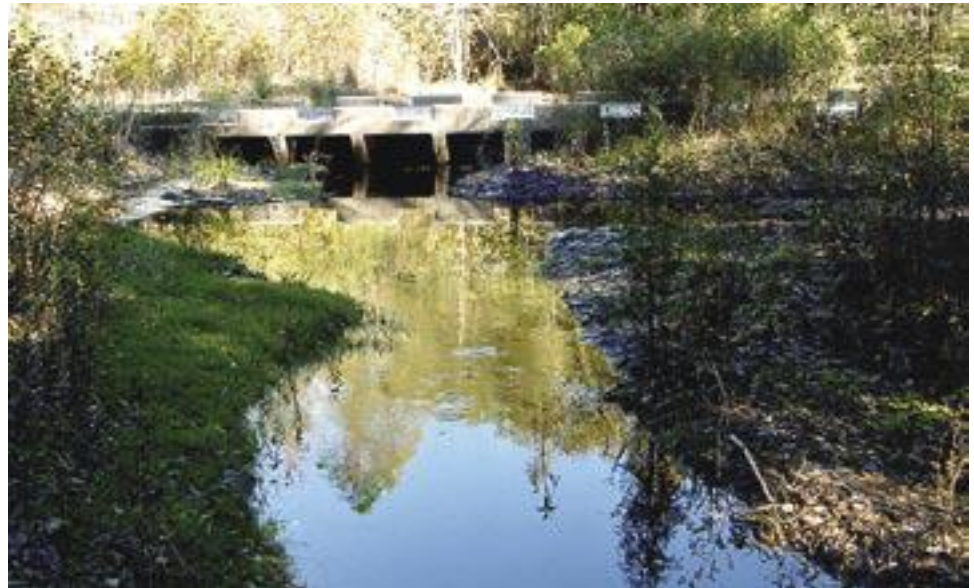
Figure A131. Sand and silt deposit downstream of the bridge (2003).

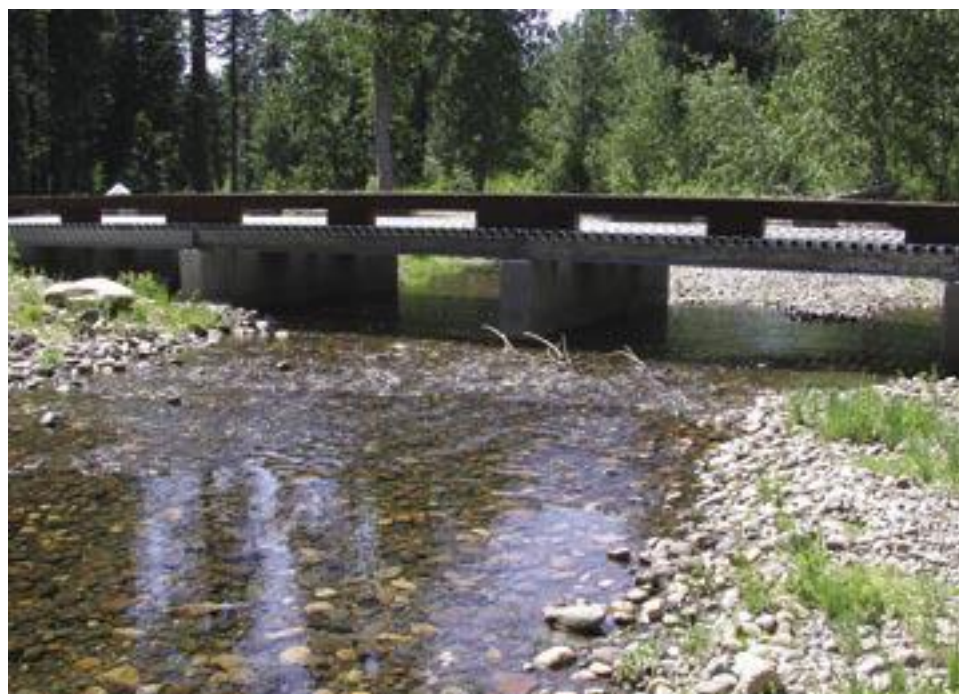
Figure A132. Looking downstream at the Capps low-water bridge. July 2002.

This low-water bridge was constructed in 1998 as an Emergency Relief for Federally Owned Roads (ERFO) project (figure A132). It replaced a vented concrete slab ford that plugged and caused substantial channel and flood plain damage during the 1997 flood. Because the old ford blocked sediment transport during high flows, it had caused dramatic channel aggradation and flood plain erosion. To reestablish channel stability at the site, the designers decided to bridge the entire flood plain, and to provide for overflow in case of debris jamming. The bridge has 13 concrete piers set on bedrock and the deck is square steel tubing with two smooth steel plate runways.

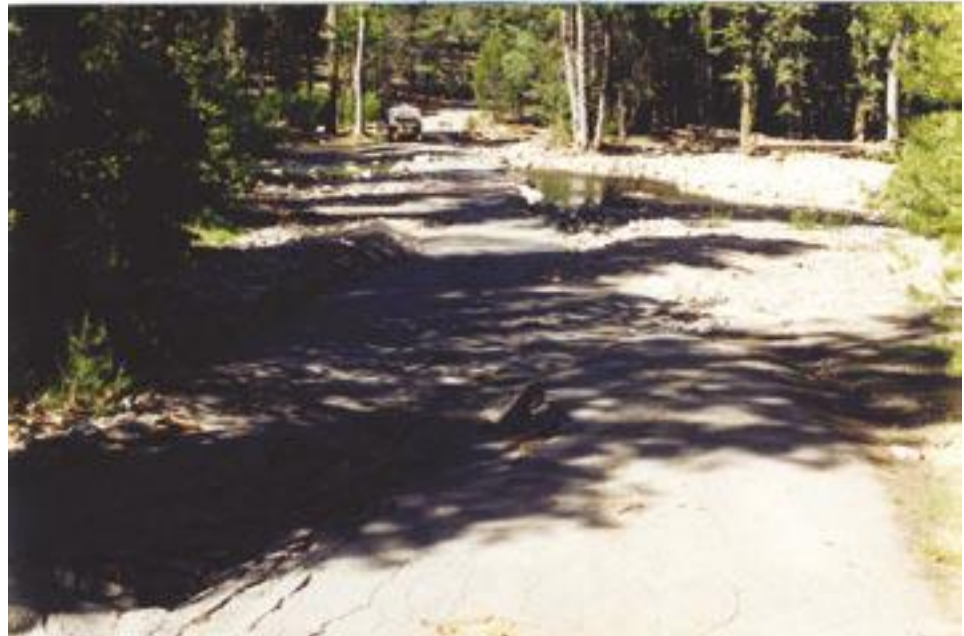
Figure A133. Capps ford after the 1997 flood. Flood flows spread out across the entire valley and road is washed out on far side.

Subsequent ford improvements did not solve the problem. The structure that existed prior to the 1997 flood of record was a concrete slab with an 8-foot-wide concrete box culvert, which filled with bed material and needed annual cleaning even during normal years. During floods, the ford plugged and flow spread over the flood plain, eroding and changing channel location, and washing out the road approaches. To reopen the road after floods, onsite stream-deposited material was routinely heaped up into a turnpike across the eroded flood plain, topped with an aggregate base, and either paved or oiled. This practice, combined with erosion during floods, explains why the flood-plain surface at the crossing site is several feet lower than in adjacent sections upstream and downstream of the site. Because of the widened section, sediment deposition was a serious problem, and the channel became so embedded it seemed to be paved. The vented ford washed out in 1997, during the flood of record (figure A133).

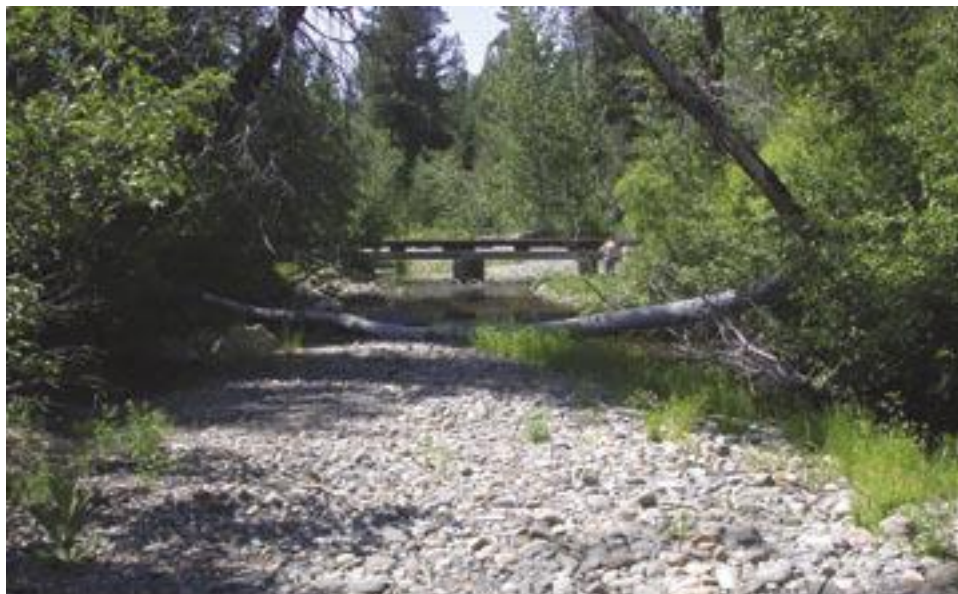
Figure A134. Downstream view of Capps bridge showing cobble bars and debris in channel.

Because the previous structure obstructed sediment transport, bed material at the site was much finer than in up- and downstream reaches. Cobble-embeddedness was very high. The new structure has allowed fines to migrate through, opening up the cobble bed again, and improving fish habitat.

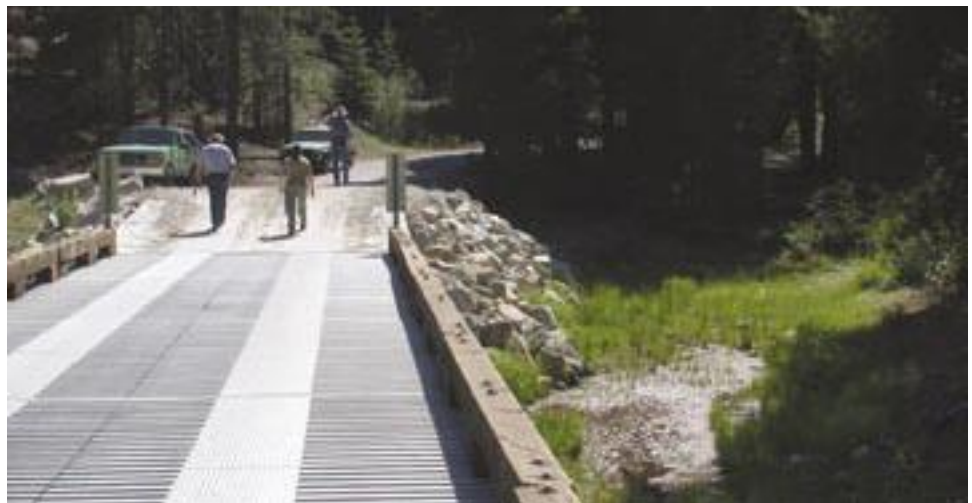
Figure A136. Note concrete abutment with riprap, grating with tire runways, and wood curbs.

Safety: Early cold weather in this area makes icing a hazard while the road is still open. Wooden guard rails were added to keep vehicles from sliding off the roadway (figure A136). Safety signing is limited to type III object markers on the ends of the bridge.

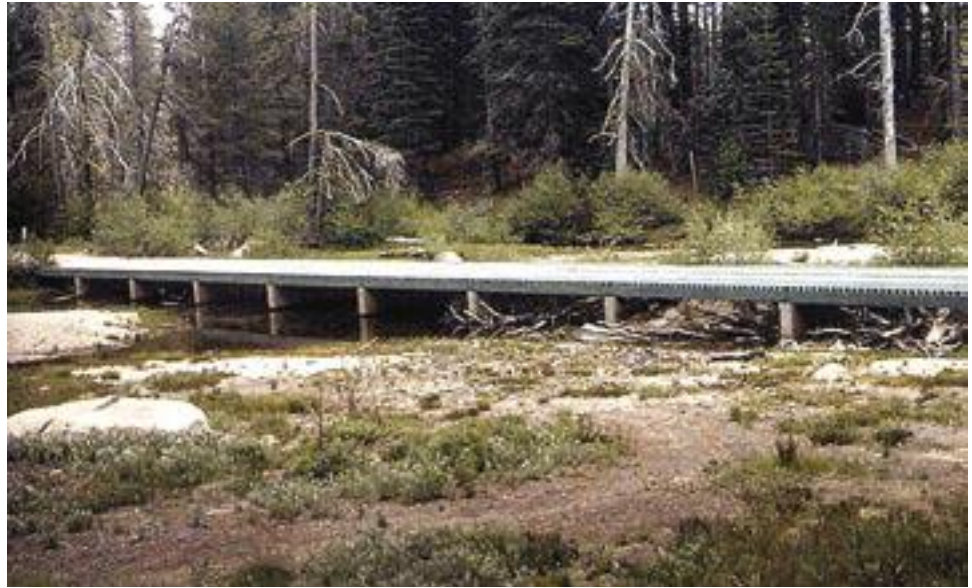
Figure A137. Looking downstream at Capps bridge with debris trapped under deck, 1988.

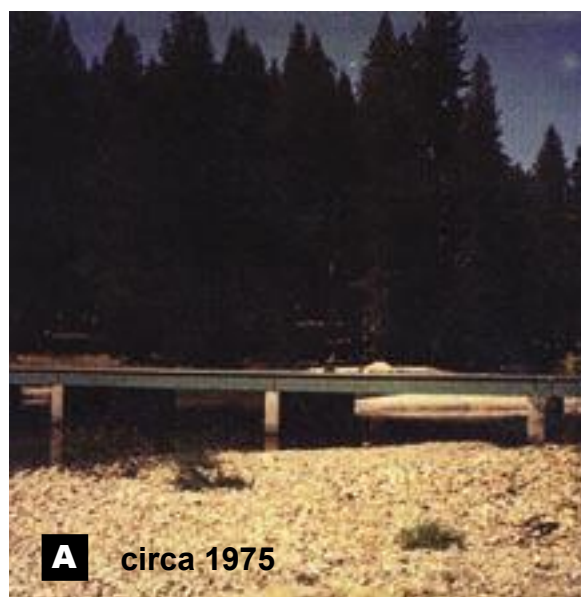
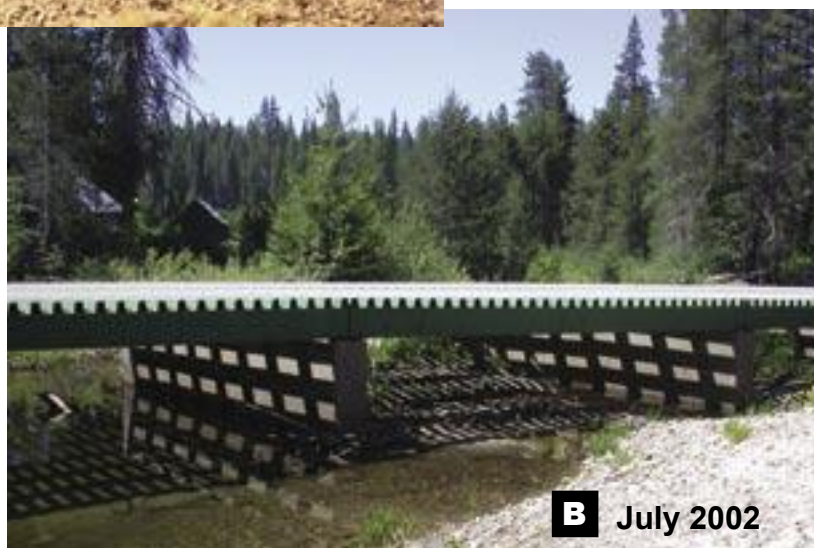
Figures A138a and A138b. Looking downstream at the Jones Wreckum Bridge.
A138a. Bridge inspection photo.

This reach is flatter than Capps, bed material is finer (coarse gravels about 1 to 1½ inch), and the channel appears to be more stable. The bridge is located just upstream of a right-angle bend in the river and crosses the point bar leaving enough space for natural adjustments in sediment storage. Woody debris trapped under the bridge on the point bar side has not been removed, and has contributed to sediment accumulation (figure A137). Both upstream and downstream bars have enlarged since the 1970s (figures A138a, A138b). Nonetheless, comparing current channel conditions to Brink's 1974 description, the channel does not seem to have changed much, indicating that the stream is functioning naturally and is stable. None of the pier footings are exposed.
